Final report RL 2020:06e

Accident at Vuoggatjålme, Norrbotten County, on 10 August 2019 involving the helicopter SE-JOA of the model Bell 206L-1, operated by Arctic Air AB.

File no. L-110/19

16 June 2020

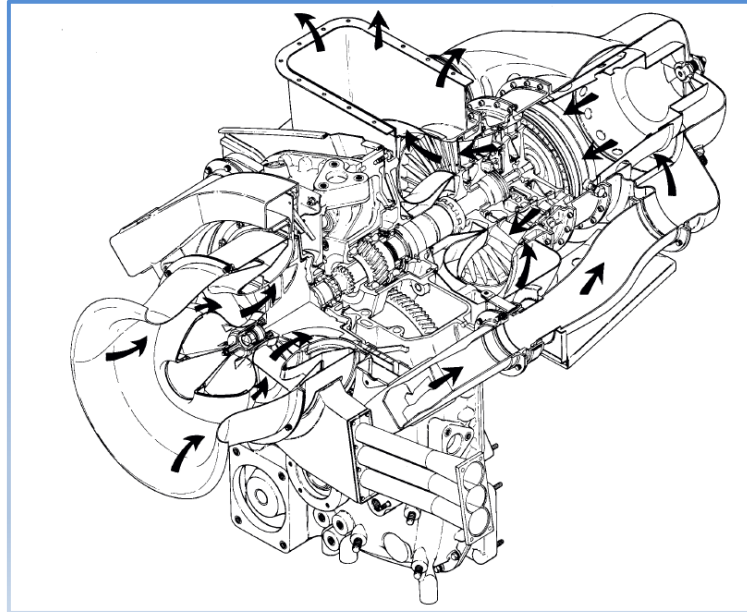
Figure 2. The engine, with arrows that show the airflow through it. Image: Rolls-Royce.

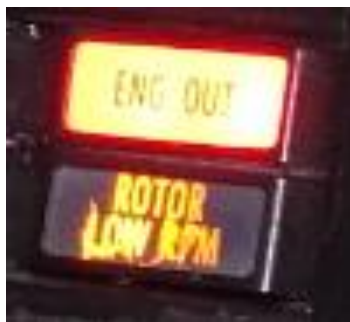
The helicopter’s instrumentation and monitoring system includes a warning for engine failure (ENGINE OUT). This warning is activated when engine speed is less than 55 % N1. Upon activation, a visual indicator “ENG OUT” (see Figure 3) is shown on the caution/warning panel and there is an intermittent audio signal.

The caution system for low rotor rpm (ROTOR LOW RPM) is activated when main rotor rpm falls below 90 % NR and if the collective pitch is of the down stop. The low rpm of the main rotor activates the “ROTOR LOW RPM” light (see Figure 3) on the caution/warning panel and a continuous audio signal is heard.

Figure 3. The indicators for engine failure and low rotor rpm are located furthest to the right on the caution/-warning panel.

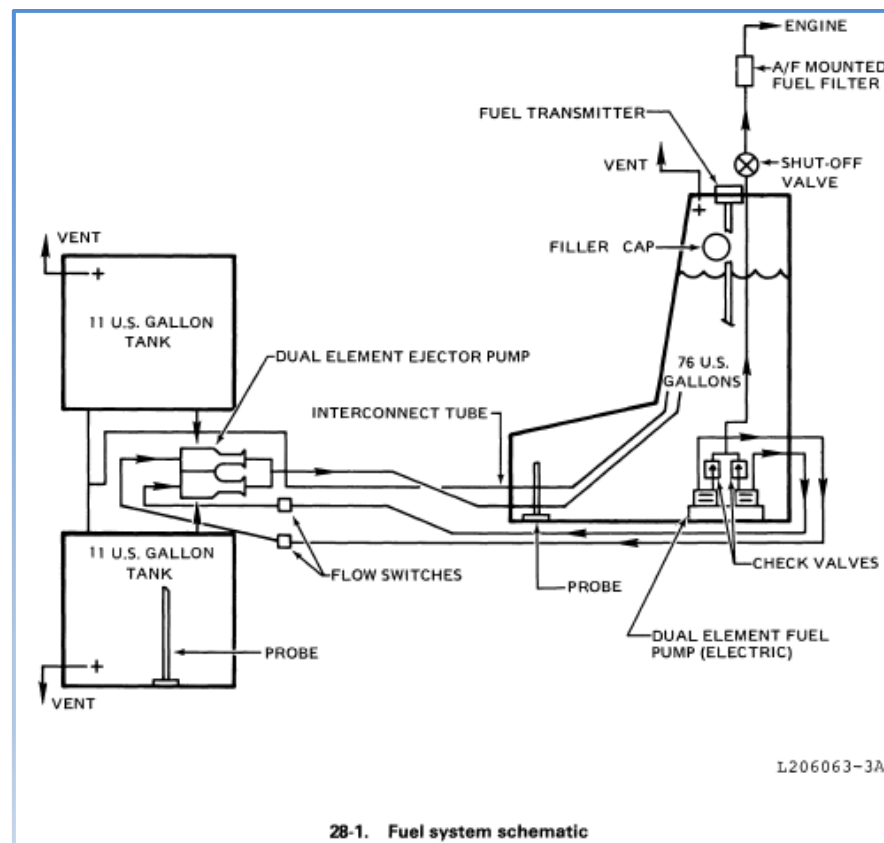
The system is comprised of three interconnected fuel tanks with a total capacity of 374.6 litres. Two of the fuel tanks are a little smaller and are located forward of the larger tank. When the fuel level exceeds 154 litres in the aft tank, the two forward tanks are filled via a standpipe. Two electrical fuel pumps mounted in the lowest part of the aft tank move pressurised fuel to two ejector pumps that are located between the forward tanks, which in turn move fuel from the forward tanks to the aft tank. The electrical fuel pumps also supply the engine with pressurised fuel via a shut-off valve and a filter. Both of the forward tanks have sensors that measure the fuel flow through the ejector system. The fuel quantity system consists of probes in the left forward tank and in the aft tank. The fuel quantity caution "FUEL LOW" is illuminated when there is a remaining fuel quantity of just under 38 litres. The quantity of unusable fuel is 3.78 litres.

Figure 5. Schematic of the helicopter's fuel system. Image: 206L-MM-CH28, Bell Helicopter Textron Inc.
