The Islamic Republic of Iran
Civil Aviation Organization
Aircraft Accident Investigation Board

Preliminary Report #2

Issue date: January 21, 2020

State File Number: A981018URPSR
Type of Occurrence: Accident
Date of Occurrence: Jan. 08. 2020
Place of Occurrence: Near Imam Khomeini INTL Airport/ the I.R of Iran
Aircraft Model: B737-800
Registration: UR-PSR

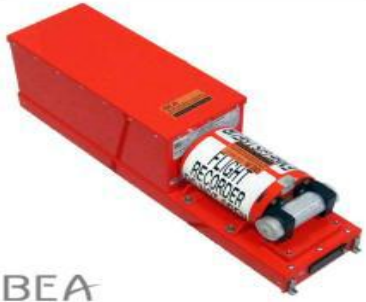
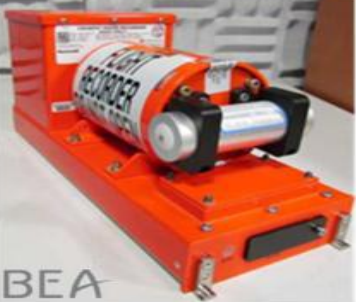
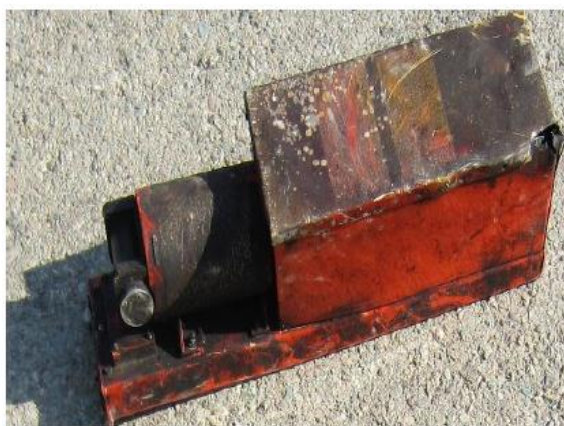
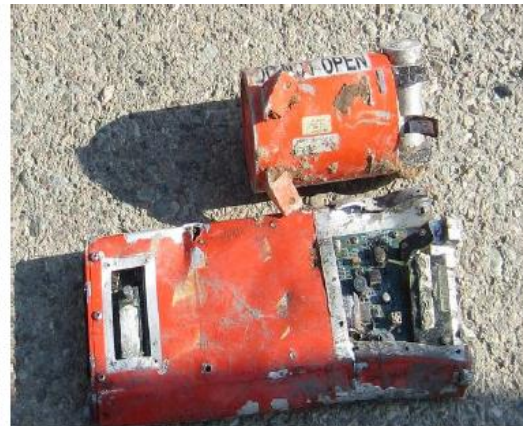
The aircraft was equipped with a Solid State Flight Data Recorder (SSFDR) with P/N 980-4750-003, which is capable of recording over 3000 digital and analog parameters as well as a Solid State Cockpit Voice Recorder (SSCVR) with P/N 980-6032-003 capable of recording the last two hours of flight conversations, and also a QAR, but only the SSFDR and SSCVR were found at the accident site. Damage to SSCVR was more serious, whose main memory (CSMU) has been detached. The condition of component indicates that the SSCVR has not been exposed to the fire on the aircraft and was detached as a result of the sever impact with the ground.

FDR P/N 980-4750-003	CVR P/N 980-6032-003
View of similar recorders in good condition
