Final report RJ 2022:02e

**Derailment involving a freight train
between Kummelby and Häggvik,
Stockholm County, on 11 February
2021**

File no. J-05/21

2022-06-02

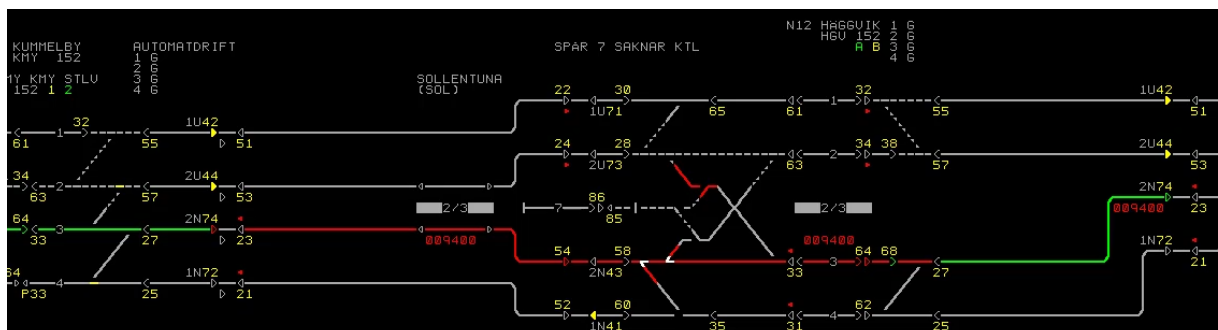
Figure 2. The traffic controller's control and monitoring system at 02:16:22 hrs. White markings indicate that control of the points is not confirmed (out of control). Source: Swedish Transport Administration.

At 02:16:16, the locomotive was at Häggvik commuter station at the same time as the derailed wagons were passing the points south of the platform. In conjunction with the derailed wagons passing the points, these were indicated as being ‘out of control’ (see Figure 2).

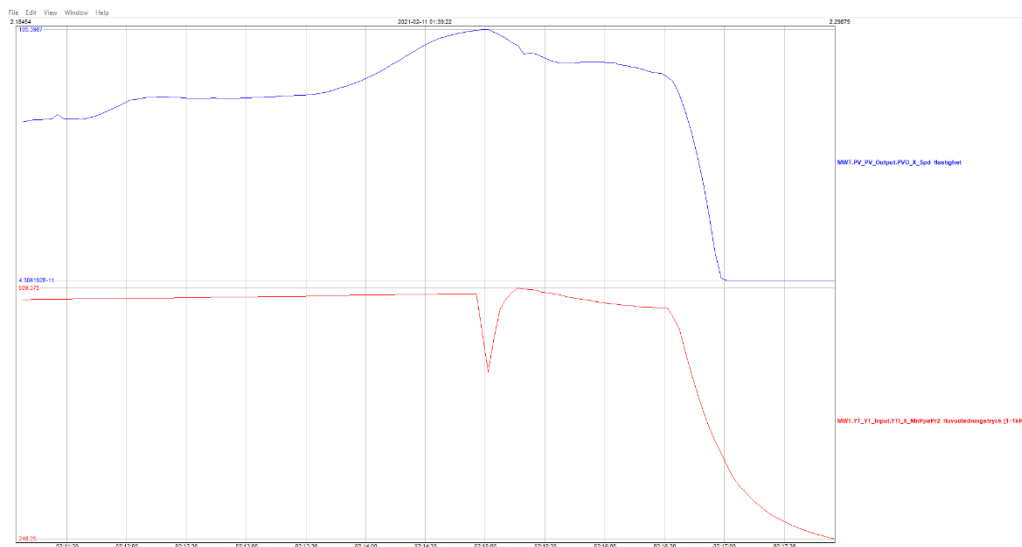
It is possible to establish from the data from the train event recorder that the train was being operated at a speed of no more than 105 km/h and that the driver adjusted the speed with a reduction in the train pipe pressure at 02:14:55–02:15:05 hrs (see Figure 14). The track slopes downhill from Kummelby to Sollentuna, which may explain why the speed of the train increased temporarily to 105 km/h.

Figure 14. Excerpt from the train event recorder from 02:11 to 02:17 hrs. The blue line shows the speed and the red line shows the train pipe pressure. Source: Green Cargo AB

As shown in Figure 14, a short ‘notch’ in the speed curve coincides with the brake pipe pressure slowly beginning to fall. This is probably the effect of the derailment having begun, which is affecting the brake pipe pressure and the speedometer.

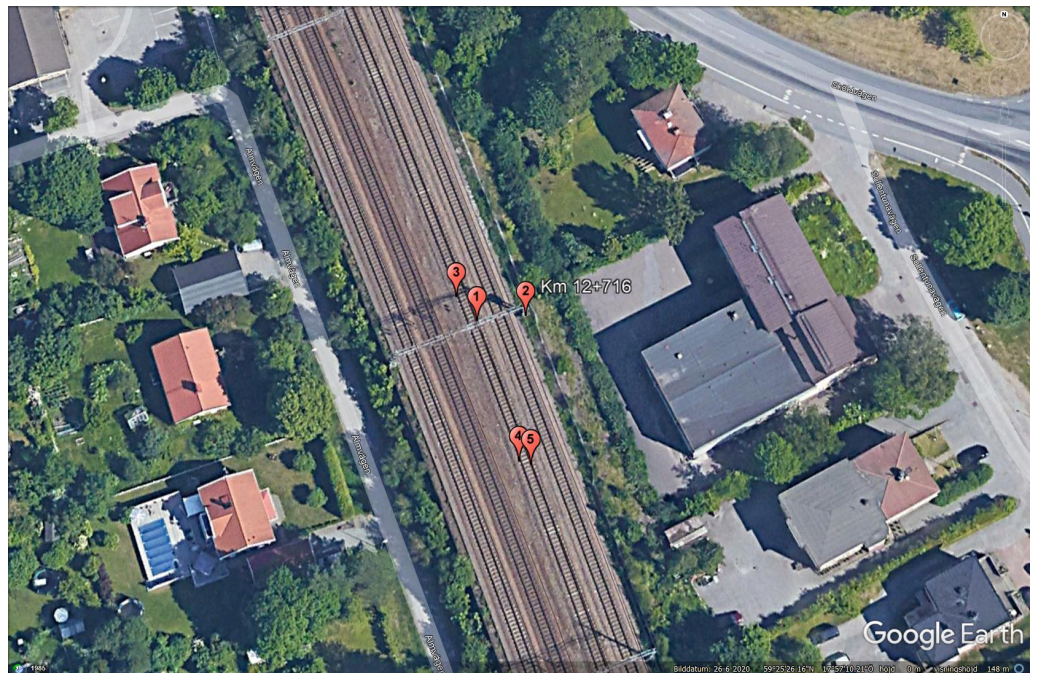
In Figure 36, SHK has marked the location of the primary fracture (1) and the closest overhead line post (2), as well as other relevant positions based on GPS data. The figure shows the closest NDT remark according to Bessy, kilometre indication 12+691 metres, based, on the one hand, on the ultrasound train's GPS position (4) and, on the other, based on the GPS position (5) that the NDT technician verified. The figure also shows the position (3) of the indication that was in Sperry Rail's data about a defect that was below the limit for reporting.

Figure 36. Positions of primary fractures (1), post 12–13 (2), remark that does not fulfil the criterion for remarks that have to be reported to Bessy (3), closest NDT remark from the ultrasound train that fulfils the reporting criterion (4), closest NDT remark according to verification/Bessy (5). Image from Google Earth, https://earth.google.com/web/@59.42396596,17.95280292,29.53804661a,143.61087405d,35y,0h,23.594,01692t,360r?utm_source=earth7&utm_campaign=vine&hl=sv, with position markings added by SHK.

Based on the review of GPS data, it can be established that the GPS position verified by the NDT technician for kilometre 12+691 metres is consistent with the GPS position from the ultrasound train. It is also not unusual for positions to differ slightly from each other because the position indication is affected by where the NDT technician is when they register a defect as verified. It is SHK's assessment that the GPS data do not suggest that it is the site of the broken rail that was being referred to when verifying the defect that is listed in Bessy as having the position kilometre 12+691 metres.
