Rapport RS 2007:01

General cargo ships MARINA-S and TINTO Collision on 25 April 2006 in the Baltic Sea

**MARINA-S and TINTO
Collision on 25 April 2006**

The report has been issued on 15 March 2007

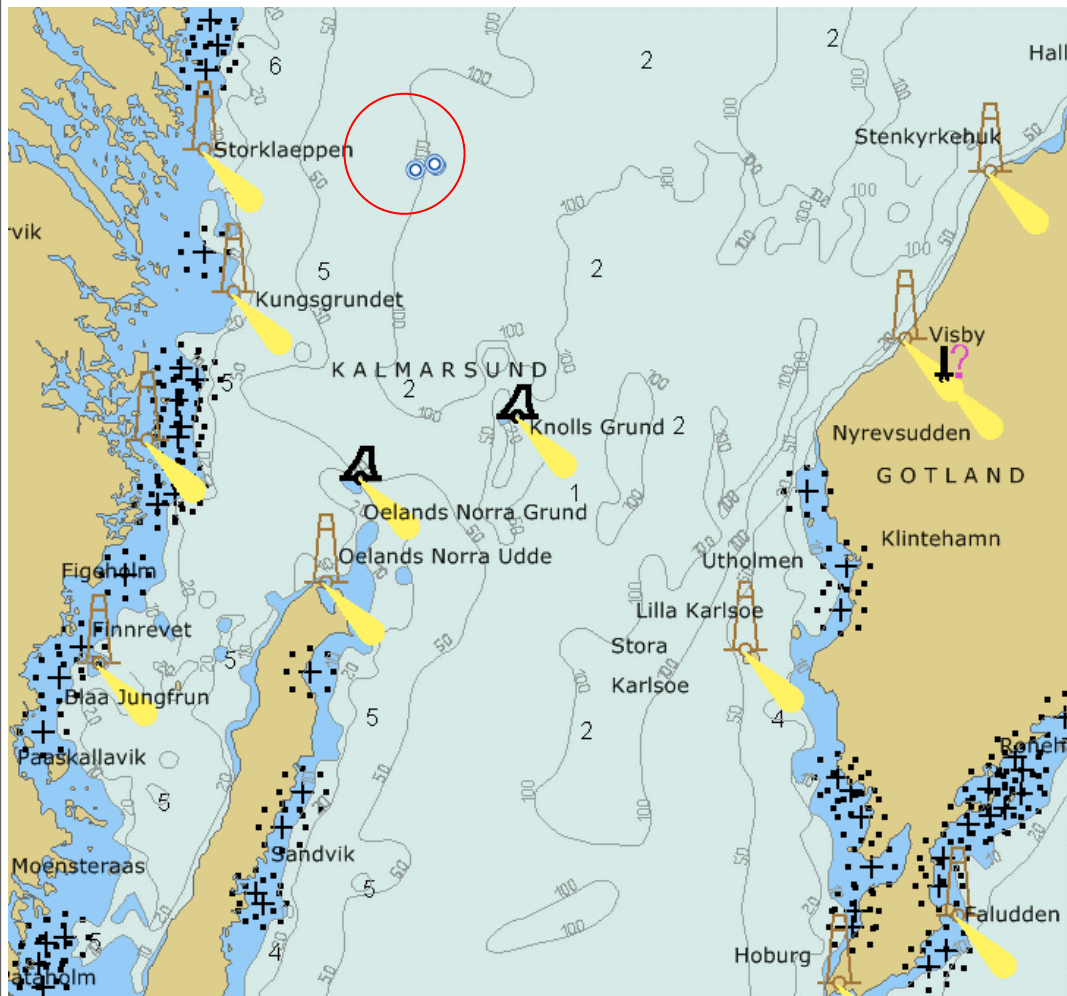
Scene of accident

Source: Diving report by the Swedish Coast Guard. The above chart extract indicates the position of the collision and the position where MARINA-S was located by the Swedish Coast Guard on 26 April 2006 on a depth of 100 metres. The wreck was located on position 57°49,710' N 017°19,502' E
