Final report RL 2018:08e

**Accident in Älvsbyn, Norrbotten County,
on 26 September 2017 involving the
helicopter SE-JVI of the model
MDHI 369D, operated by First European
Aviation Company (FEAC).**

File no. L-114/17

20 August 2018

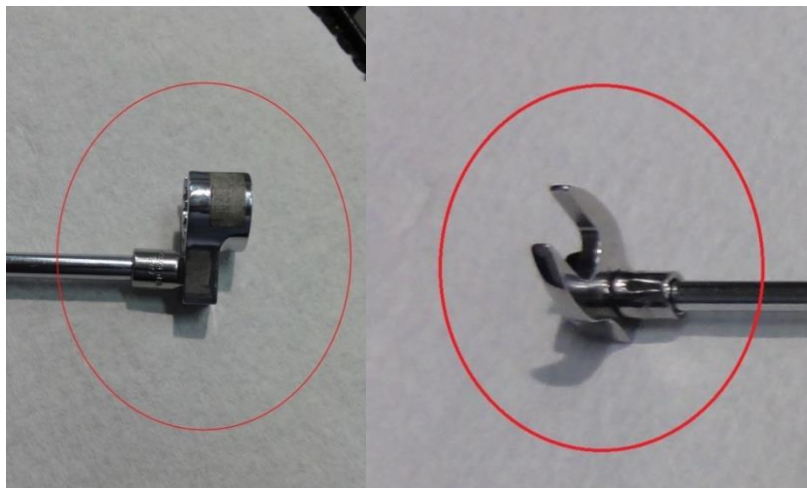
Figures 10 and 11. The flare-end and open-end (Also known as Crow foot) adapters used to install the pipe nut.

When working with an offset torque measuring point, the torque needs to be configured, taking into account the length of the offset as well as the point where the force impacts on the torque wrench (see figure 12). At the time of SHK's visit, the operator maintenance organisation had access to both types of adapters. However, the open-end adapter (see figure 11) can cause an unwanted movement of the tool, meaning that the torque wrench extension is not parallel to the pipe and the nut, which in turn can lead to an incorrect torque. If the torquing is carried out in a narrow space, there is also the risk of the adapter not turning freely, which results in the torque wrench indicating the achievement of a set torque before this is actually the case.

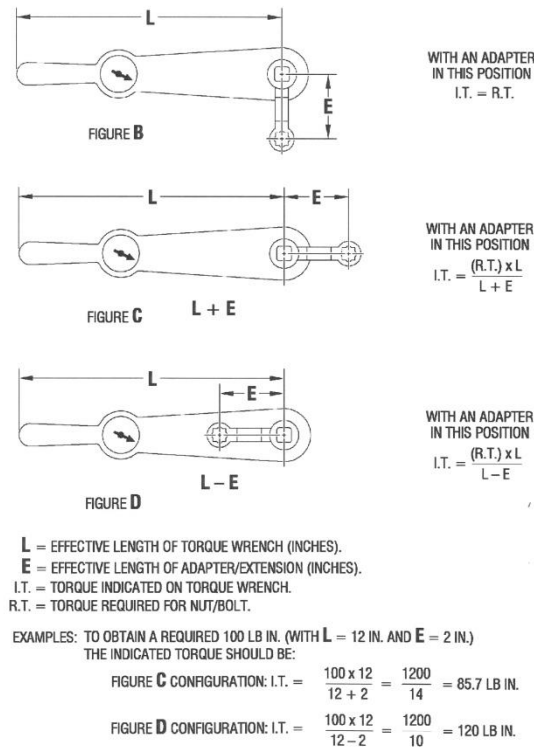
Figure 12. Torque calibration for offset measuring point. Graphics: Rolls-Royce

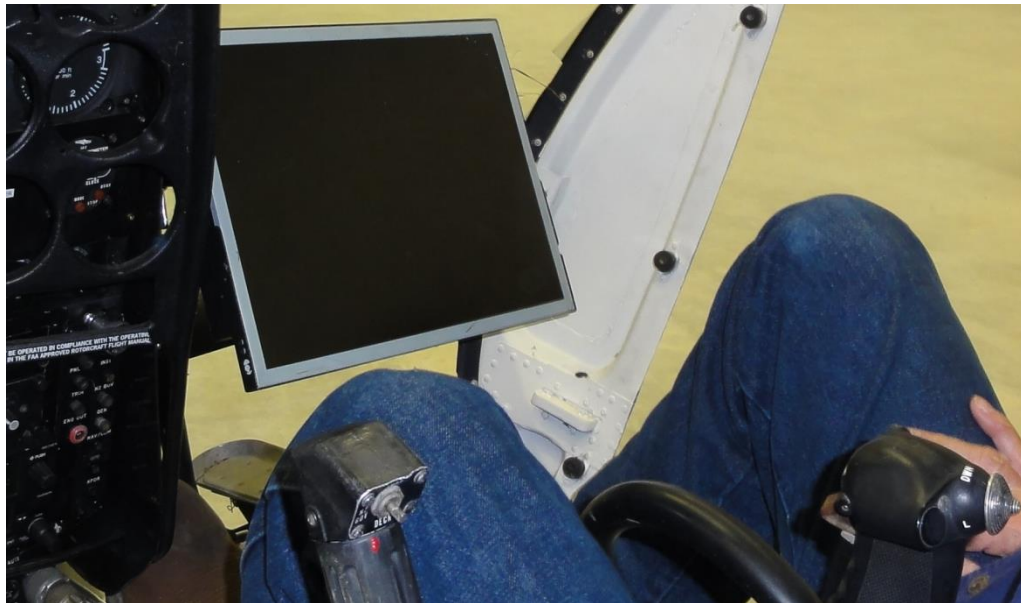
A screen and keyboard were fitted on the right side of the cockpit in order to operate the system during power line inspections (see figure 13). These are not included in the STC, and SHK has been unable to find a description of how this installation is to be carried out or by whom.

Figure 13. The field of view to the right and downwards as seen from the pilot's position, with the screen of the measuring system in place.

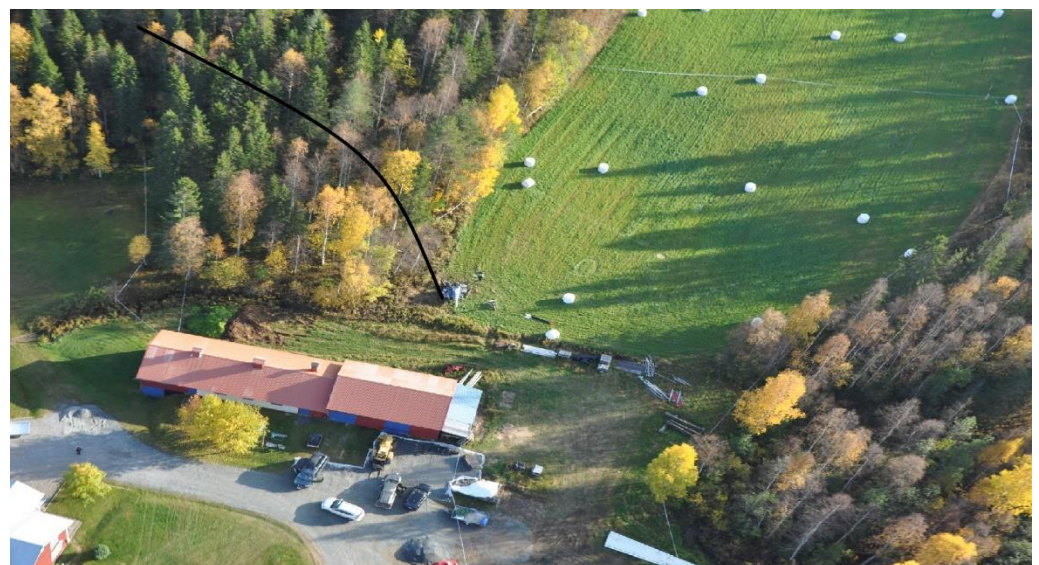
The accident site is located at the edge of a slightly sloping grass-covered meadow next to a group of buildings at the edge of a forest (see figures 15 and 16).

Figure 16. The accident site seen from above with an illustration of the probable flight path.
