## *Final report RL 2017:10e*

**Serious incident after take-off from Gothenburg/Landvetter Airport on 7 November 2016 involving SE-DSV an aeroplane of the model AVRO-RJ 100, operated by Braathens Regional Aviation AB.**

File no. L-112/16

7 December 2017

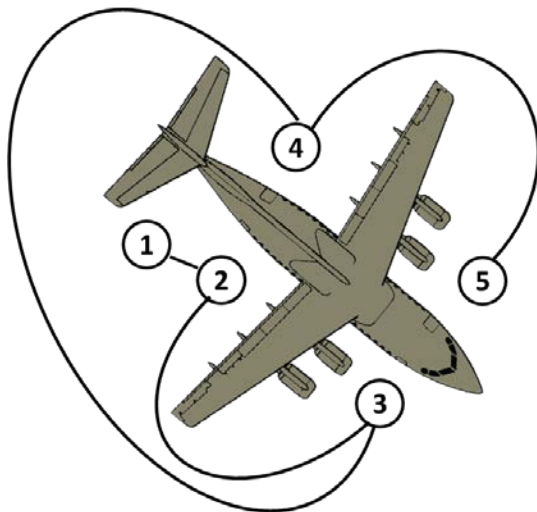
Figure 1. The positioning pattern of the de-icing vehicle.

The de-icing operation was captured by an airport CCTV. The sequence has been analysed by SHK. Figure 1 shows the positioning pattern of the de-icing vehicle.

2. Spraying of the right, aft side of the fuselage for 47 seconds. Thereafter, the vehicle was moved directly to point 3 without pause.
3. 15 seconds spraying of the right wing with 11 seconds' pause. 2 minutes and 7 seconds spraying of the mid-section of the wing and front right side of the fuselage with a one-second pause.
4. 40 seconds of spraying the left side of the fuselage without subsequent restraints, moved to point 5.
5. 27 seconds of spraying the left wing with 3 seconds' pause after which the vehicle left the site.

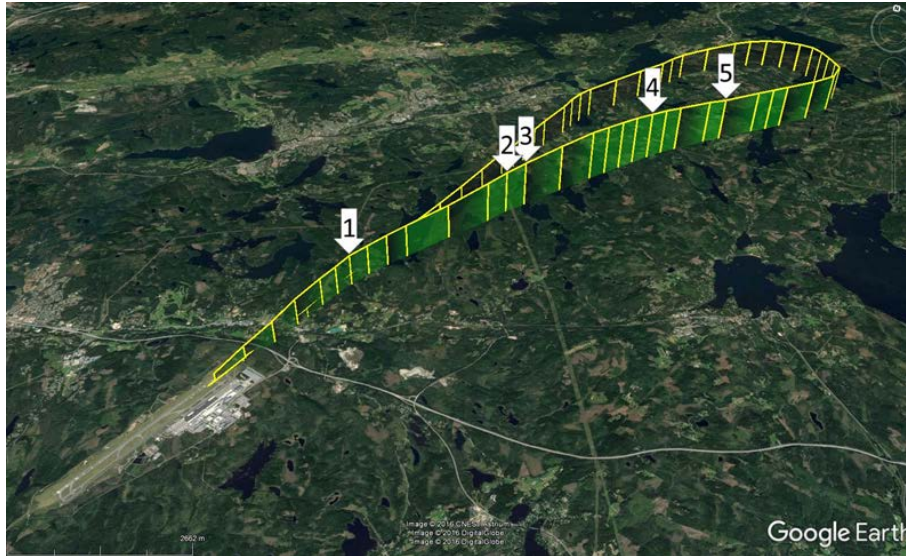
Figure 2. The aeroplane's flight path, according to radar data with take-off from runway 03 and landing on runway 21.

1. The vibrations occurred at 05:20:33 at an indicated air speed of 214 knots at 3 200 feet.
2. The vibration ended at 05:21:21 when the indicated airspeed was reduced to 184 knots at 4 500 feet.
3. A distress call was sent at 05:21:27.
4. Vibrations came back at 05:22:15 at an indicated airspeed of 205 knots at 4 500 feet.
5. The vibrations ended at 05:22:41 when the indicated airspeed was reduced to 184 knots at 4 500 feet. A descend and a left turn was performed for returning to the airport.

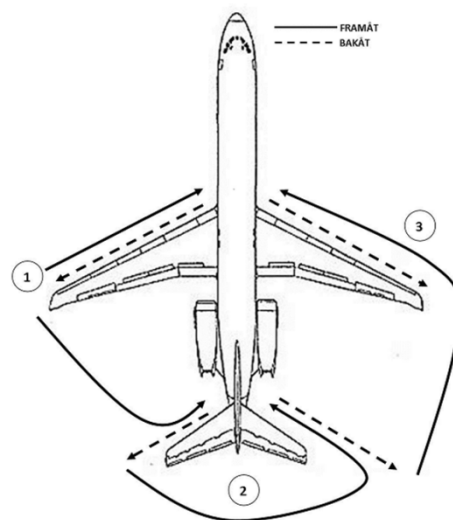
Figure 11 The driving pattern presented in Aviator's Local Procedures for Gothenburg/Landvetter airport.

The driving pattern around the aeroplane is described in three different steps, (see Figure 11).
