Final report RL 2021:06e

**Accident at Linköping/Saab Airport,
Östergötland County on 26 September
2020 involving SE-CXN, an aeroplane of
the model Cessna-180D, operated by a
private individual.**

File no. L-83/20

10 June 2021

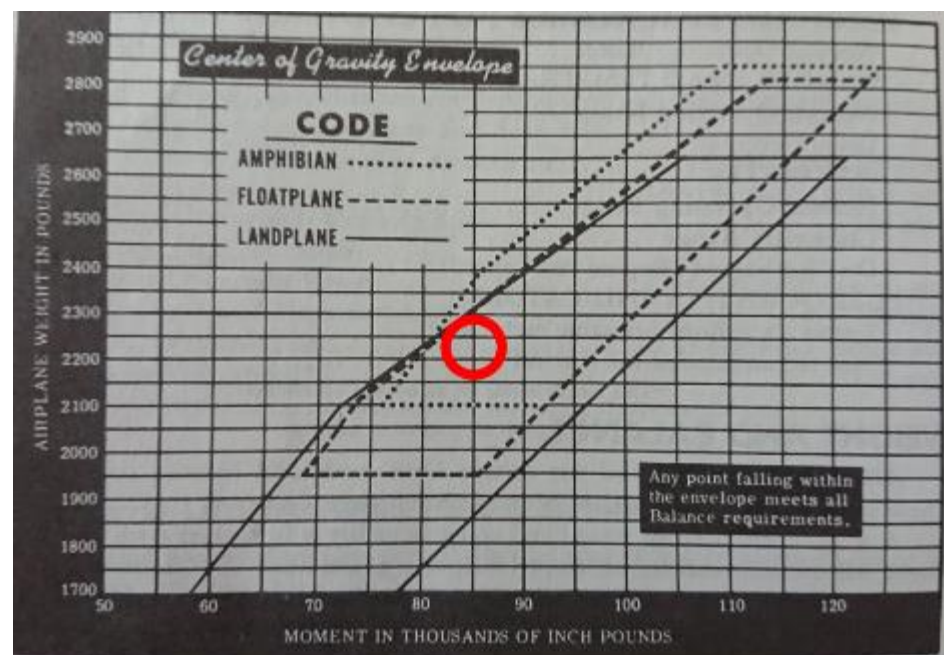
By estimating the conditions at the time of the landing using information obtained, SHK has calculated the gross mass and centre of gravity. Figure 3 shows the permitted mass and balance states as per the aircraft flight manual.

Figure 3. Mass and balance state at the time of the accident (red ring indicates the calculation by SHK).

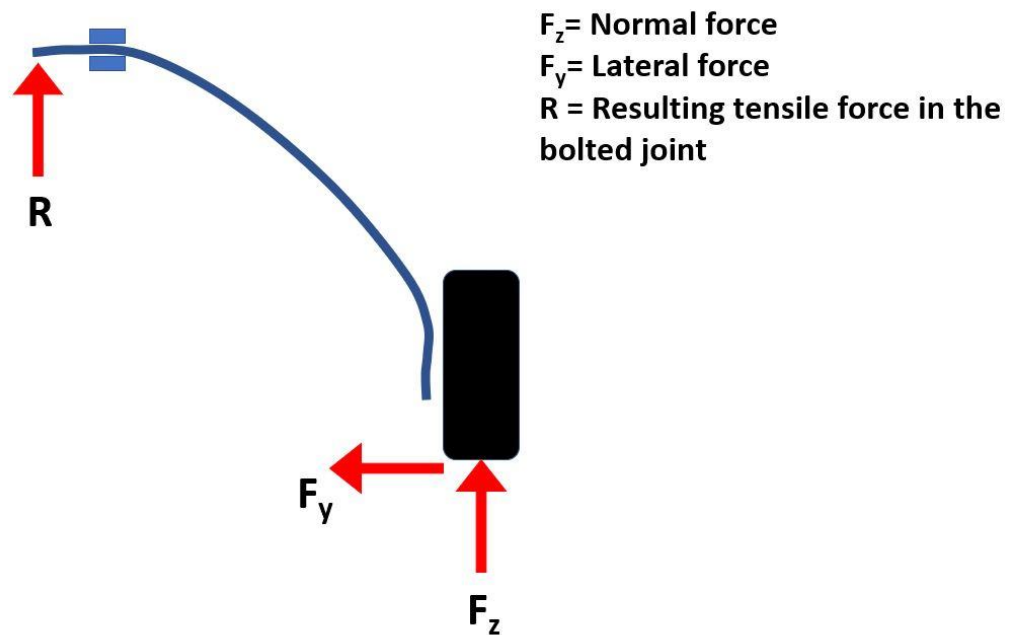
Under normal circumstances, there are no large tensile loads on the bolted joint during take-off and landing. However, in a ground loop, a lateral load on the landing gear arises, which causes a tensile force in the bolted joint, i.e. in an opposite direction to that to which the construction is intended to be exposed in normal use (see Figure 5). Also refer to section 1.16.4 for calculations of the forces in a ground loop.

According to the type certificate holder, a ground loop that is intensive or takes place at high speed or on an uneven surface can cause the landing gear to collapse due to the lateral load.

Figure 5. Diagram showing the forces exerted on the landing gear in a ground loop.

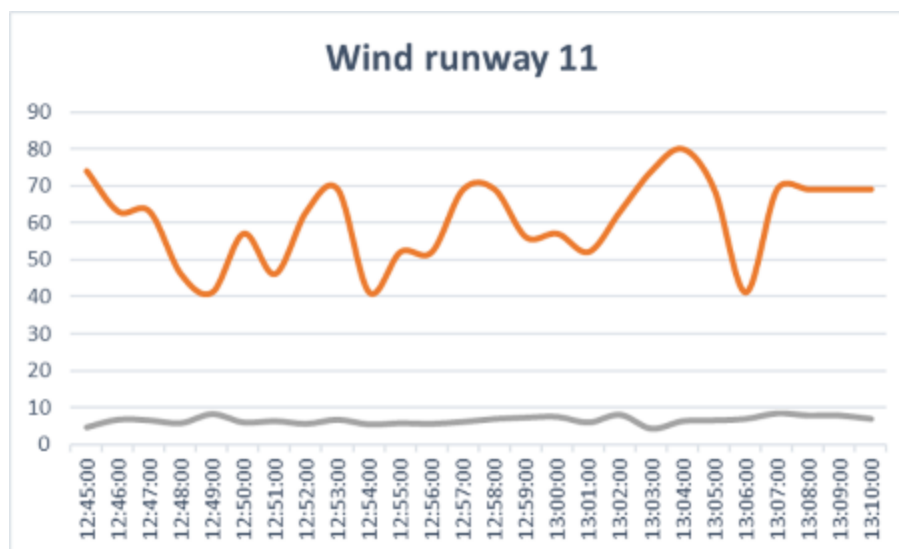
Instantaneous wind registration (one-minute wind speed) at runway 11 indicates that in the period 12:45–13:10 UTC, the wind was 040–080 degrees 5–8 knots and without any gusts that differ markedly from the average wind speed (see Figure 6).

Figure 6. Registration of the instantaneous wind (one-minute wind) at the start of the runway. The upper curve represents the wind direction in degrees and the lower curve the wind speed in knots. SHK graphic.

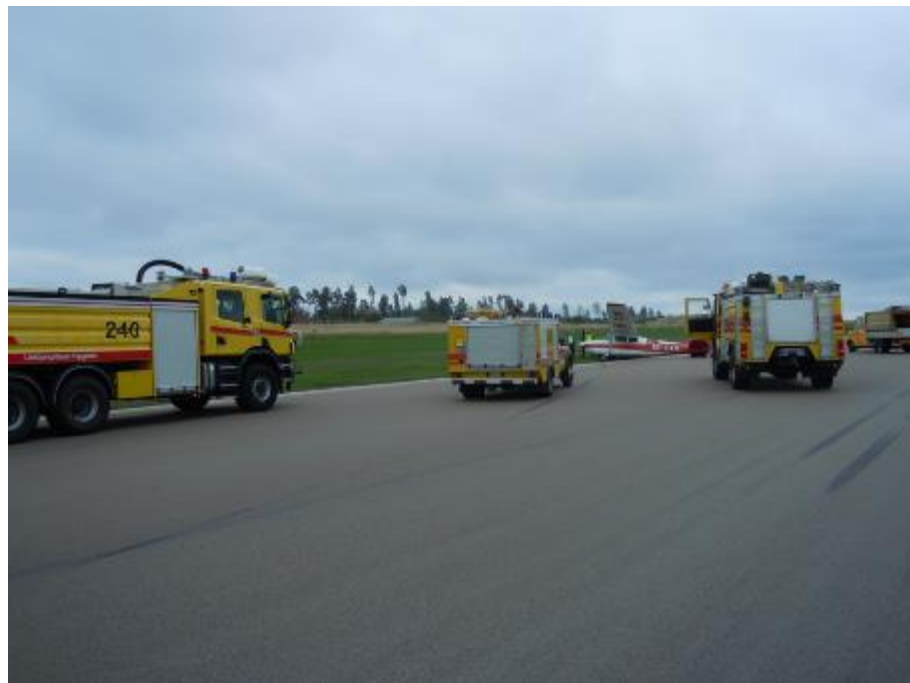
When the aeroplane exited the runway, the air traffic controller activated the accident alarm and the airport's fire and rescue service were thus called out. An ambulance, SAR helicopter and the municipal fire and rescue service were also called out. The airport's fire and rescue service were on site within around a minute (see Figure 24). No rescue operation was necessary and the other emergency services were recalled. The people in the aeroplane had got out themselves and no fire or leak of hazardous substances had occurred.

Figure 24. The airport fire and rescue service at the crash site. Photo: Saab fire and rescue service.

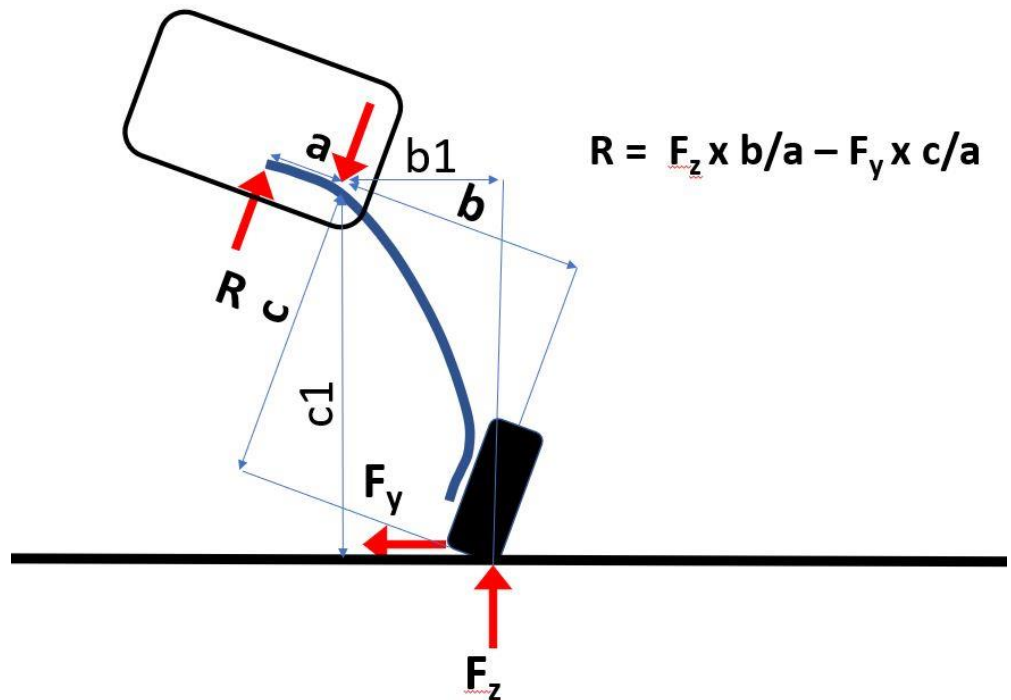
The factors used in the calculations were the aeroplane's mass, the dimensions of the landing gear, the coefficient of friction for dry asphalt and the angle at which the aeroplane was banking during the sequence of events. The calculations show that the resulting tensile force in a ground loop is around half the breaking load of the bolted joint according to the specifications.

It should be emphasised that these calculations are theoretical. The dynamic effects during the sequence of events are difficult to determine. Nor have the calculations taken into account deficiencies in the joint related to tightening torque or if the threads have been worn.

Figure 28. Theoretical calculation of forces exerted on the landing gear in a ground loop. F_z is normal force, F_y is the side force generated in a ground loop, a , b and c are the dimensions of the landing gear. R is the resultant force in the bolted joint.

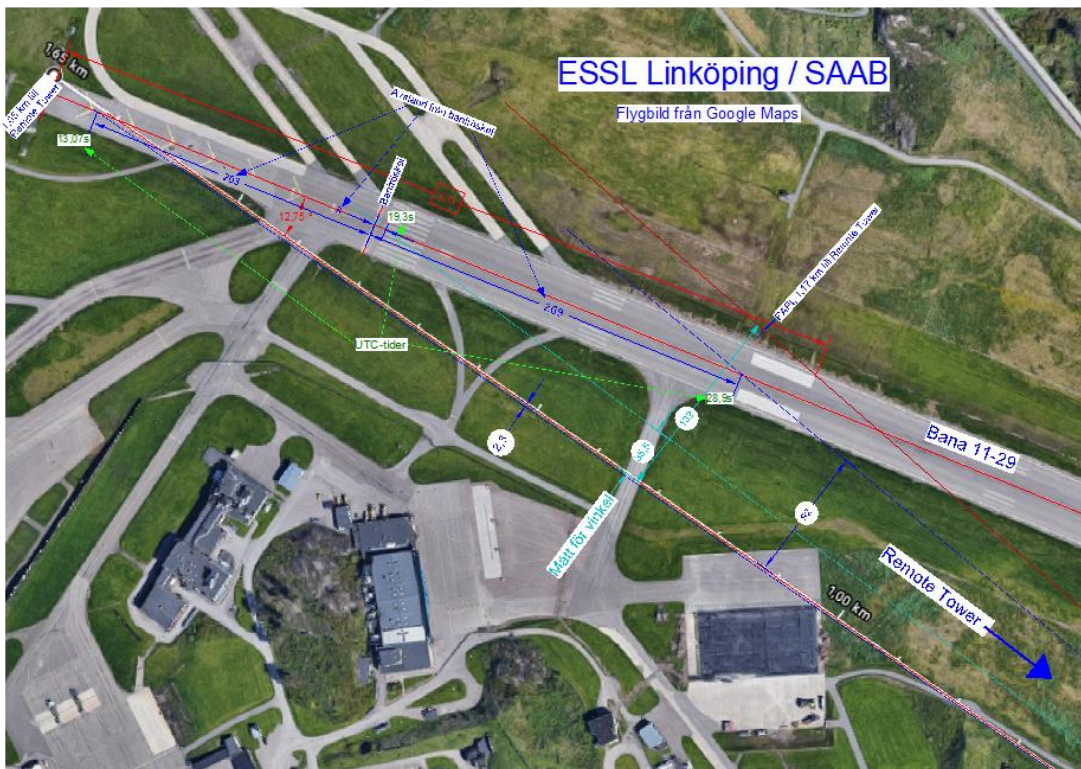
The speed during the landing phase has been estimated using still images from various points in the video recording from the camera tower and with the help of the consultancy firm Magnic AB (see Figure 29).

The calculations are based on two fixed points in the images – the left edge of the start of the runway and the light in the PAPI (*Precision Approach Path Indicator*) that was closest to the runway. The distance in millimetres in the image from the aeroplane to a vertical line from the start of the runway and the PAPI light, respectively, was measured in order to work out how much of the visual field from the camera tower was taken up at each distance.

Figure 29. Lines drawn on image to calculate the aeroplane’s ground speed. Source: Google Maps with SHK added graphics.
