## *Final report RS 2016:07e*

VICTORIA – Running aground at Fladen,  
Halland County, den 19 September 2015

File no. S-172/15

02/09/2016

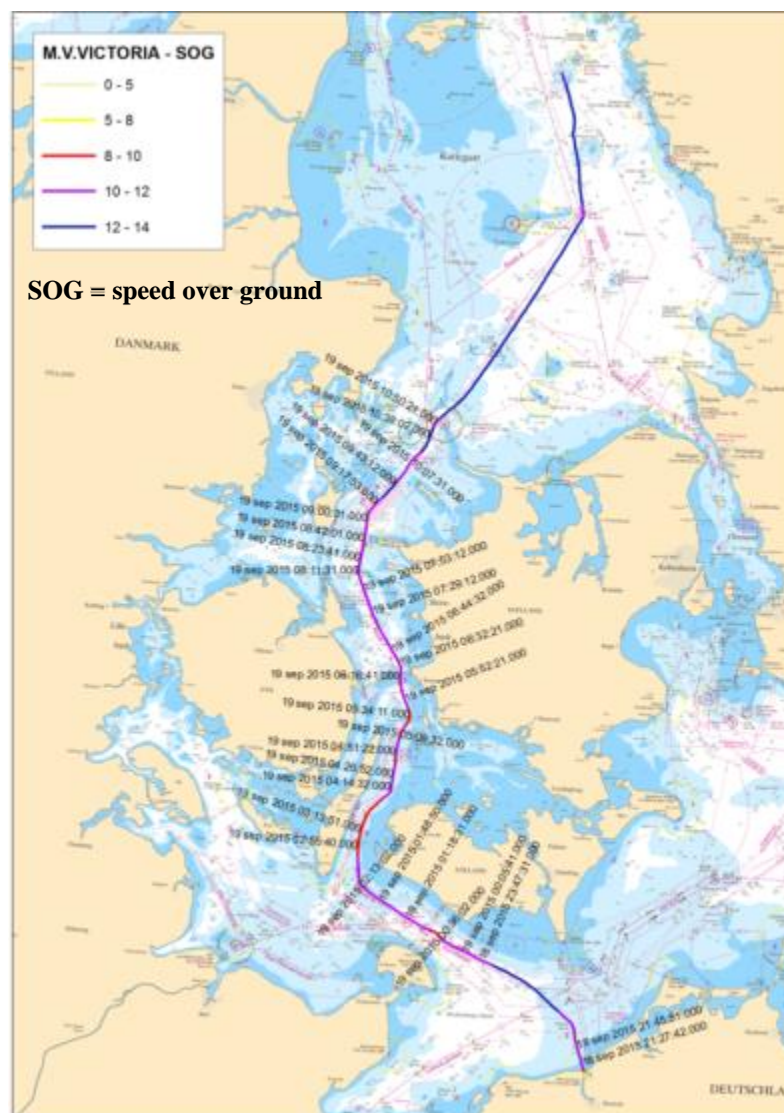
Figure 1. VICTORIA's voyage from Rostock to the site where it ran aground at Fladen, times in UTC<sup>2</sup>.

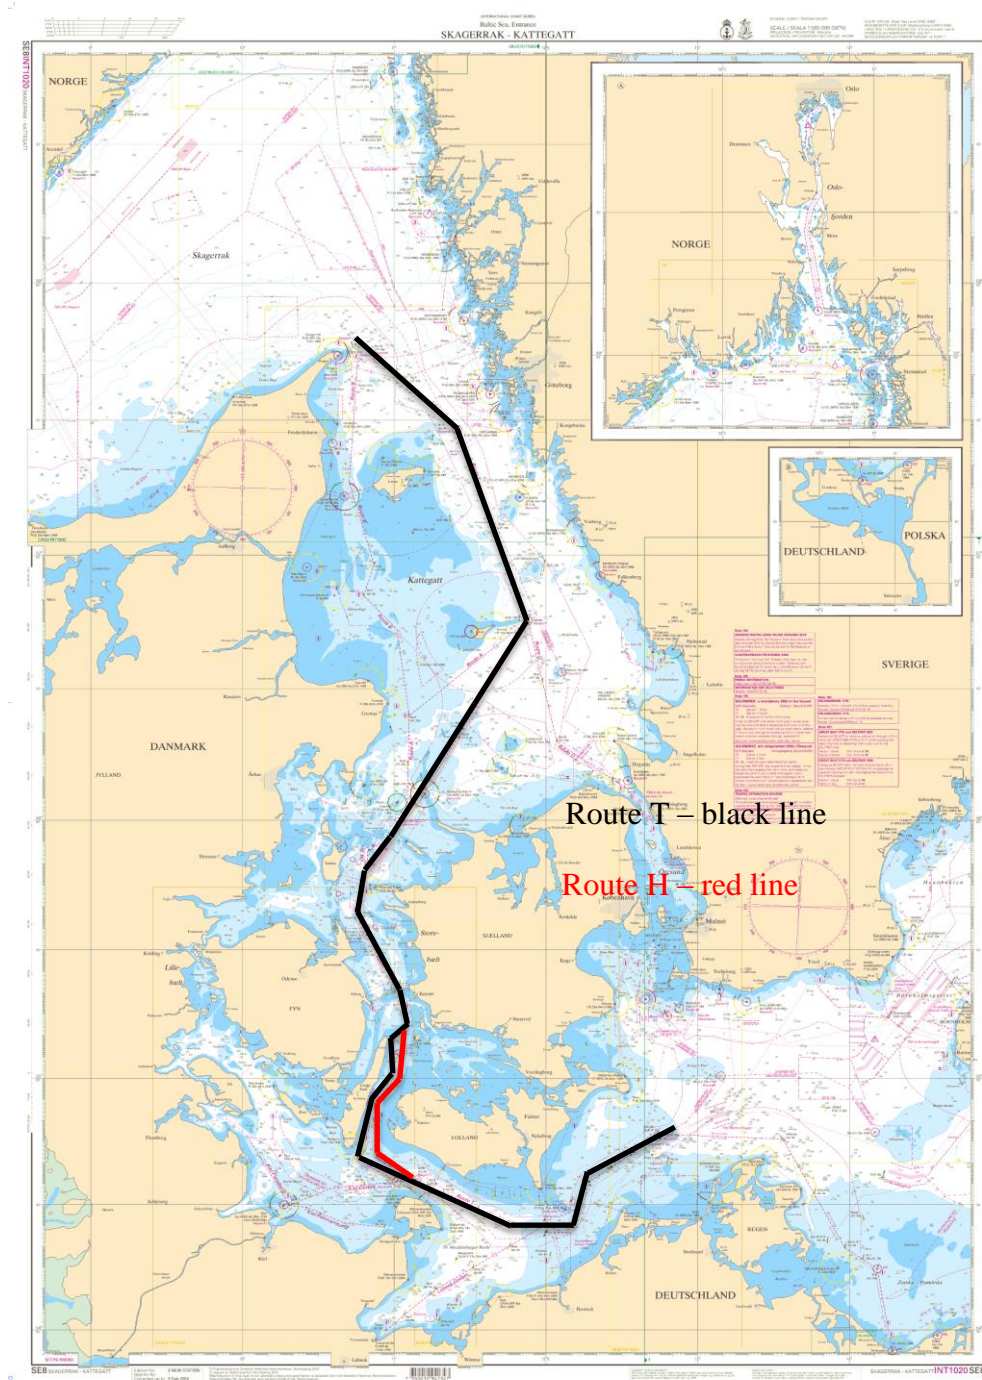
Route T runs from a position 5 M north-east of Skagen to approx. 25 M west of Cape Arkona. Route T is marked with buoys, light buoys and mid-channel light buoys (fig. 8). There are two routes running through Langeland Belt; Route T, which is marked here as a deep water route with an established depth of 19 meters (DW 19) and Route H with an established depth of 12 metres and which, according to *Admiralty Sailing Directions* and Danish navigational chart 103 (INT 1303), vessels with a draught of 10 metres or less *must* follow. The IMO Ships' Routeing stated however that ships with a draft of 10 meters or less *should* choose the nationally recommended Route H. Route H only has marking in the form of mid-channel buoys with lights. At buoy 7 there is a severe turn to starboard, northbound. Just before buoy 7 there is a shoal at a depth specified in the navigational chart as 10.4 metres, which VICTORIA passed close by. At buoy 7 (where the vessel changed course), there is another shoal at a depth of 10.6 metres. Both shoals are without marking (fig. 2).

Figure 8 Route T (black) and Route H (red).

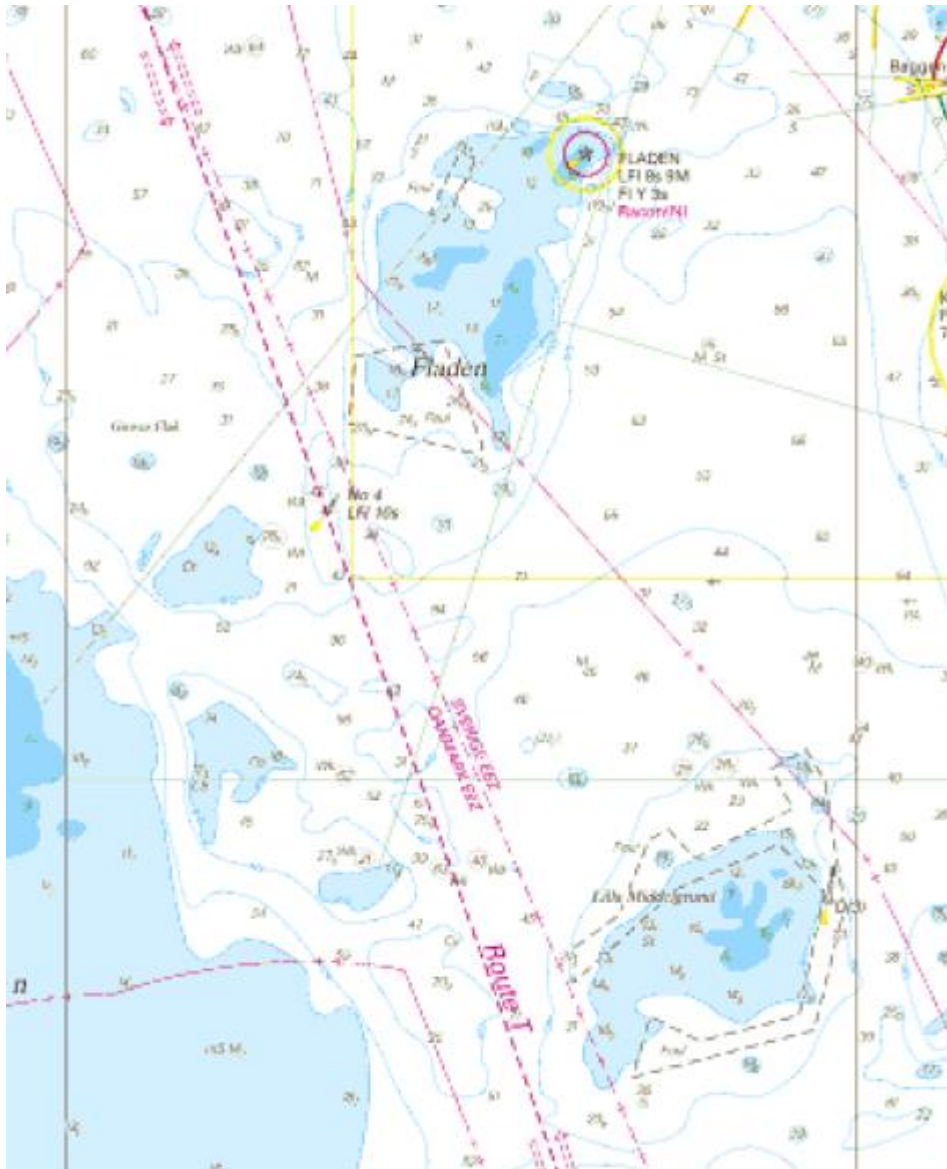
Fladen lighthouse is in the north-east part of the bank, but at the time there was no stick or buoy to mark the west part of the bank. The deep water channel that separates Fladen from Groves Flak is marked with a mid-channel buoy (buoy 4). Lilla Middelgrund, which lies south of Fladen, is marked by a light buoy east of the shoal, but there is no marking west of the shoal, (fig. 9).

Figure 9. Navigational Chart, Kattegat, Image: Swedish Maritime Administration no.: 10-01518.

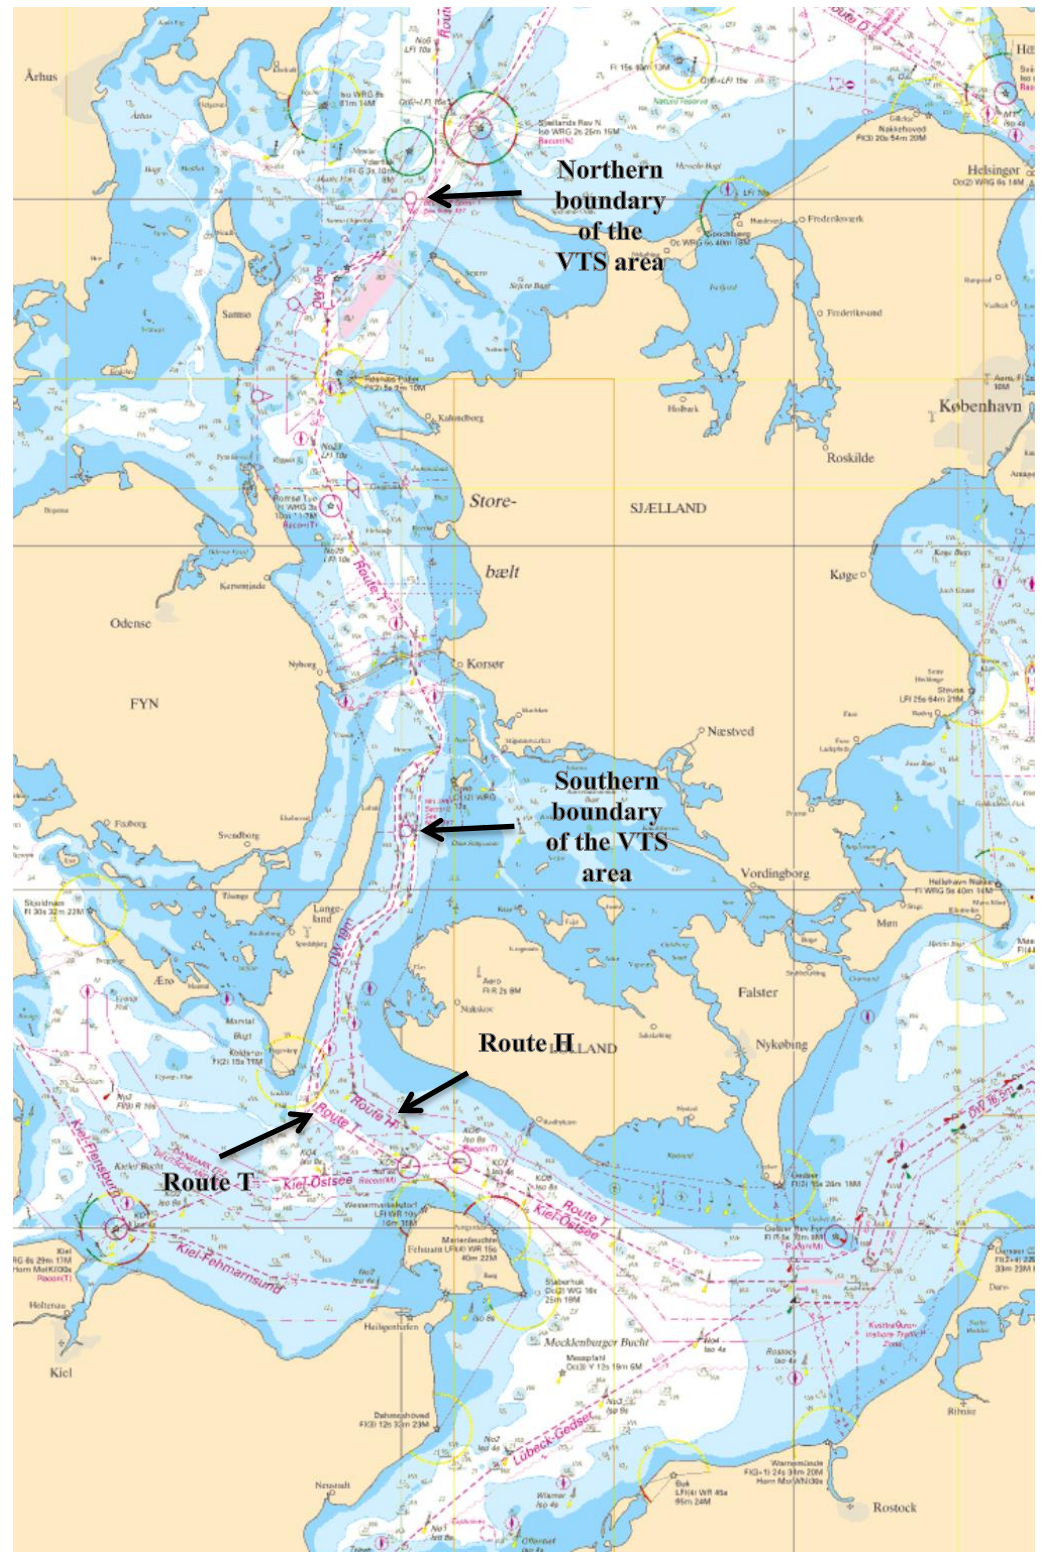
The VTS area stretches from Själlands Odde in the north to a line which intersects the northern part of Langeland (fig. 10). The area of Kattegatt where the vessel ran aground is not a VTS area.

Figure 10. Navigational chart Route T/Route H Image: Swedish Maritime Administration no.: 10-01518.

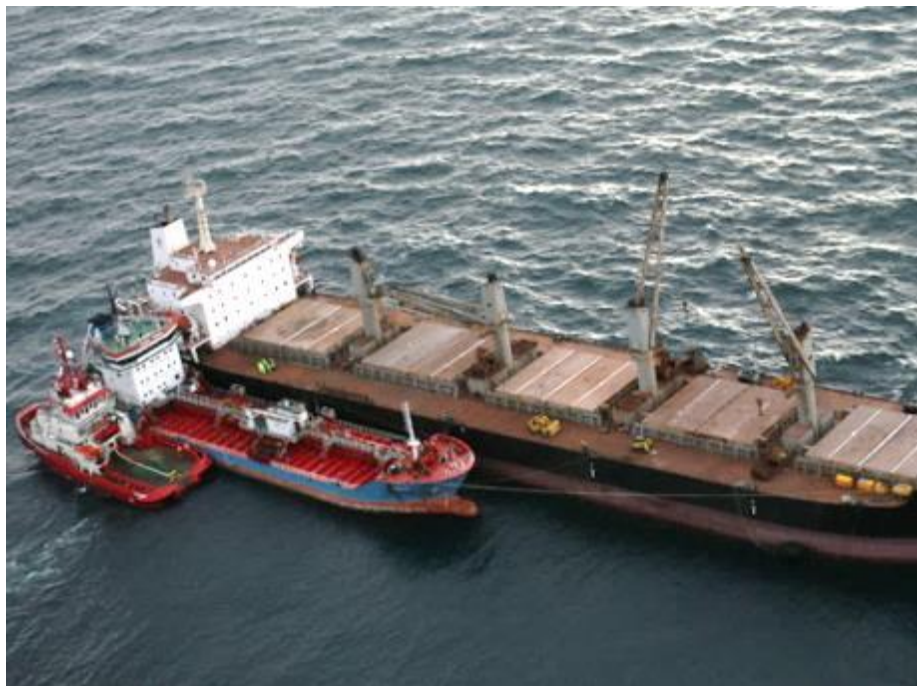
On 22 September at 14:40, bunker boat LEON moored to the side of VICTORIA to prepare for lightering<sup>24</sup> of bunker fuel (fig. 14). At 17:44 on the same day, lighterage commenced and was completed on 25 September at 15:47. By this time, 977m<sup>3</sup> of bunker oil had been pumped out from VICTORIA. A total of 35m<sup>3</sup> of bunker fuel which was not pumpable remained aboard VICTORIA.

Figure 14. VICTORIA lightering bunker fuel to LEON. Image: The Swedish Coast Guard.

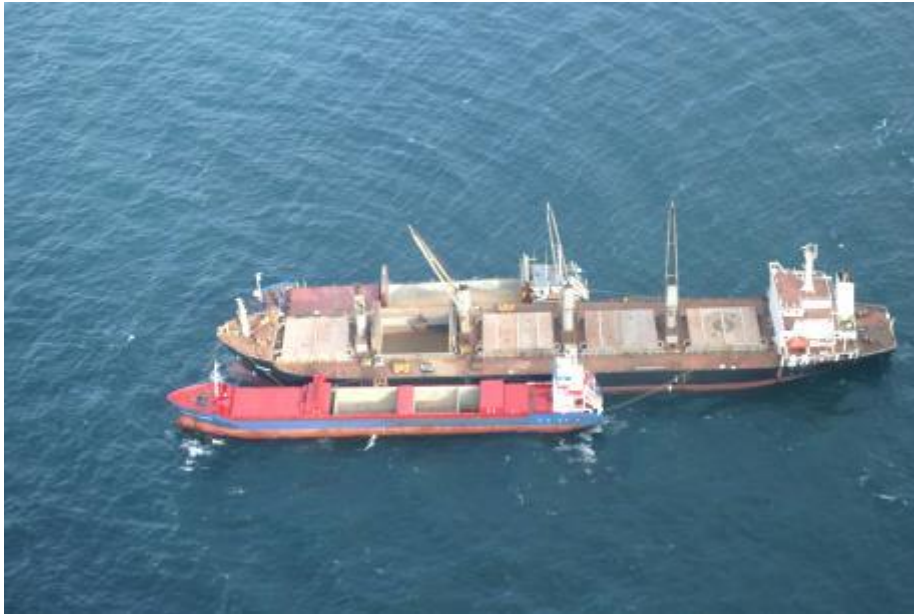
On 25 September at 18:30, the bunker boat left VICTORIA and thereafter began lightering of the vessels cargo (fig. 15). On 26 September at 20:47, VICTORIA notified that they had come clear of the shoal after lightering 6,000 tons of the cargo. With the help of a tugboat, the vessel anchored at a nearby anchorage. Divers from the coast guard performed an additional inspection of VICTORIA and found no leakage from the bunker tanks.

Figure 15. VICTORIA lightering the cargo Image: The Swedish Coast Guard.
