DUTCH
SAFETY BOARD

Runway excursion after leakage in hydraulic system

30 September 2015

The Hague, December 2016

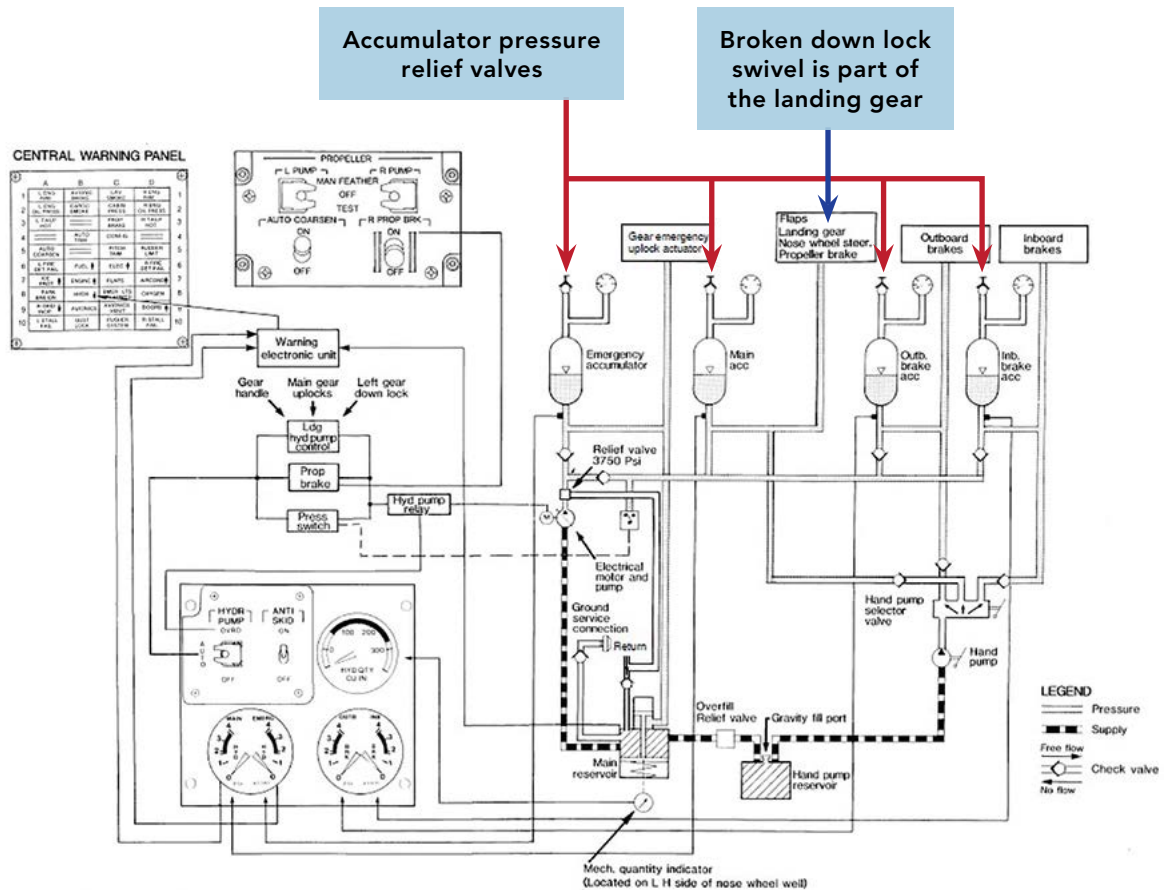
Figure 2: The hydraulic system - schematic.

The Saab 340B hydraulic system (see figure 2) as described in the operator's Aircraft Operations Manual (AOM) includes an electrically driven main pump, which under normal conditions supplies pressure to four accumulators. For emergency and maintenance use, a hand pump is installed which is operated by a lever. The hand pump is located in the floor at the cockpit's right hand seat on the left hand side.

The hydraulic system contains two reservoirs for hydraulic fluid supply: the main reservoir with a capacity of approximately 5 litres and the hand pump reservoir of 2.5 litres. The hand pump reservoir supplies fluid to the hand pump exclusively.

Return lines (not presented in figure 2) will guide the hydraulic fluid from the aircraft systems powered by the hydraulic pressure back to the main hydraulic reservoir.

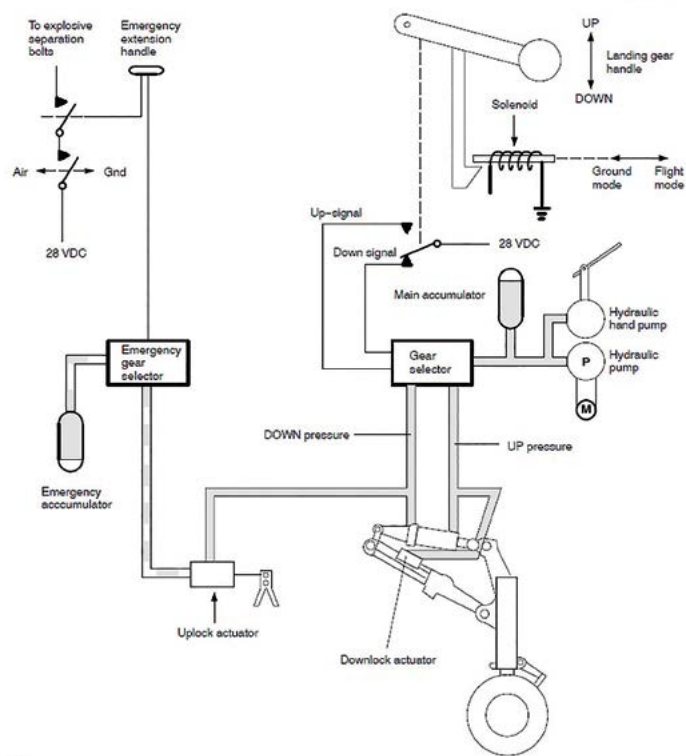
Figure 3: The landing gear system - schematic.

The Saab 340B is equipped with a conventional retractable landing gear. All gears retract in a forward direction. Normal landing gear operation (gear up or gear down) is by hydraulic power provided by the main pump and the main accumulator, resulting in a constantly pressurized system during normal operations. A spring load will keep the gears down and locked. In an emergency situation the landing gear can be extended by free fall or by use of the hydraulic hand pump. In case of hydraulic failure, the gear may be extended by free fall. By pulling the landing gear emergency extension handle in the cockpit floor, the gear actuator hydraulic pressure lines will be connected to the return lines to prevent hydraulic lock.

Emergency accumulator pressure will then release the uplocks and the gear will extend and lock by gravity and aerodynamic forces. When the hydraulic pressure in the main accumulator drops below 2100 psi due to hydraulic system usage or by a leak in the main hydraulic system, the hydraulic pressure switch will switch the main pump to on. In the event of a leak in the main system the main pump will continue to supply hydraulic pressure to the hydraulic system. To mitigate the risk of spilling excessive hydraulic fluid, the main pump must be switched off manually.

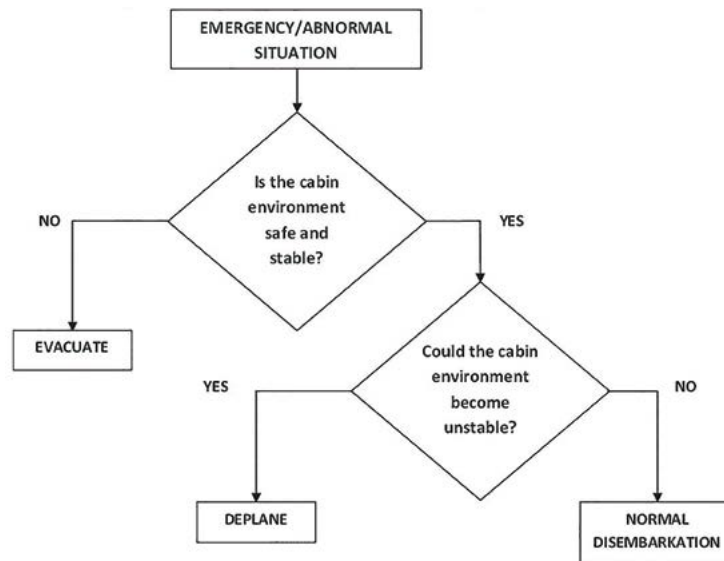
Figure 5: Operator's decision tree for emergency/abnormal evacuation assessment.

The operator issued a decision tree in OM part B, page 11-14, to aid the captain of an aircraft in the decision to order an emergency evacuation or precautionary evacuation for the occupants (see figure 5). The assessment leads to three possibilities: evacuation, deplane, or normal disembarkation.

The operations manual lists a number of examples when to evacuate the aircraft including the situation when the aircraft has left the paved surface and the integrity of the aircraft is uncertain.

According to the operator's OM the emergency evacuation procedure can easily lead to multiple injuries of passengers exiting the aircraft. Therefore, the flight crew should make the best possible decision for the situation. In this situation the captain solely based his decision to emergency evacuate the aircraft on the fact that the aircraft had left the paved surface. The captain did not follow the company's procedures as depicted in the decision tree (See figure 5). According to this procedure, the best possible way to disembark the passengers in the current situation was a normal disembarkation.
