STATE MARINE ACCIDENT INVESTIGATION COMMISSION

FINAL REPORT 46/15

TUG BOAT *ZEUS*

The fire of the tug boat berthed in the port of Sölvesborg
on the day of 23 September 2015

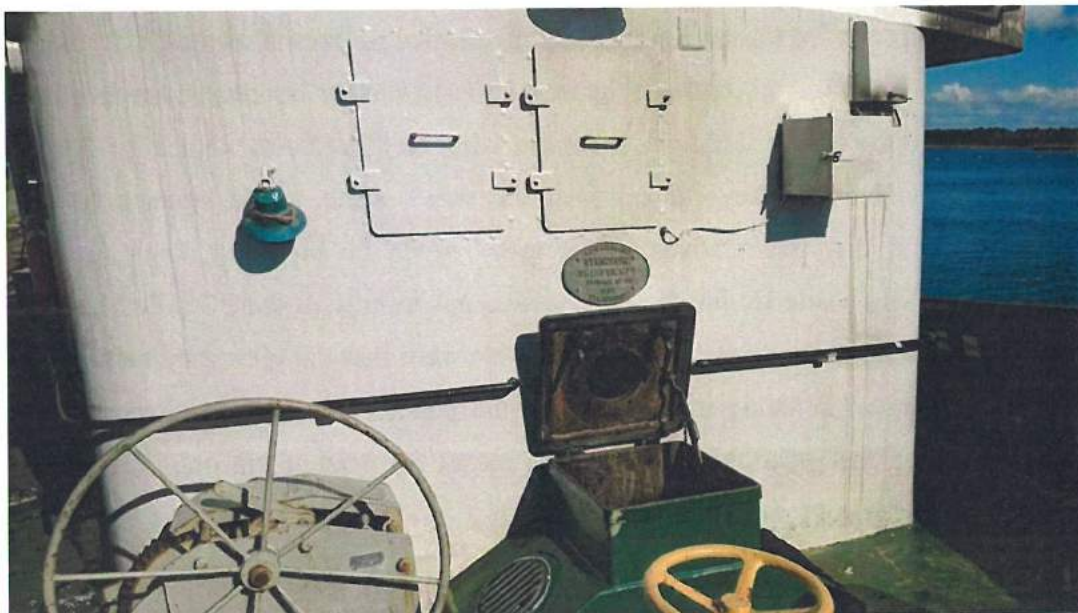
Photograph 3: The hatch in the forward deck through which the accommodation could be reached

The rescue team was divided into two sectors. The task for team in sector 1 was to extinguish the fire and enter the vessel when possible. The task for team in sector 2 was to secure the foam and water feeding system and to search areas on board that were not affected of fire and smoke. During this search a fire protection plan over the vessel was found. A hatch was also found in the forward deck of the vessel (the emergency exit) that could be used for reaching the fire with water.

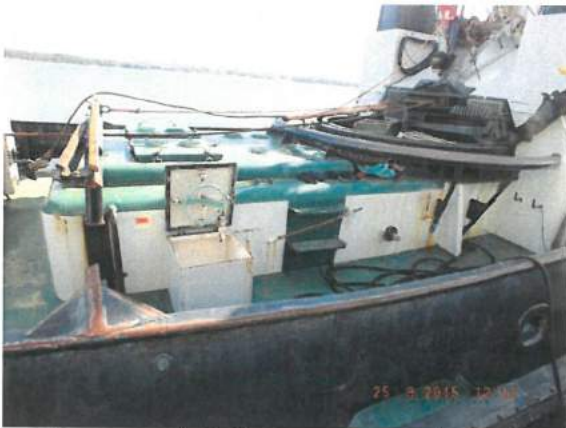
Photograph 6: Emergency exit from the engine room at the stern of the tug boat

The noise woke up two other crew members. The first one, a second engineer, who was sleeping in the central cabin on the port side, dashed out of the cabin half-dressed, passed by the watch officer standing at the steps and went into the engine room of the tug boat by internal passageway. There, he switched on the fire pump, went to the main deck by the emergency exit and started to connect to the fire-plug a rubber hose used for cleaning.

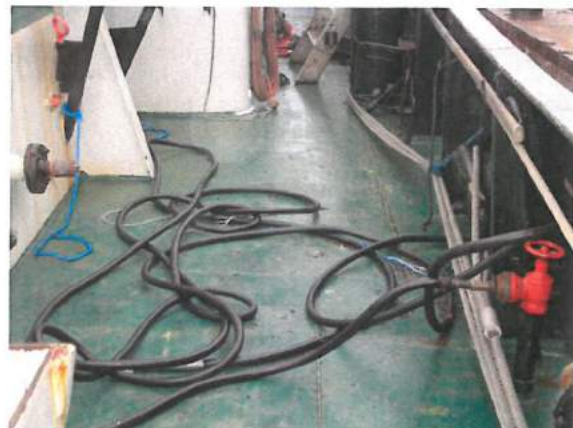
Photograph 7: A working rubber hose which was used by the crew to extinguish fire

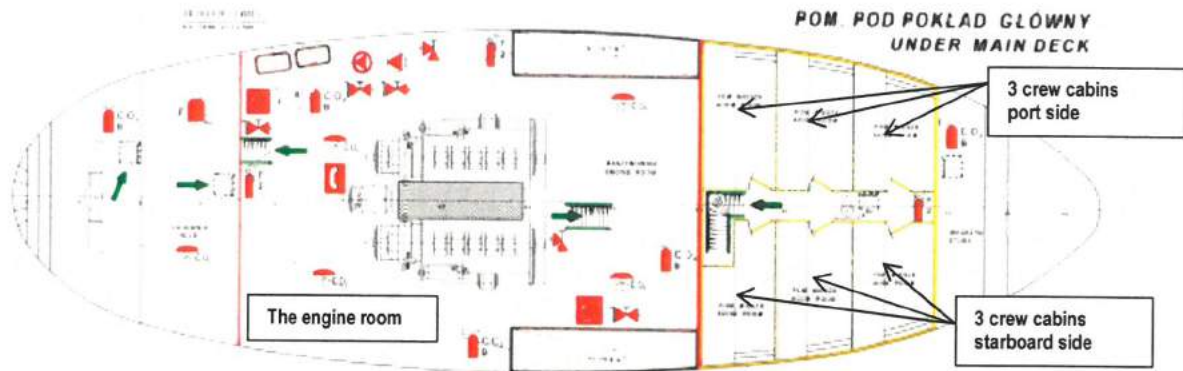
Figure 3: The layout of premises under the main deck of the tug boat

The accommodation premises of the crew were under the main deck of the tug boat which could be reached through a narrow staircase with a platform turning to the right at an angle of 90° in the lower part of the stairs (Figures 3 and 4, and Photograph 8).

The crew cabins were arranged symmetrically - 3 on each side - on both sides of the tug boat; each of them having exit to the alleyway situated in the central line of the tug boat, leading to the staircase. All cabins were similarly equipped and constructed of the same flammable materials⁶. The walls between the cabins, linings, furniture and decorations were made of wood and wood-like materials.

⁶ The materials used for elements of construction and equipment of the cabins did not fulfil current standards of fire resistance.

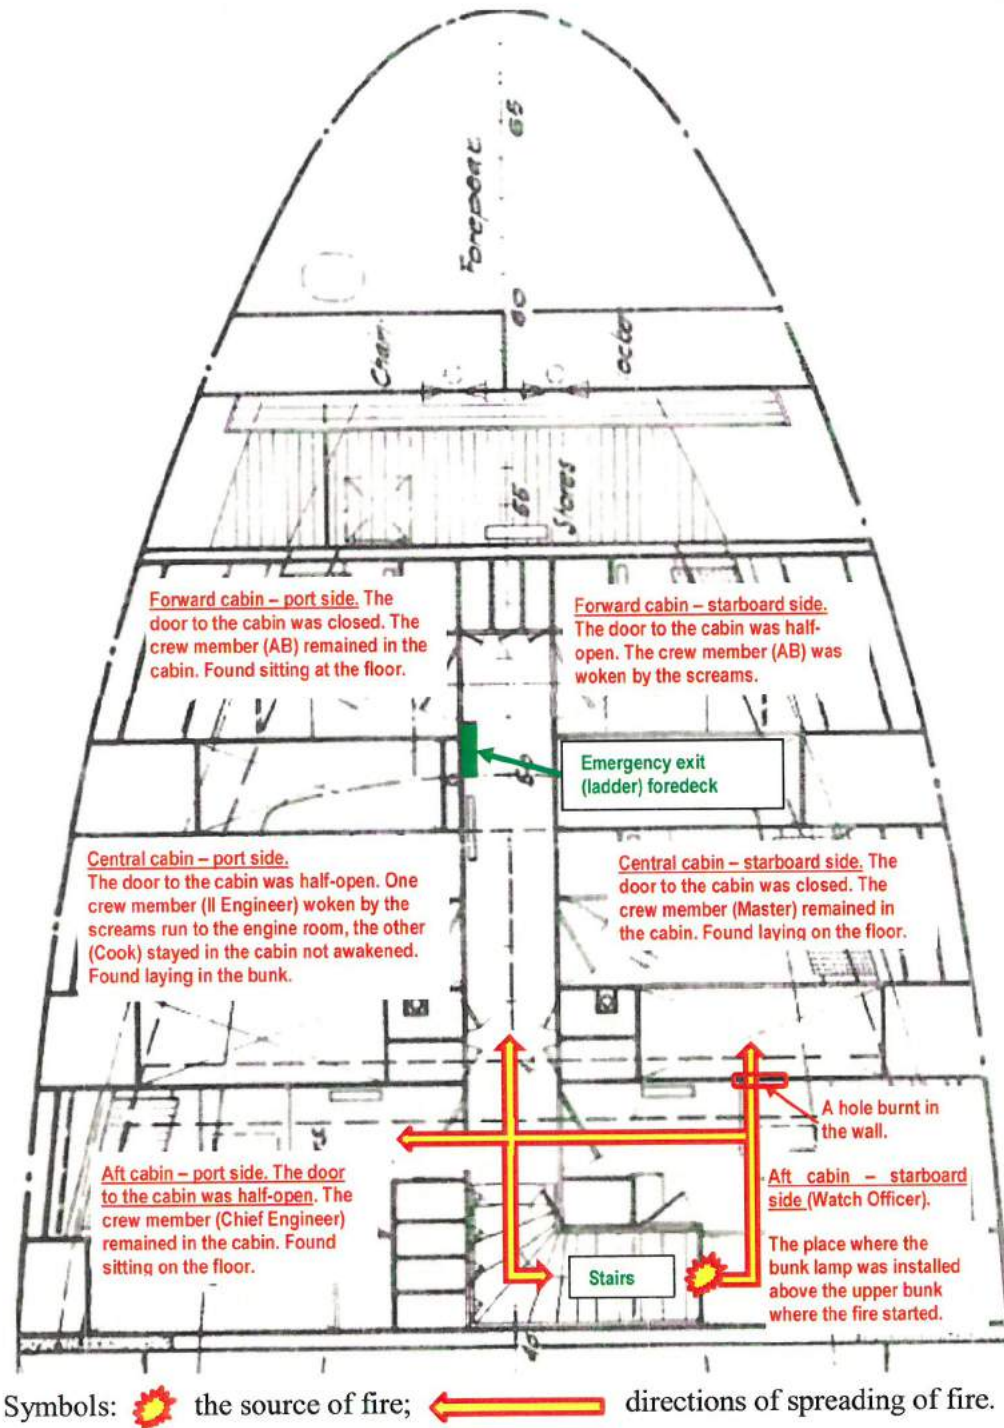
Figure 4: Accommodation of the crew members of the tug boat „Zeus”

There were two escape routes from the accommodation. One - up the stairs in the aft part of the alleyway (Figures 3 and 4, and Photograph 8) to the alleyway on the main deck, with the exit door to the open deck, and the other - from the fore part of the alleyway up the exit trunk with a steel ladder through the hatch directly onto the foredeck (Figure 4 and Photograph 9).

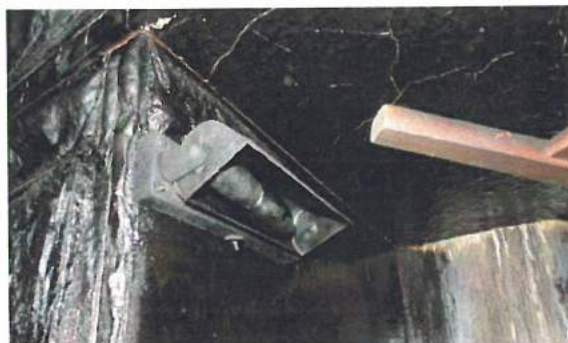
Deep, local patches of scorched wall of the watch officer's cabin where the incandescent socket was mounted indicate that the cause of the fire was most likely the direct contact of the flammable material (e.g. clothing or bedding) with a heated up glass lamp bulb¹¹.

Photograph 15: The bunk lamp with a bulb; picture taken in the another crewmember cabin

Given that the wall on which the night-lamp (bunk lamp) was mounted was built of flammable laminated chipboard, it could catch fire in about 20 minutes¹².

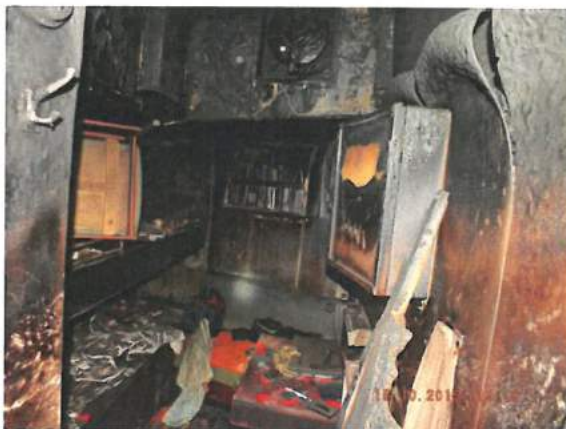
Through the open door of the cabin where the fire started, open fire spread to the alleyway and the staircase and set the door on fire and it burned part of the door frame in the cabin on the opposite side of the alleyway, belonging to the chief engineer (Photograph 18). However fire destruction in that cabin was moderate. Apart from the door, it was limited to the upper part of the cabin and came from the flames of the burning ceiling.

Photograph 18: The cabin of the chief engineer

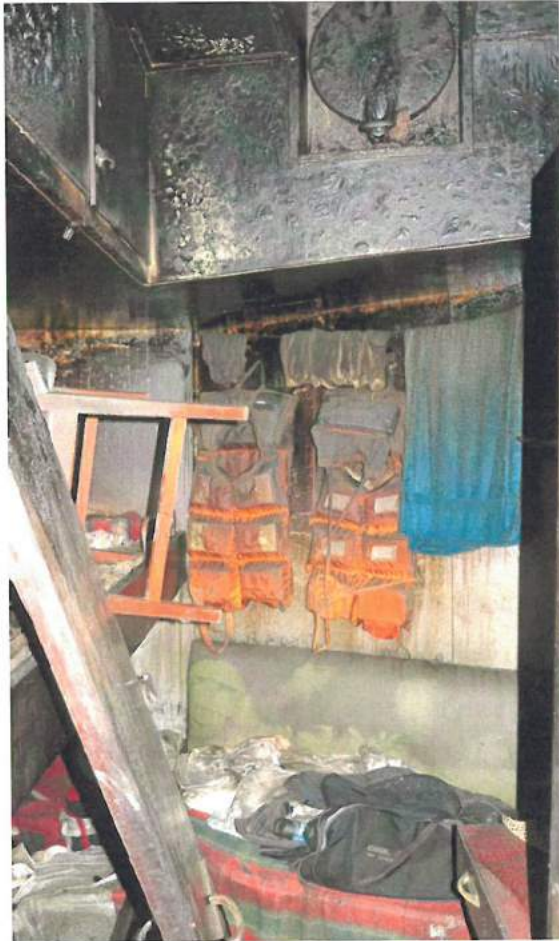
There are significant differences as far as damage is concerned, between the cabin where the fire started and other cabins. Moving away from the watch officer's cabin, thermal

destruction of the same flammable construction materials is clearly declining. Large amounts of smoke emitted from burning ceilings resulted in the formation of sediment.

Photograph 20: Central cabin – port side

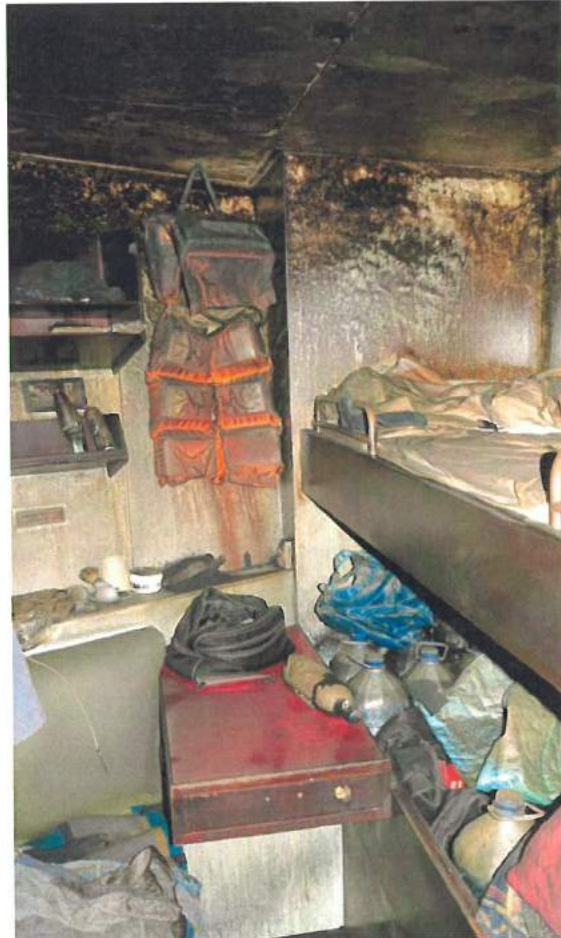
Photograph 21: Forward cabin – starboard side

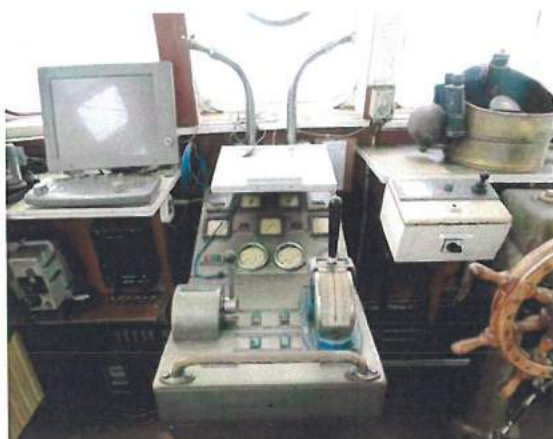
Since the door to the bridge and the engine room of the vessel were closed, the fire did not reach these premises¹³ despite the surface of the entrance doors being partly burned.

Photograph 26: A part of the bridge

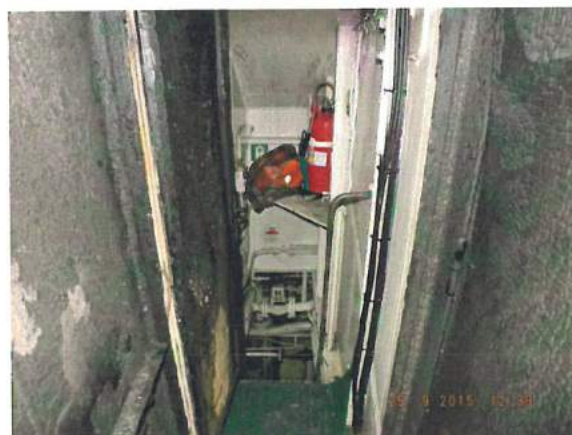
Photograph 27: The entrance to the engine room

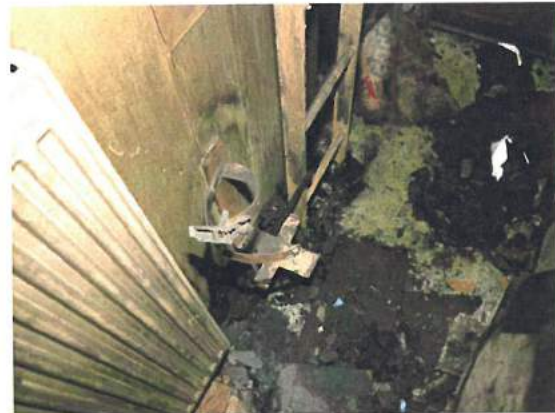
No fire-fighting equipment located in close proximity of the cabins and the source of fire had been used to extinguish the fire²². The fire extinguisher which was fixed by the stairs leading to the crew cabins was left untouched in its bracket (Photograph 30). The second extinguisher, fixed on the wall between the first and the second cabin at the port side (Photograph 29) had been found by the firemen inside the first cabin on the floor (Photograph 28). It means that the crew member who occupied this cabin probably went outside the cabin, grabbed the extinguisher, which was nearby, but was not able to use it, as he was forced by smoke or flames to return to his cabin.

Photograph 29. Fire extinguisher holder at the corridor between the crew cabins.

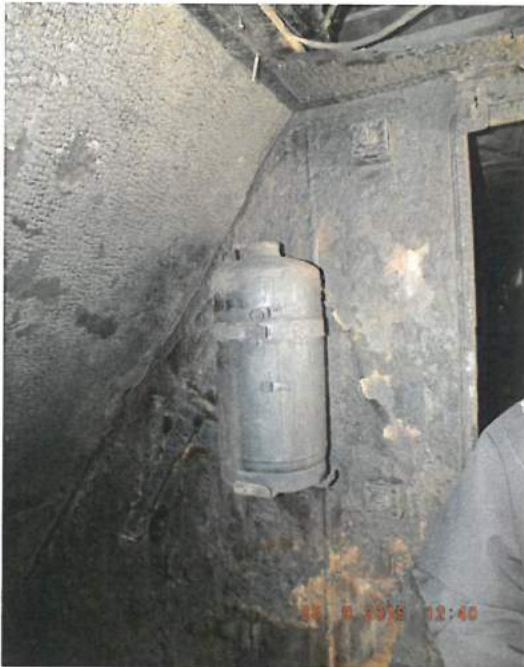
Photograph 30: Fire extinguisher at the stairs
