Danish Maritime Accident
Investigation Board

MARINE ACCIDENT REPORT

February 2015

STENA NAUTICA
Allision on 8 July 2014

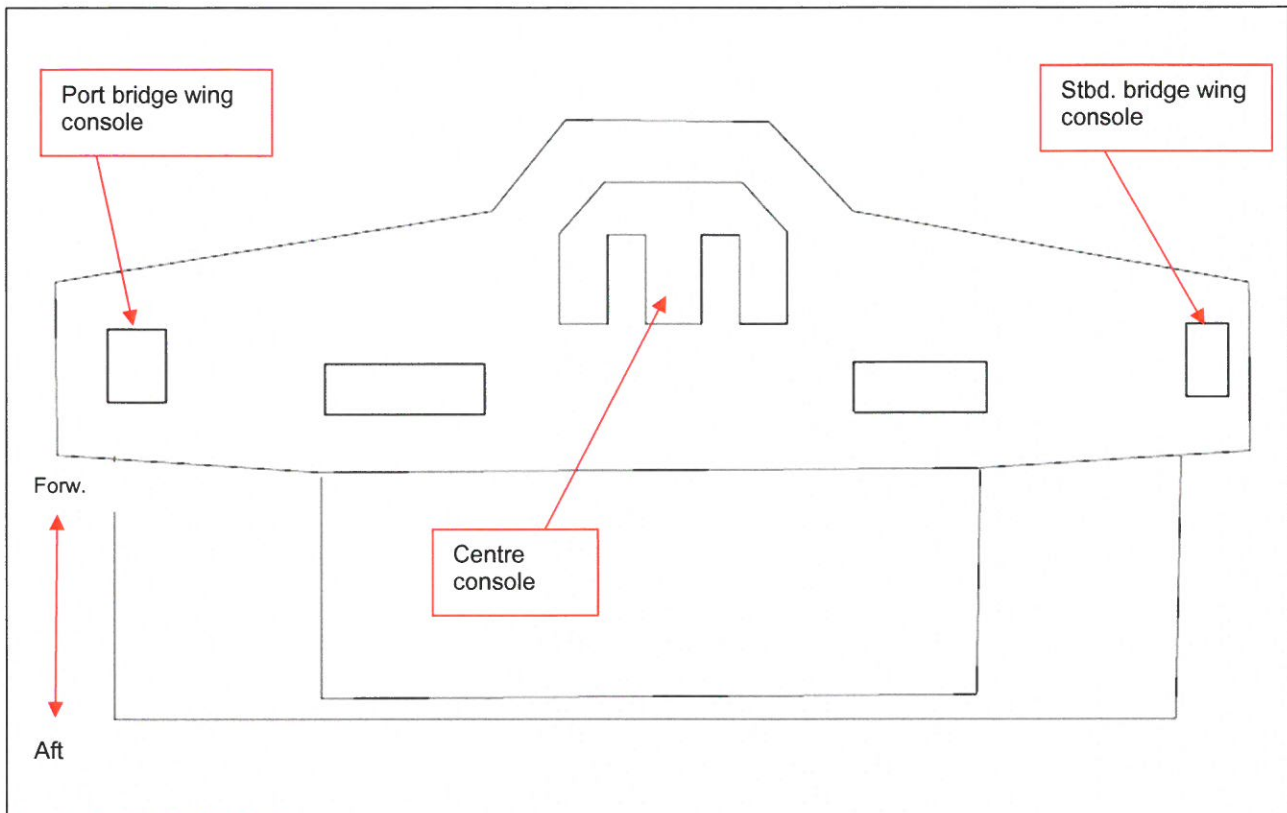
Figure 3: Outline of STENA NAUTICA's bridge. Approx. locations of steering consoles indicated.
Source: DMAIB

The ship was equipped with two main engines driving two individual controllable pitch propellers. In addition there were two bow thrusters and one stern thruster. The bridge layout consisted of a centre control station, including a steering console, and a bridge wing steering console in each side (figure 3).

On the night of 7 July 2014 at 2340, when STENA NAUTICA departed the berth in Grenaa two crewmembers were present on the bridge: the master and one 2nd officer. The master was in command, manning the port side bridge wing control station from where he controlled the main engines, the rudders and bow propellers (figures 3 and 4).

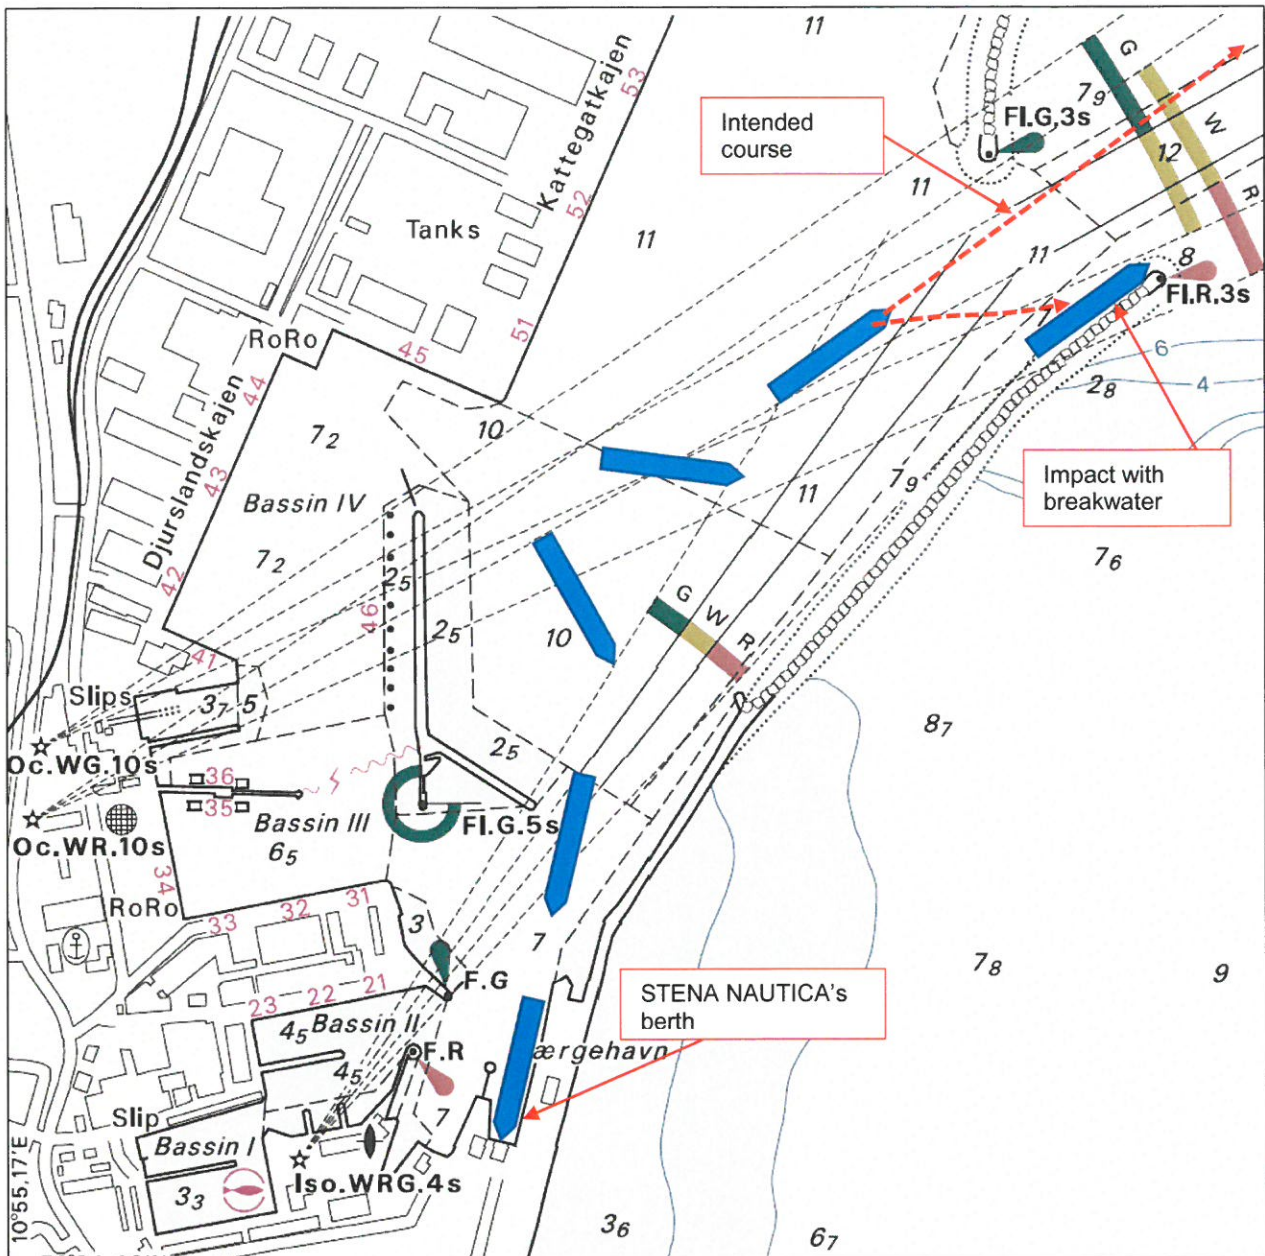
Figure 5: Port of Grenaa. STENA NAUTICA's berth and tum manoeuver sketched
 Source: Danish Maritime Authority/Danish Geodata Agency

As per normal procedure, the ship manoeuvred by the stern out of the berth and proceeded to perform a turning manoeuvre in the outer basin (figure 5). During the turn, the other 2nd officer and a helmsman came to the bridge and positioned themselves near the centre console.

When the ship was approximately 50-100 metres from the end of the outer southern breakwater, the master ordered the steering transferred to the centre console (figure 5), which also meant that the steering was switched to manual steering by the helmsman. As per normal practice, the master ordered the helmsman to take over on course 051.

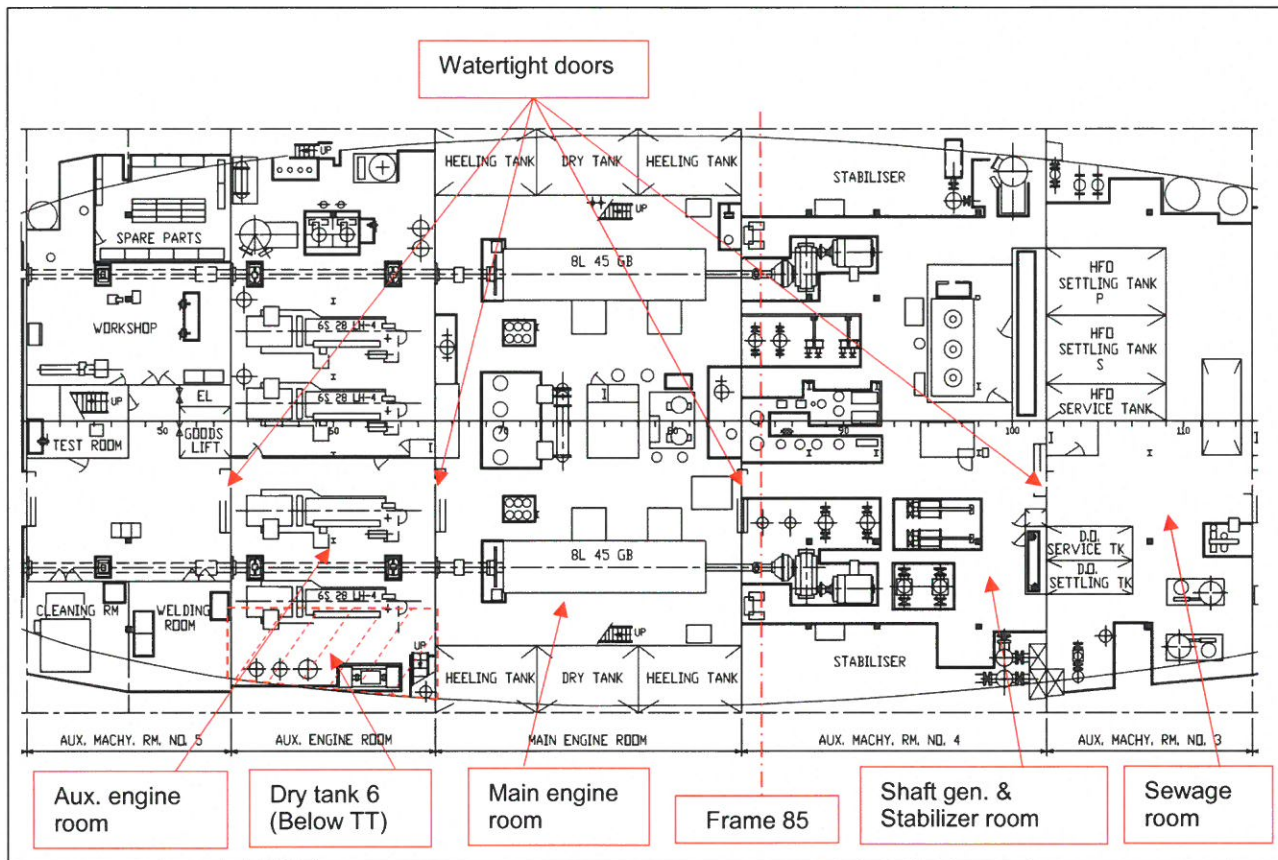
Figure 6: Excerpt of engine room layout. Deck 1 (Tank top level, viewed from above).
Source: Stena Line AB

Figure 6 below shows a plan of the engine room layout seen from above tank top level. The sections of the engine room, auxiliary engine room, main engine room, shaft generator room and sewage room are separated by watertight bulkheads and doors. At sea, the watertight doors are generally closed, and are opened only to allow passage.

In accordance with the ship’s emergency procedures for grounding, the motorman commenced sounding by hand of all tanks on the starboard side. When the motorman lifted the cap on the sounding pipe to Dry Tank 6, the water gushed straight up to the deck above. Soon after, when he opened the watertight door to the shaft generator room, he saw water gushing into the room from the area around the starboard stabilizer and reported to the engine control room that the ship had a leak near frame 85.

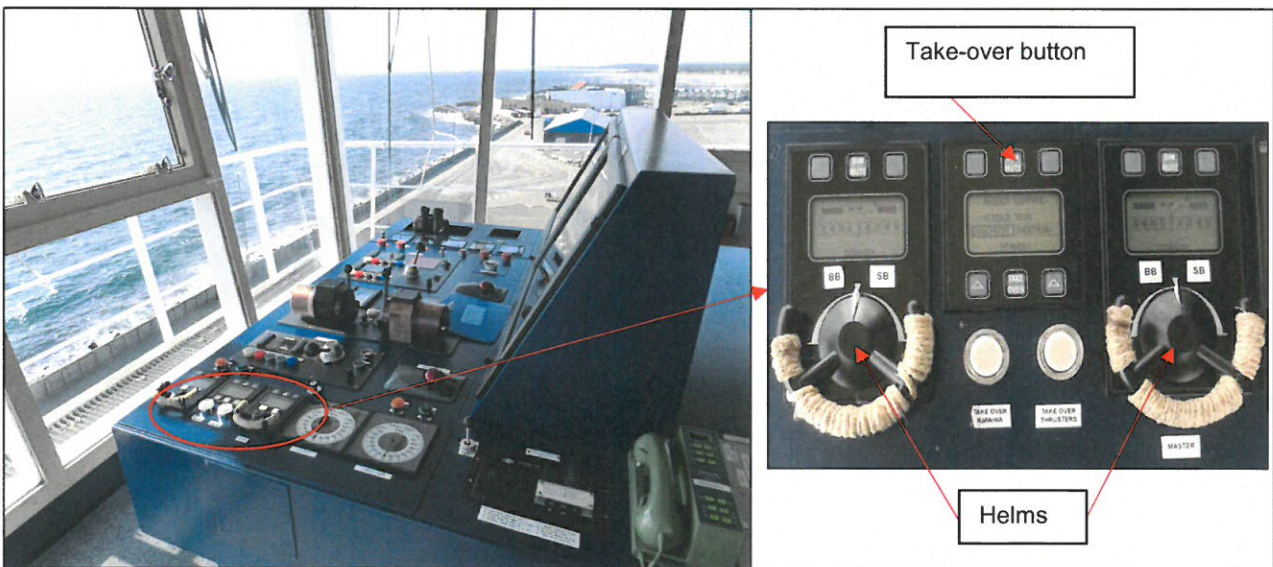
Figure 10: Port bridge wing console.
Source: DMAIB

Figures 9 and 10 below show overviews of STENA NAUTICA's centre steering console and the port bridge wing console. Various parts of the steering system are indicated on the photo and dealt with in detail in the following sections.

The accident revealed a weakness in the overall design of the bridge layout. The position of the override steering made some officers prefer one system over another, because they wanted to avoid accidentally activating the rudder. In addition, when the bridge officers and ratings were applying different strategies for operating the system, it would at some point lead to confusion caused by a fixation on which mode the system was in. The strategy applied by the bridge crew was to repeatedly confirm that it was switched to helm, while in fact it had already been switched over.

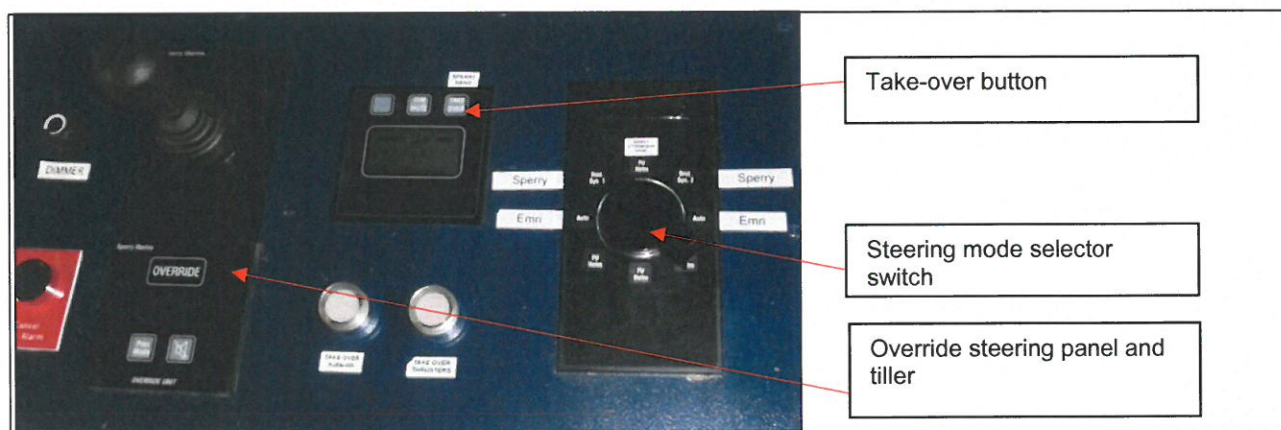
Figure 12: Detail of centre steering console. Source: DMAIB

As a part of the installation of the new steering system, the helm had been replaced with a new one which was smaller than the original one. It was designed with a turn indicator placed on the helm itself. The helm was not fitted with a counterweight or spring which meant that the helm would stay in the position to which it was turned. There were no mechanical or procedural features that could ensure that the helm was in neutral when hand steering was used. Although back lighting was fitted, it was difficult to visually establish the actual position of the helm, especially at night (figure 13).

The investigation revealed no technical failure in the steering arrangement. It is therefore highly likely that the ship made contact with the breakwater as a result of the following factors: the helm was already turned to a hard starboard position when the switch was made from port bridge wing to hand steering at the centre helm. At that time, the helmsman assumed that the helm was in a neutral, centred position. Thus, when the master ordered port helm, and the helmsman believed he followed the order, he actually just decreased the starboard helm, and the ship kept turning to starboard. When the crew realized what was wrong, it was too late to avoid impact with the breakwater.
