## *Final report RL 2021:05e*

**Accident at Visby Airport, Gotland County, on 19 June 2020 involving the aircraft SE-IMY of the model TB 10, operated by private individual.**

File no. L-48/20

19 May 2021

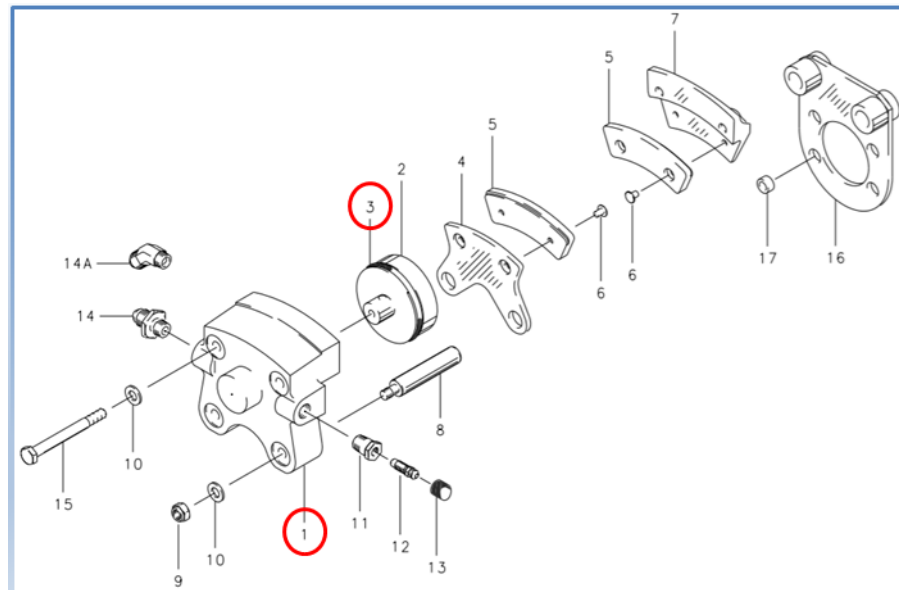
Figure 3. Exploded view of the brake caliper and its parts. Number 1 in the view is the brake caliper and number 3 is the O-ring installed on the piston. Image: Parker Hannifin Corporation, Illustrated Parts List, Catalog AWBPC0001-25/USA.

The caliper with part number 30-63J which was installed on the left landing gear was made of sand cast AZ81A-T4 magnesium alloy and certified according to FAA TSO C26. The certification means that the brake is required to endure 100 stops from 70 mph, with a deceleration rate of 10 ft/s<sup>2</sup>. Proper cooling is required between stops in order to accomplish the requirement. The O-ring that is installed on the piston inside the brake caliper has an operating range between -40°C and +121°C. The magnesium alloy from which the brake caliper is made of has a melting point of at least 421°C.

The latest replacement of brake pads on the left side was made on 15 October 2019 at 4 702 hours total time. There is no information when the O-ring for the piston was replaced.

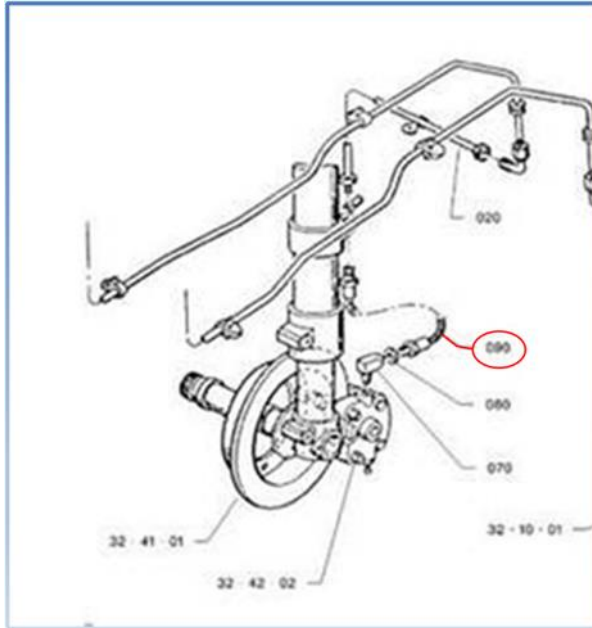
Figure 4. Image from the type certificate holders illustrated parts catalogue (IPC). The brake hose has item number 090 on the image.

According to the type certificate holder's illustrated parts catalog (IPC), the brake hose that is to be installed at the brake caliper on the main landing gear can have three different part numbers, see Figures 4 and 5.

According to the service bulletin (SB10-31-32-Rev02) published in October 1992, the type certificate holder recommends replacing brake hoses with part number 7850091700 to part number 7850091701, during inspection or at the latest at the next annual inspection. The service bulletin is not mandatory to follow, but the type certificate holder does not provide new brake hoses with part number 7850091700.

According to the spare parts catalog, it appears that part number TB1045017000 is also no longer provided, but has been replaced by part number 7850091701, which is the only part number provided by the type certificate holder.

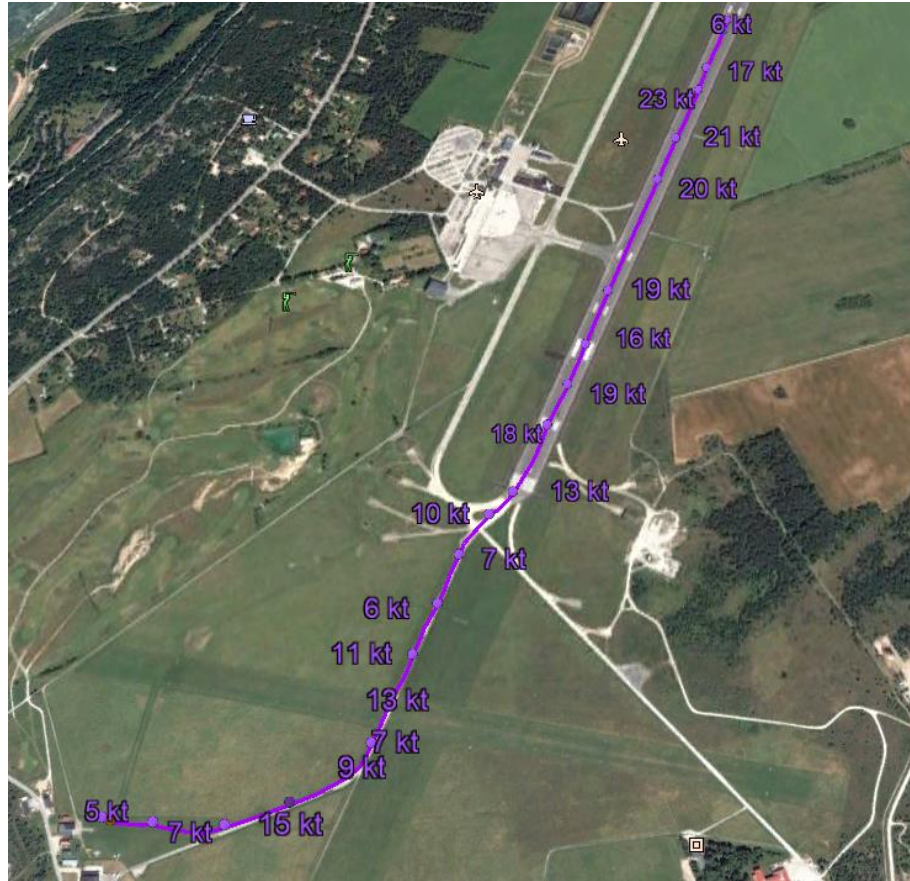
Figure 10. The aircraft's taxi route on ground after the turn around on the runway. Each point represents the average speed (ground speed) calculated from the previous point. Some points have been removed to enhance presentation. Route and text inserted by SHK. Picture: Google Earth.

When taxiing south, the pilot experienced that the aircraft turned to the left and he had to constantly correct with the right pedal to steer the aircraft in the direction of the runway. The pilot has explained the behaviour of the aircraft, that the wind was blowing obliquely from behind on the left side of the aircraft's vertical fin, which caused the aircraft to turn to the left.
