Final report RL 2017:07e

**Accident at Åre Östersund Airport,
Jämtland county on 13 June 2016
involving the helicopter SE-JVP of type
AS 350, operated by a private person.**

File no. L-59/16

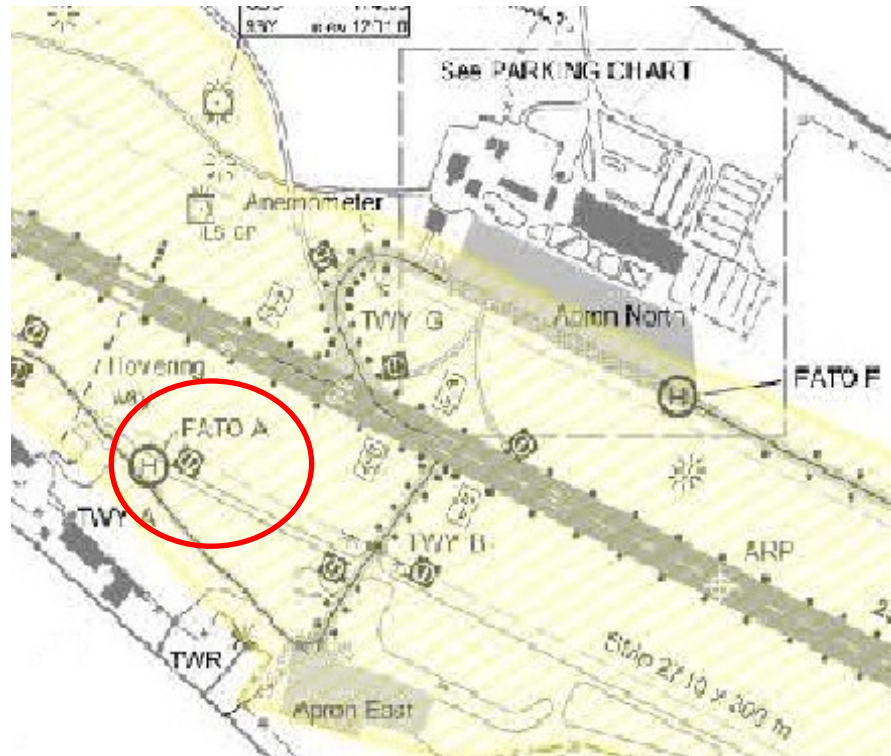
Figure 4. A schematic of the airport, and FATO A marked with a red ring.

The response routes from the fire station to FATO A, which is located on the other side of the airport landing runway, see Figure 4, have a number of very sharp turns. The fire fighting vehicles, which fully loaded weigh about 30 metric tonnes, must therefore brake to a very low speed in several turns. Previously, when Åre Östersund Airport was operated by the Swedish Armed Forces, there was a response route that led directly from the fire station to the helicopter pad Mitt. However, this route was removed when the airport went to only

commercial operation. It is noted that the present rescue routes are primarily designed to facilitate operations at the main runway. The investigation shows that the sharp turns on the response routes mean that the drivers must maintain a very low speed in the turns. SHK is therefore of the opinion that Swedavia should consider to take measures to assure that they can meet the existing response time requirements of three minutes, e.g. should the rescue routes be redrawn with smoother turns or, alternatively, be supplemented with direct rescue routes in order to facilitate response with heavy fire fighting vehicles to FATO A.
