## *Final report RS 2019:02e*

MIGNON – Cargo hold fire on 4 April 2018

File no. S-59/18

28 March 2019

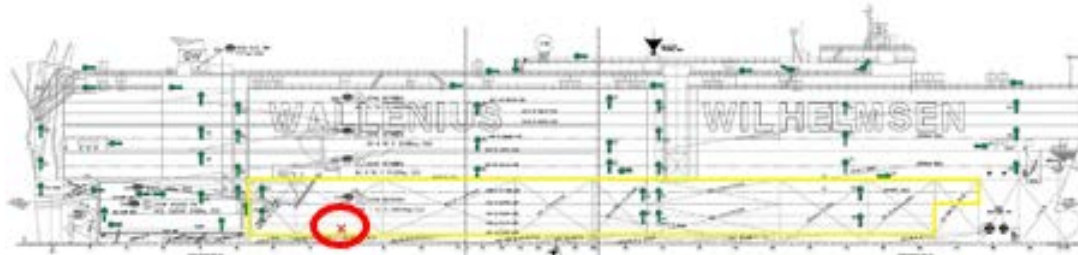
The first fire alarm, which came from a detector in the aft part of the cargo compartment on deck 1, was followed shortly afterwards by fire alarms from several other detectors on deck 1, and then later from more detectors on the decks above.

Figure 2. The first fire alarm was sent by a detector on the bottom loading deck, deck 1, in the circled area.

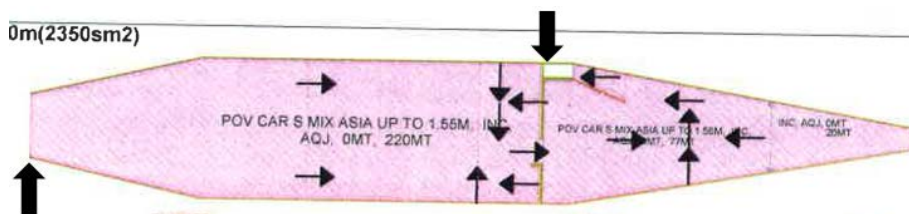
Deck 1 was fully loaded with used passenger cars, while deck 2 was only partially loaded with cars (see figures 10 and 11). The cars were parked very close together, with lashings on all wheels. Often, the spaces between the cars were so narrow that it was not possible to pass through at all, but in some cases it was possible to pass sideways. The lashings were fastened to the deck and to the top half of the wheel, stretching out a bit from the cars (see figure 12). For this reason, it was difficult to move around among the cars, as there was a risk of tripping over the lashings. A firefighting operation where smoke divers would have to pass the cars would thus entail a very great risk for the crew.

Figure 10. Cargo on deck 1: used passengers on the whole deck. The passages down to the deck that were used by the search team and the chief engineer respectively have been marked with bold arrows.

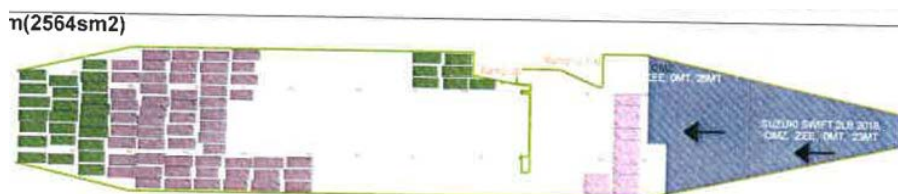
Figure 11. Cargo on deck 2: The filled boxes indicate the positions of the used cars.

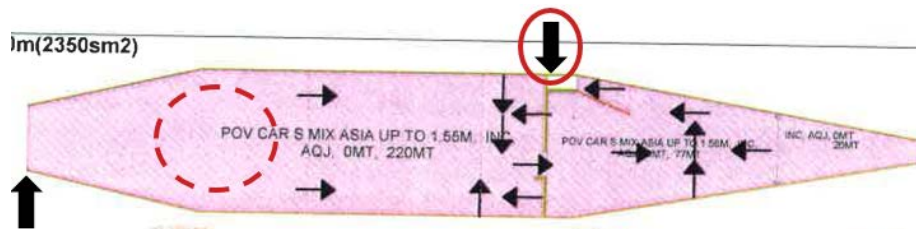
Figure 14. The first fire alarm came from deck 1, in the area circled with a broken line. The search team entered by the circled arrow.

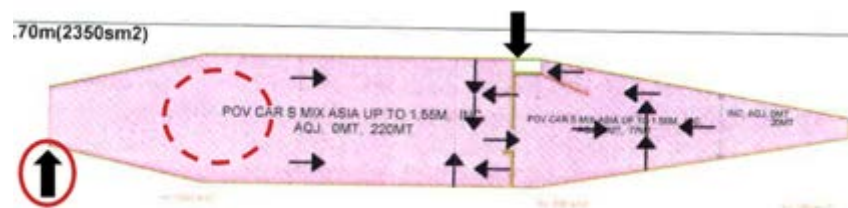
Figure 15. The chief engineer arrived on deck 1 at the circled arrow in the image. The first fire alarm was triggered by a detector circled with a broken line.

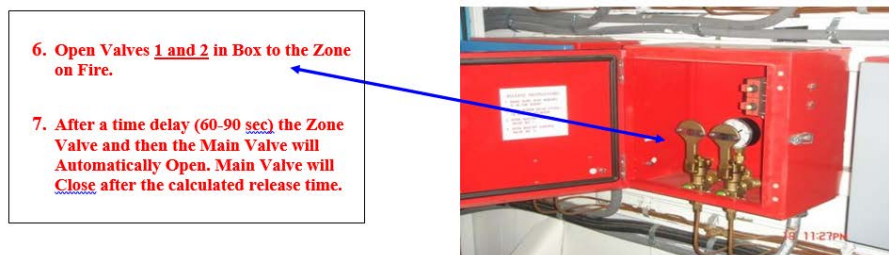
Figure 32. Instruction produced on the vessel.

The vessel's own instruction was more concise and only focused on the manoeuvres required to activate the fire suppression system, which ought to make it easier for the person doing it to quickly activate the system.

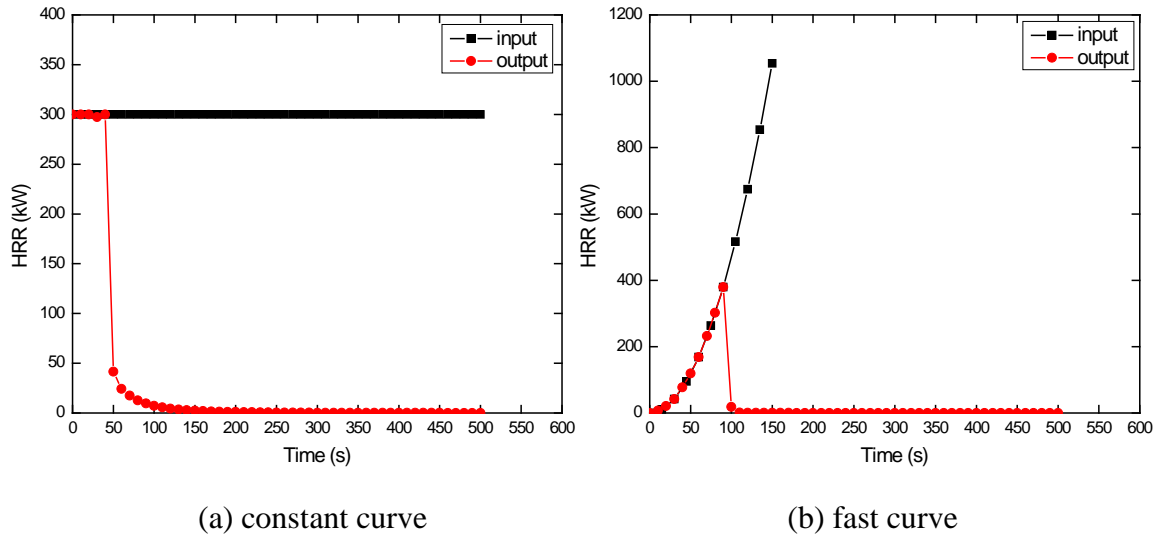
In the CFAST simulation, the predefined and output HRR is shown in Fig. 1. For the constant curve, the HRR drops from predefined 300 kW to 41 kW at 50 s, and then takes another 50 s to reach 7 kW. For the fast curve, the HRR drops from predefined 380 kW to 18 kW at 100 s, and then quickly self-extinguishes. The maximum HRR the fire can reach is 380 kW at 90 s.

The total energy released can be obtained by integrating the HRR over time. For constant curve, the total energy is 11.87 MJ, which requires the combustion of 11.87/30=0.40 kg fuel. For fast curve, the total energy is 13.69 MJ, which requires the combustion of 13.69 /30=0.45 kg fuel. The total energy released by a fast curve is larger than that from a constant curve. Compared with the preliminary estimation of 0.35 kg fuel, a larger value is obtained with CFAST.

Fig. 1. HRR of constant curve (a) and fast curve (b) in a sealed space.

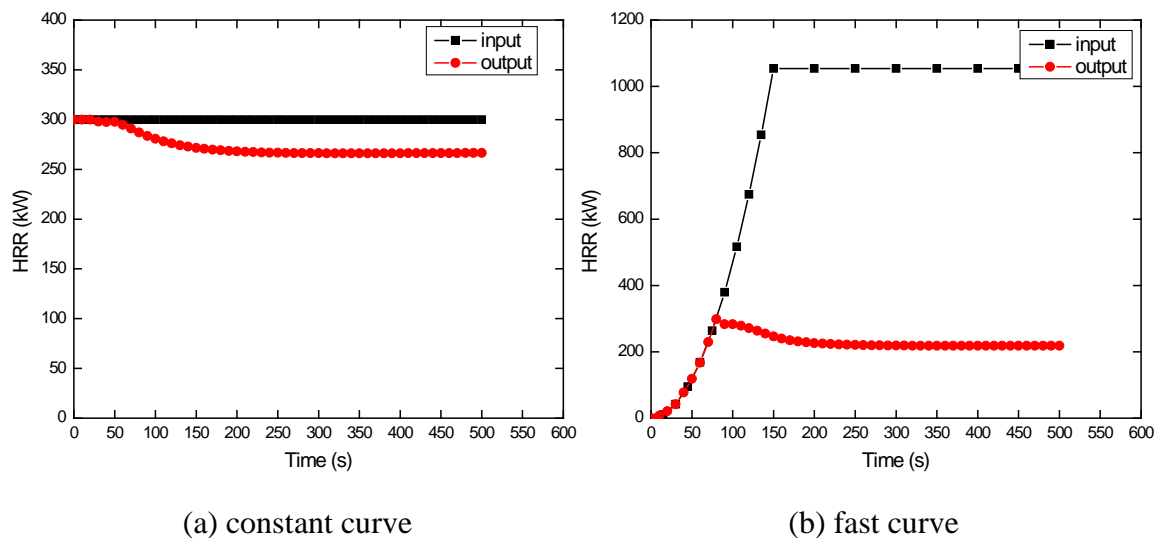
Fig. 3 shows the HRR of the constant curve and the fast curve in presence of a window. For the constant curve, the fire drops from 300 kW to 295 kW at 60 s. Due to the oxygen supplied by the natural ventilation, a steady HRR of 266 kW is reached at 170 s. For the fast curve, the maximum HRR the fire can reach is 298 kW at 80 s. The final steady HRR is about 220 kW, reached at 250 s. For both curves, the final steady state HRR is close the estimated value 265 kW. One finding is that although the geometry is the same for the constant and fast curve, the final steady state HRR is different. The reason is unclear, but one may suspect that the pressure difference induced by different combustion process may have influenced the natural ventilation in the final steady stage.

Fig. 3. HRR of constant curve (a) and fast curve (b) in a space with window.

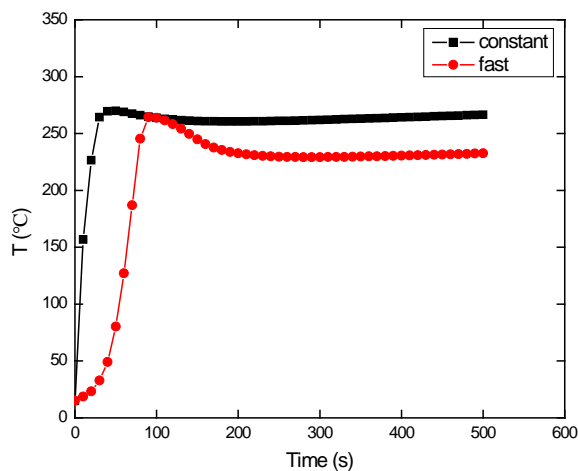
The upper layer temperature of constant and fast curve is shown in Fig. 4. In the final steady stage, the upper layer temperature is about 250 °C. At this high temperature, the window may break down, and creates larger openings than expected.

Fig. 4. Upper layer temperature of constant and fast curve inside the compartment.
