Final report RS 2019:05e

ENVIK – Very serious marine casualty in
Degerhamn, Kalmar County,
on 27 November 2018

File no. S-238/18

17 October 2019

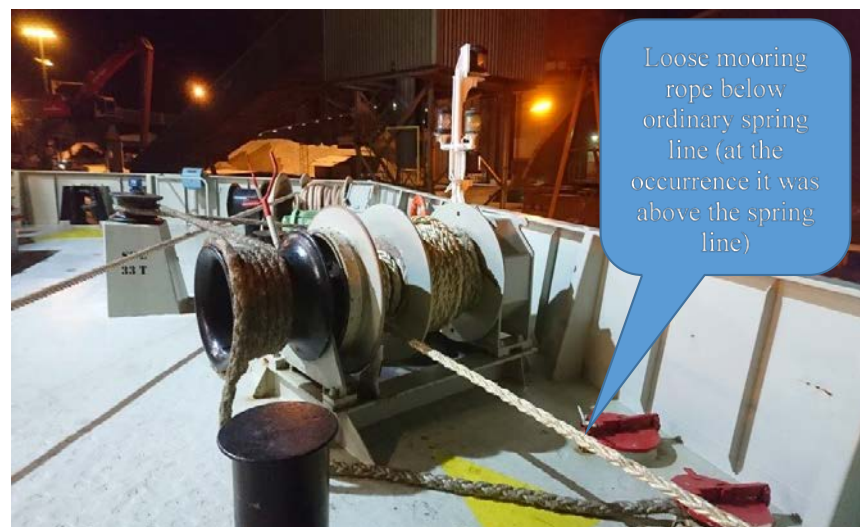
During the mooring at Degerhamn, port side to the quay, two aft lines and one spring line were used along with both mooring winches. The starboard winch was used for the aft spring line, and the port winch was connected to the two aft lines, of which one was an additional loose rope running on the winch drum (see figures 8 and 9).

Figure 9. Mooring winch and hatches to rope store.

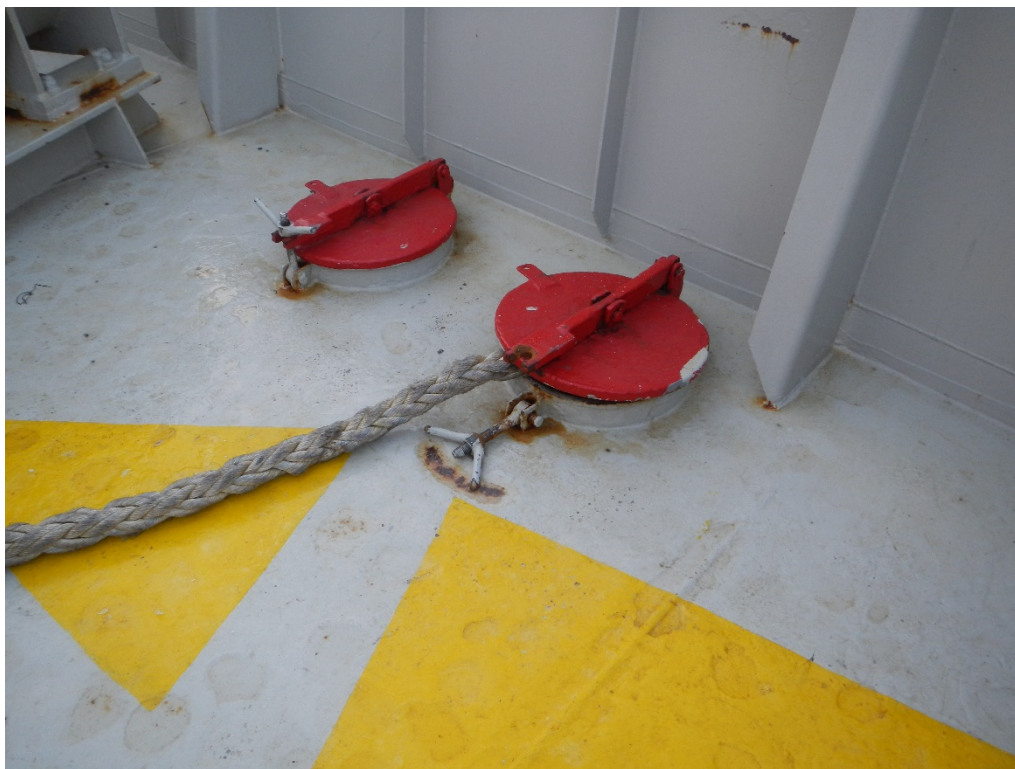
Underneath the poop deck is a store for additional ropes, which could be reached through two deck hatches (see figures 10 and 11). The AB serving on the poop deck had an approximate working area consisting of the space from the winch control box by the port bulwark to the winch, the bollard and the rope store hatches (see figures 12 and 13). At the time of the accident, the lever on the control box had been locked in place using the water adapter as a weight to ensure maximum winch speed (see figure 18).

Figure 10. Hatches to storage for loose ropes.

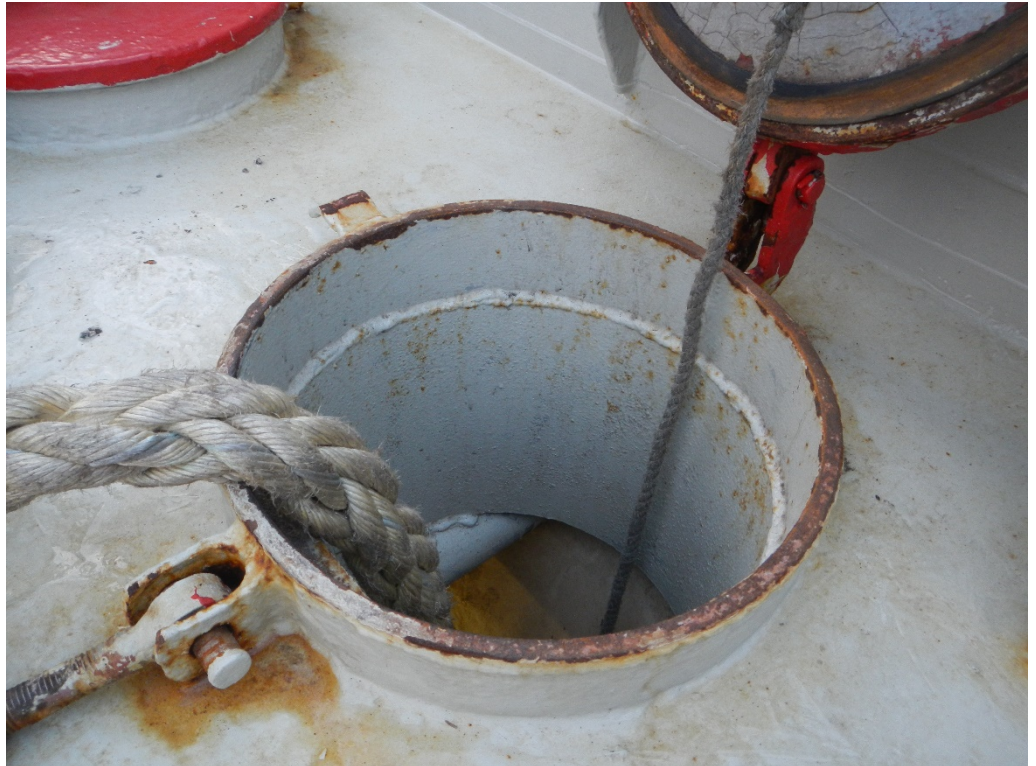
Figure 11. Opening to storage for loose ropes.

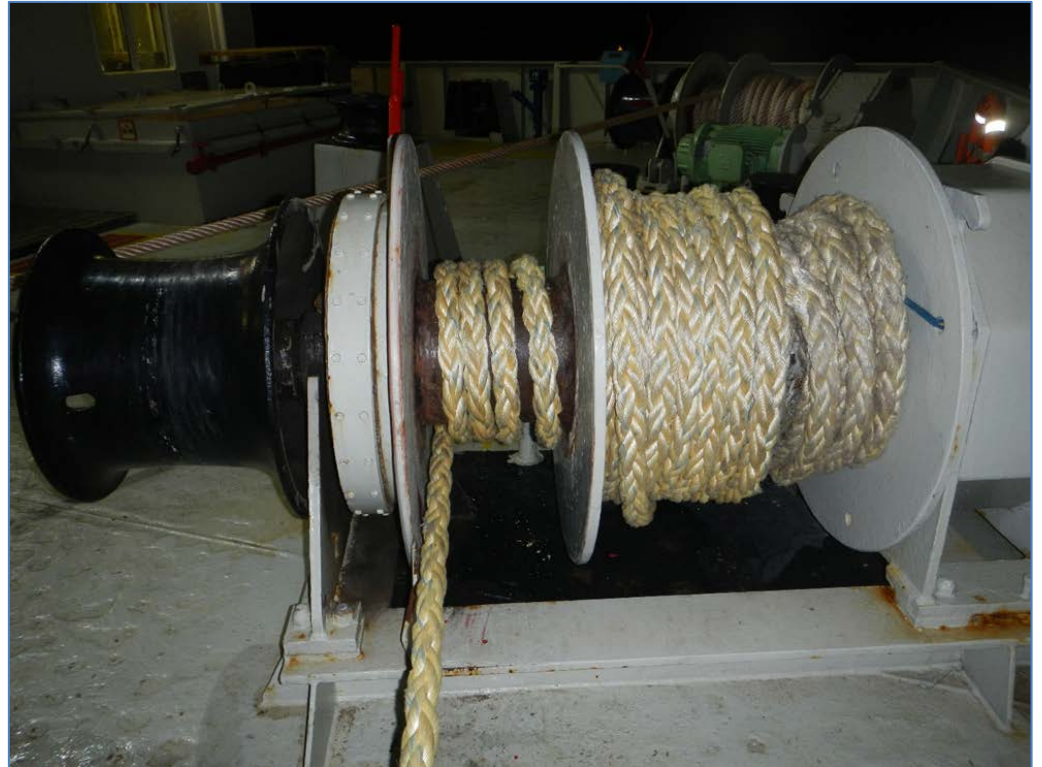
The mooring winch has a larger drum where the regular mooring line is permanently attached. It is an Atlas rope of the diameter 48 millimetres. Figure 14 shows the regular rope when moored, at which point it is redirected to the loadbearing drum with the required number of windings. When the rope is winched in, the full length is normally wound on the larger section of the drum, which then provides a storage space for the entire rope.

Figure 14. Mooring winch – the regular mooring line running from the loadbearing drum of the winch.

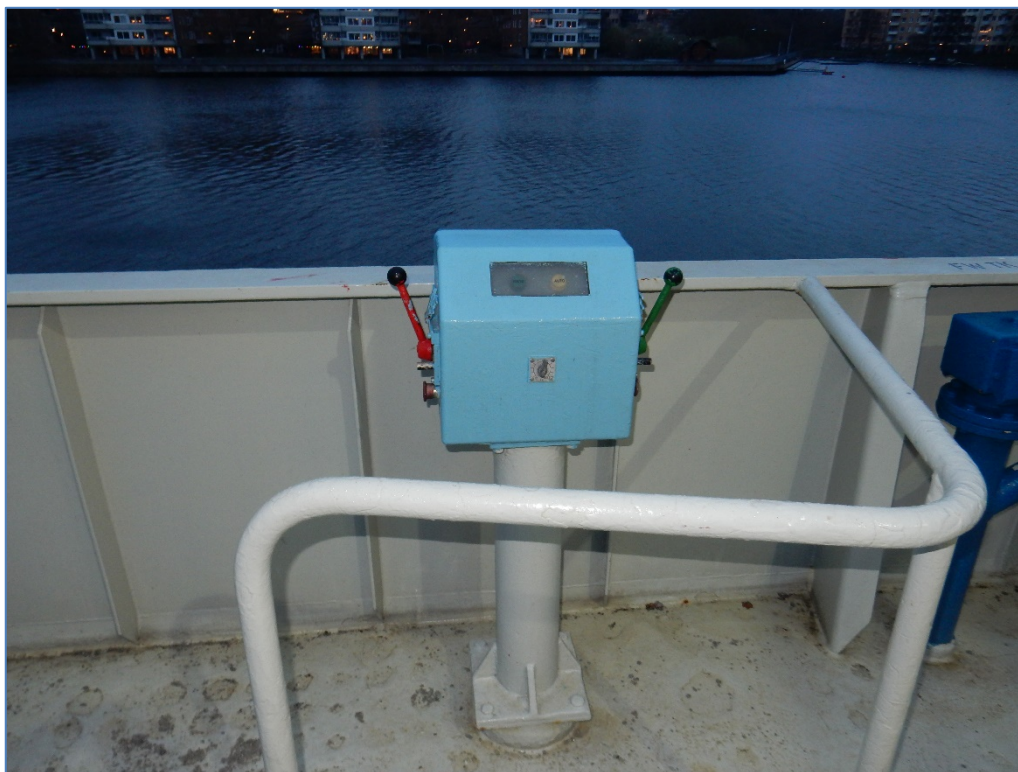
There was a control box placed at the port bulwark, and one on the starboard side, which could be used to control both of the mooring winches with a lever for each winch. The red lever (see figures 16 and 17) was used to control the portside winch. In connection to the bulwark and around the control box, there was a protection device surrounding the operator's working area.

Figure 16. Control box for the mooring winches on the portside bulwark.

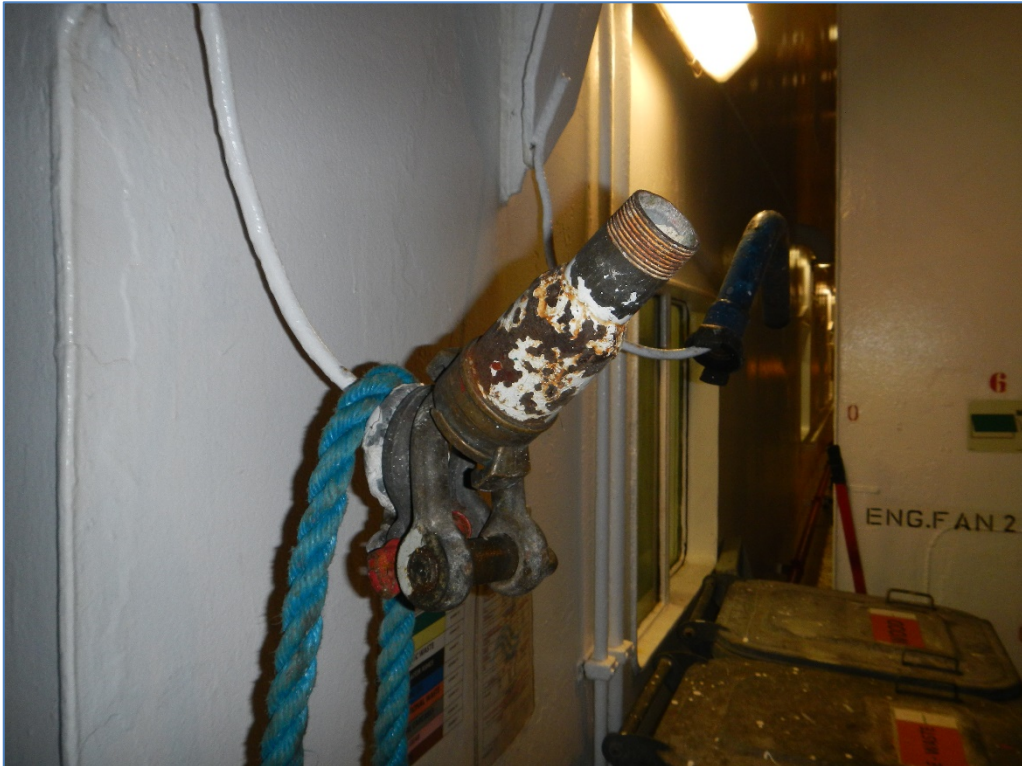
The metal coupler that was used to lock the mooring winch lever on high speed at the time of the accident was a water adapter used in conjunction with bunkering fresh water. This water adapter was heavy enough to lock the lever in the end position for maximum winch speed (see figure 18). The water adapter was normally placed on a hook on the bulkhead on the starboard side of the poop deck when it was not being used (see figure 19).

Figure 19. Placement of the water adapter on the bulkhead on the starboard side.
