Birdstrike involving a SAAB 340B, VH-OLM

Moruya Airport, New South Wales | 9 January 2015

ATSB Transport Safety Report
Aviation Occurrence Investigation
AO-2015-007
Final – 14 December 2017

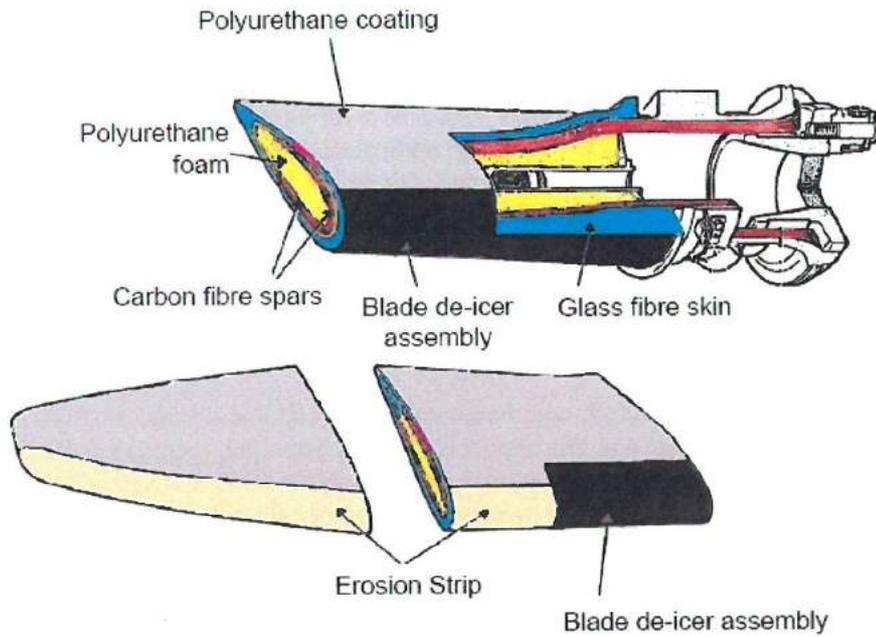
Figure 3: Propeller blade construction

The propeller blades were manufactured by Dowty Propellers. They were made of composite construction with a polyurethane foam core, carbon fibre spars, glass fibre skin, and a polyurethane coating. A braided metal strip between the glass fibre and polyurethane coating ran from the tip of the blade to its root, providing lightning protection (Figure 3).
