Investigation Report 99/13

Serious Marine Casualty

**Fire on the con-ro carrier
ATLANTIC CARTIER on 1 May 2013 in the Port
of Hamburg**

9 October 2015

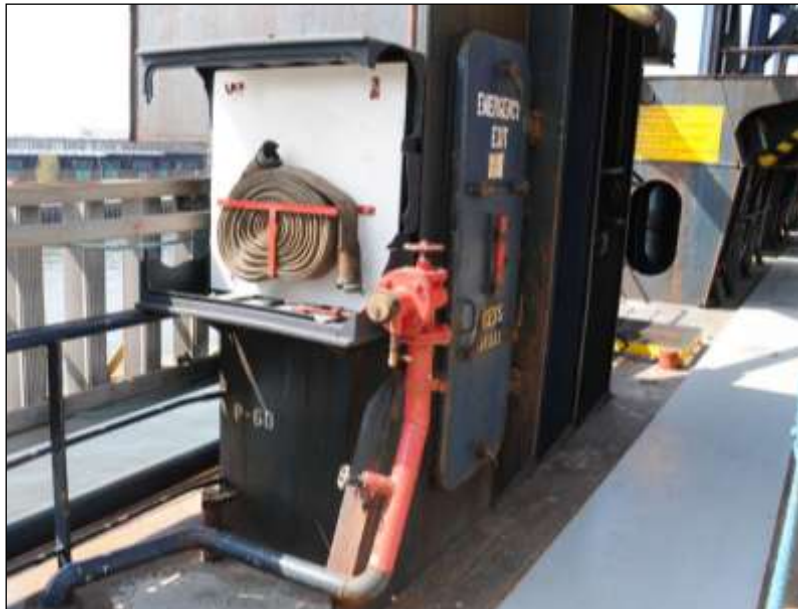
Figure 3: Emergency exit for ro-ro decks 3, 2 and 1 on the main deck

In preparation for further action, inter alia, a turntable ladder was used to establish direct access between the pier and main deck of the ship, seaborne water supply from a fireboat was set up, and potential access routes for fighting the fire on deck 3 B were explored. Here, special attention was given to the emergency exits on the main deck, each of which are not in the immediate vicinity of the presumed seat of the fire but give access to all ro-ro decks below deck via vertical ladders (see **Figure 3** above).

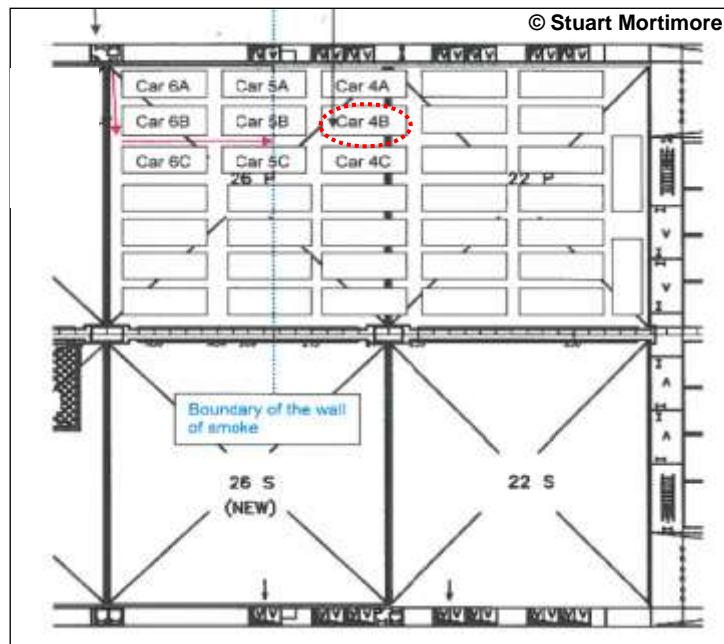
Figure 4: Witness Y's route on deck 3 B⁸

The route shown in **Figure 4** above and the marked boundary of the wall of smoke and fire source (car 4 B) correspond with the account of witness Y. The witness reportedly selected the route between the second and third row of vehicles, as it was claimed that its width was greater than between rows 1 and 2.

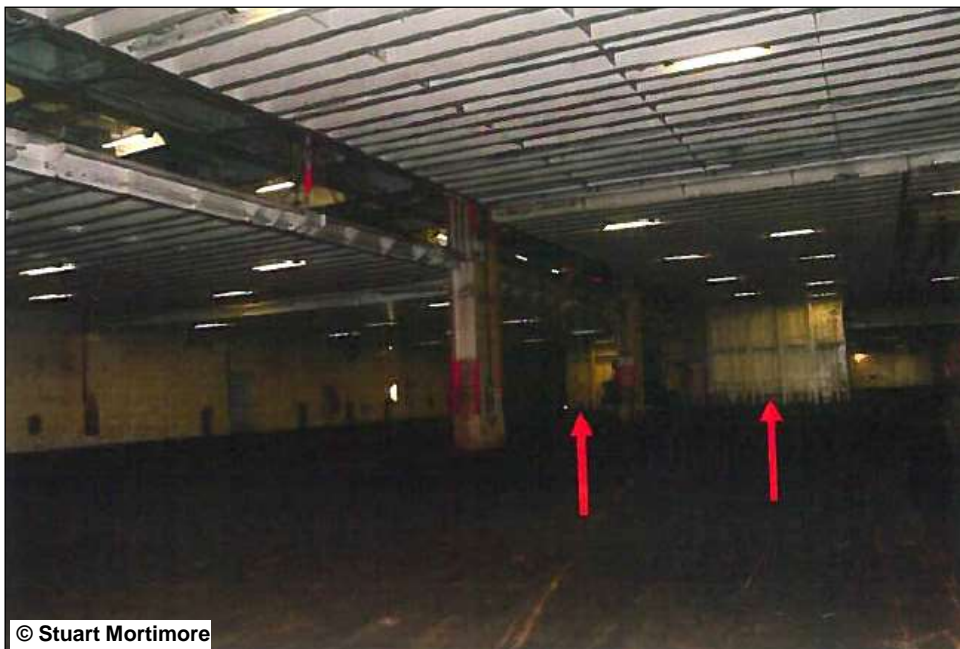
Figure 15: Sliding doors in cargo hold 3²⁴

On **Figure 15** below, it can be seen that the two sliding doors (see also the blue marking above in **Figures 12** and **13**) located in the area of frame N 11 (boundary between bay 35 and bay 37 of the main deck), i.e. within the section of the ship inserted subsequently, are half-open. They are two hydraulically operated steel doors

that make it possible to partition the starboard side and port side of cargo hold 3 athwartships over its entire height and at about its half-length. When both the doors are closed completely, cargo hold 3 is divided into two separate watertight compartments.

The two sliding doors were supposedly closed during the ATLANTICS CARTIER's passage from Gothenburg to Hamburg. Accordingly, the starboard sliding door must have been opened at some point after she made fast in Hamburg and prior to the outbreak of fire, as establishing watertight integrity was one of the subsequent activities in connection with making ready for the CO₂ extinguishing action.

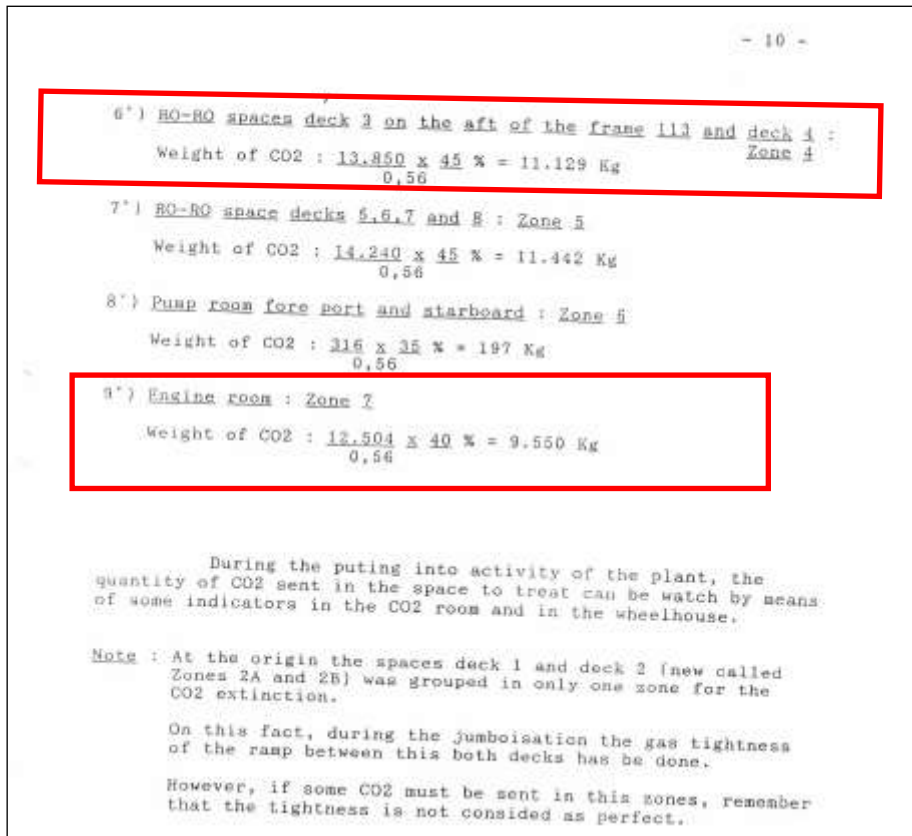
Figure 27: Extract from the technical description of the CO₂ installation after the ship was converted (page 10)

While reviewing the technical documents for the CO₂ installation, it was noted at various points that they contain incorrect or partially difficult to understand information with regard to certain volumes and computations, inter alia (see the areas highlighted in red in **Figures 26 f.** below, for example). For example, according to the

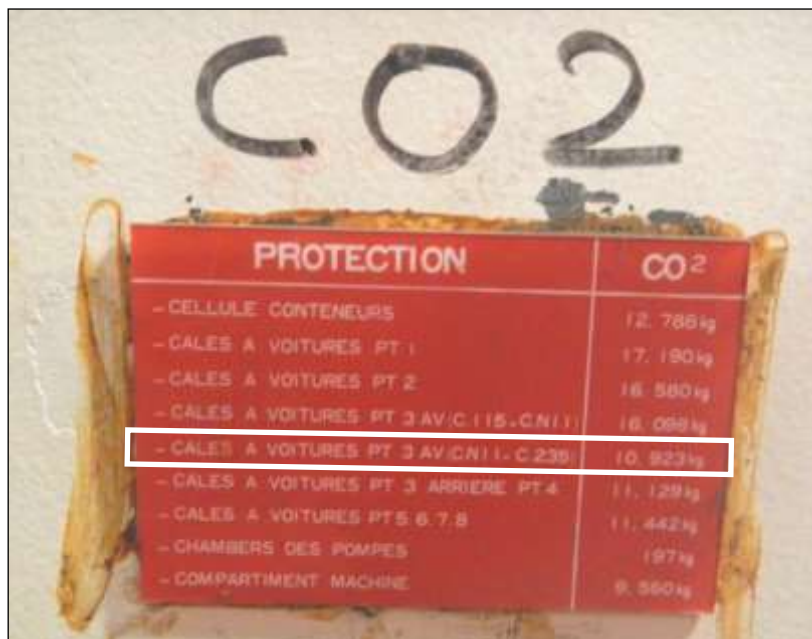
Figure 28: Overview of the CO₂ flood quantities (CO₂ control room)

The CO₂ quantity 'calculated' in the technical description for zone 3 B (10,923 kg) is shown on an information panel in the CO₂ control room, which contains details – in French – of the CO₂ flood quantities necessary for the various zones (see **Figure 28** below).

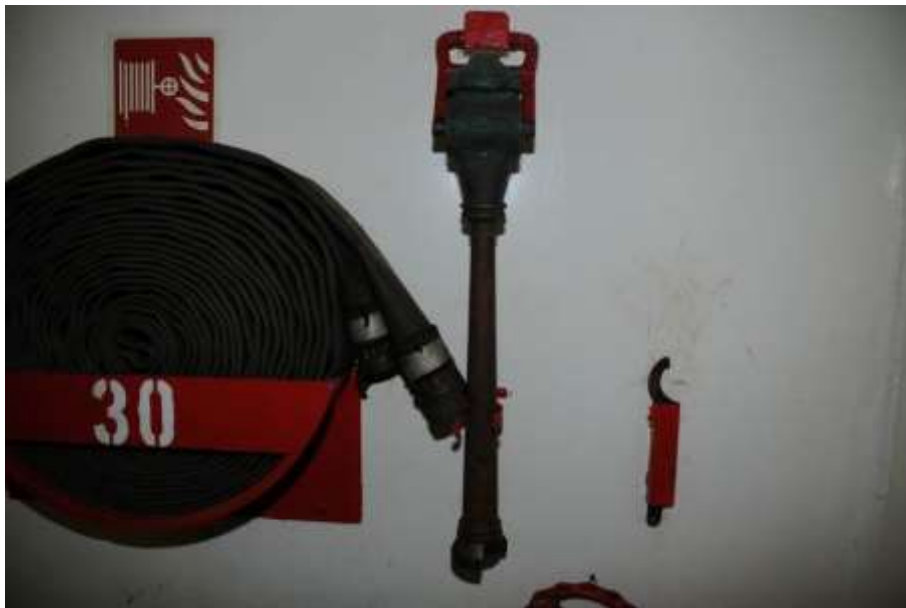
Figure 35: Example of the storage position of a firehose with extinguisher nozzle and coupling spanner on one of the ship's walls

French jet nozzles (manufactured in 1985 and earlier) that can be supplied from the water fire-extinguishing system via hydrants are available on the ATLANTIC CARTIER for mobile firefighting. Use of the hydrant system by external personnel using their own equipment fails due to the incompatibility of the French system with the standard Storz C system.

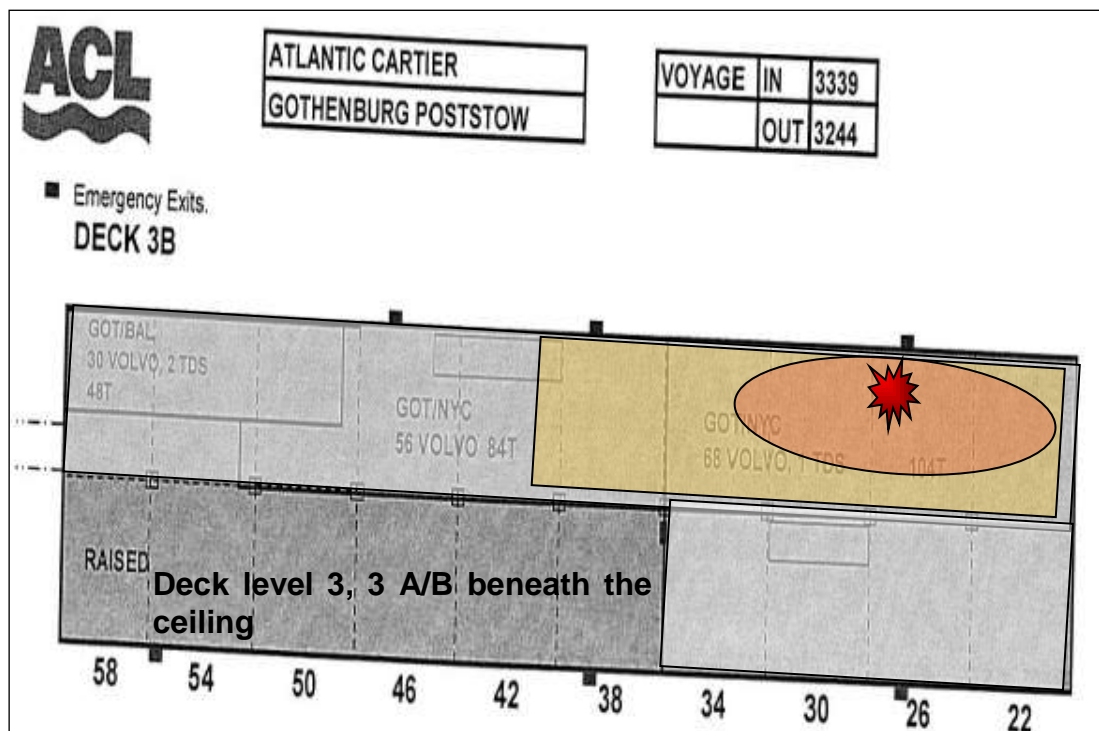
Figure 43: Area of fire development (ro-ro loading plan)

The damage on deck 3 B stretches to below the ceiling in the port area of the slots at bay 22 to bay 38. The area is limited on the port side up to the ships centreline. The starboard side was not loaded. The propagation of heat to the overlying deck 4 was apparent. When considering the extent of the damage, it is particularly striking that there was apparently no substantial fire damage outside the closed deck to the cargo on the upper deck, despite the fire developing rapidly.

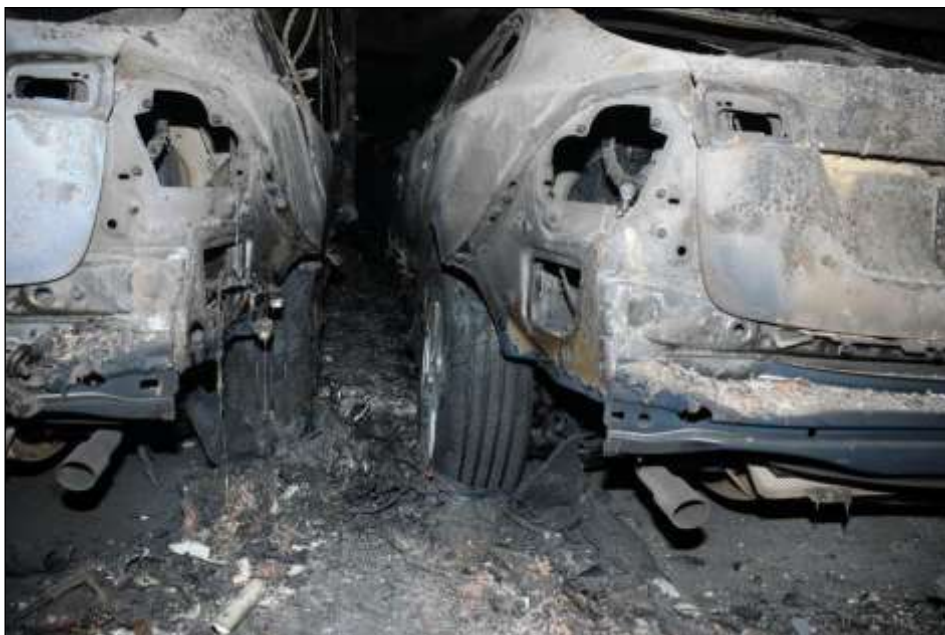
Figure 48: Spread of fire from above by heat radiation

*When considering the severity of the damage, it is evident that no effective action was taken to fight or contain the fire in the affected deck over a period of hours. Consequently, the fire was able to spread unhindered. That the entire cargo on the affected deck was not destroyed is thanks only to the specifics of the cargo, i.e. the fire resistance of the cars loaded. It is apparent that leaking fuel did not cause an extensive spread of fire, either. Most of the tyres survived at least partially even on the burnt out vehicles (see **Figure 48** below).*

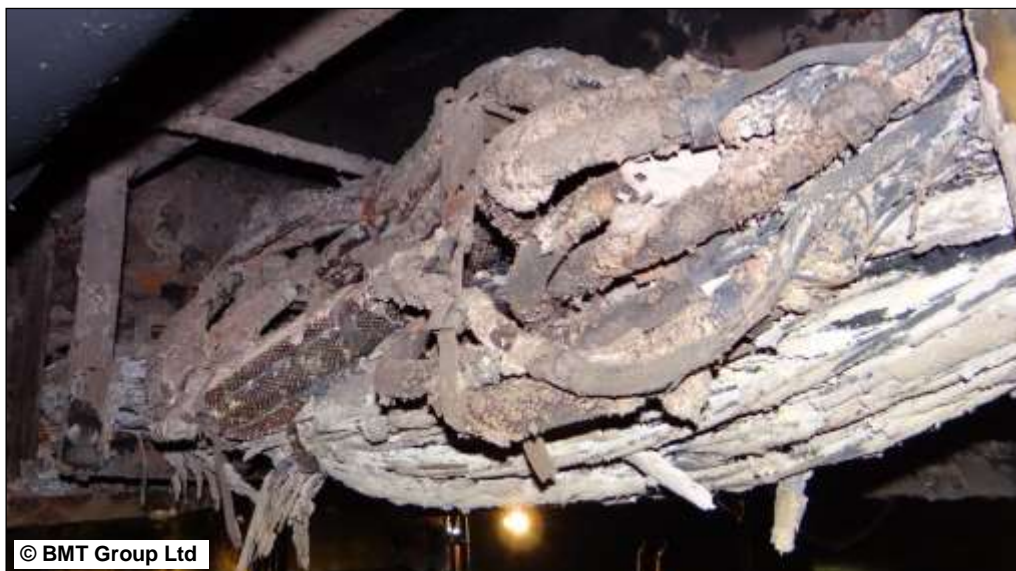
Figure 62: Cable splices on the ceiling of vehicle deck 3 B (close-up)³⁵

*In the opinion of the cargo insurer's expert, all the electric wiring on board the ship was defective and fire prone to an unusually high degree. According to that, evidence of inadequate wiring was revealed by cable loops protruding from the protective sheath, traces of corrosion on cables, cable connections of inconsistent strength, existing damage to cables due to welding operations, damage due to abrasion caused by metal cables, forcibly bent cables inside the insulation, damage to the insulation due to overheating, and traces of several earlier fires on deck 3 B. Indicative of the cable routing was numerous cable splices originating for the most part from the lengthening of the ship (see **Figures 61 f.**).*

There were about 200 cable splices in the area above vehicle 4 B alone at the time of the fire. **Figure 63** below is a schematic drawing showing the cars stowed in the forward part of deck 3 B. The nine vehicles affected by the fire most severely are highlighted in red.

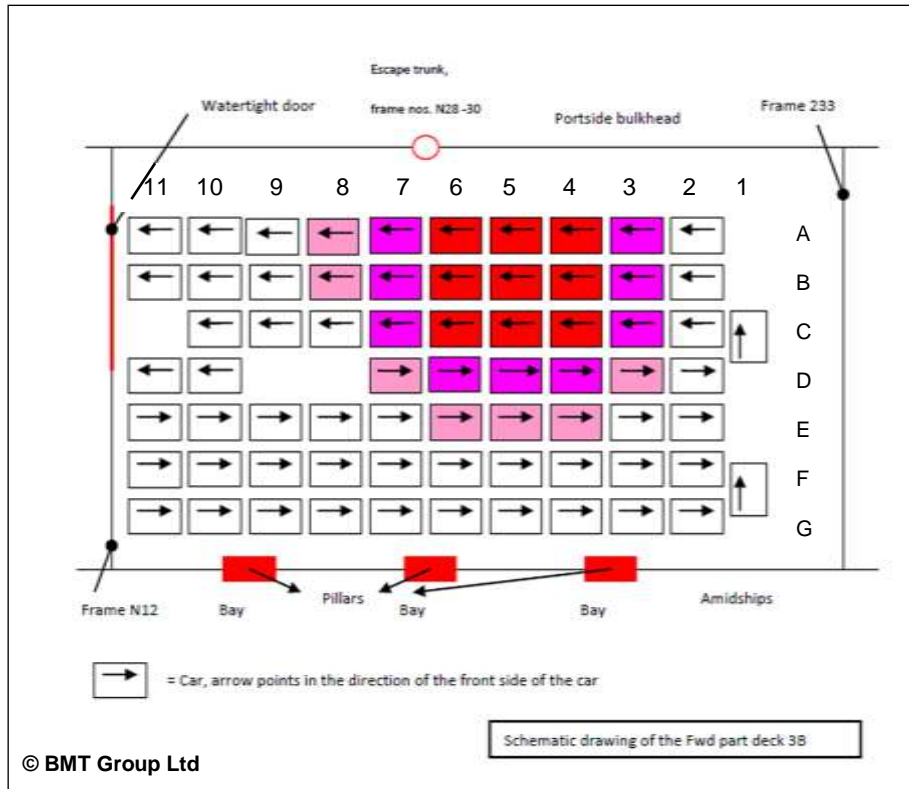
Figure 63: Schematic drawing showing the cars stowed on deck 3 B (port side)³⁶

Finally, to prove the existence of inadequate or damaged cable insulation, conspicuous signs of corrosion caused by the particularly aggressive saliferous air on seagoing vessels are referred to. This causes the formation of bright green copper chloride on metal conductors without proper insulation. The experts found chemical reactions of this nature on wiring above the positions 4 and 5 B (see **Figure 63** above and **Figure 74**).

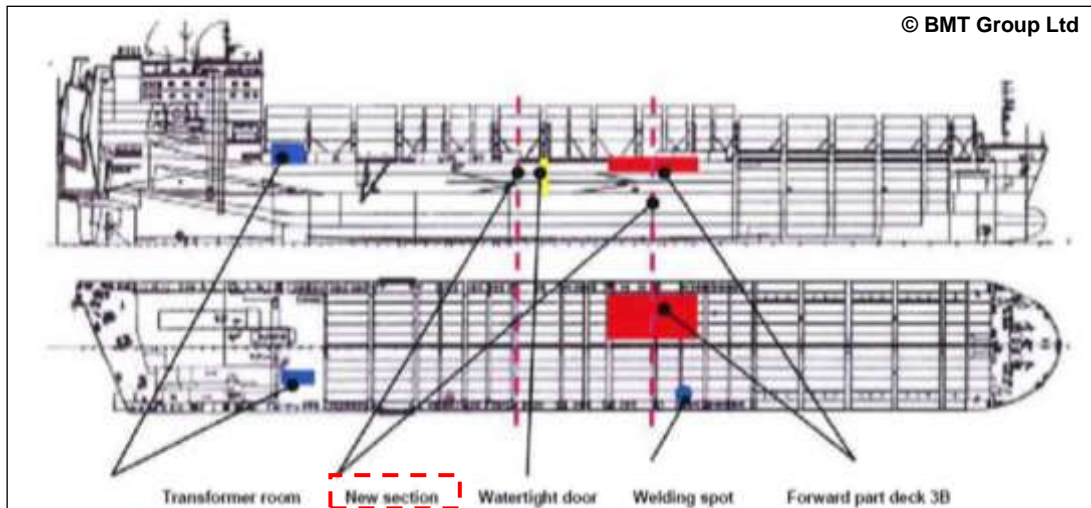
Figure 64: Seat of the fire on the threshold between the fore side of the inserted section and forward part of the ship³⁷

Figure 64 below illustrates a fact that the experts regarded as significant, which was that the fire broke out in the very section that was inserted into the ATLANTIC CARTIER after she was lengthened in 1987.

*The cable splices in the vicinity of the subsequently inserted section led from cables with a larger diameter or more conductors to cables with a smaller diameter or fewer conductors. At the time of the fire, there were various cables that consisted of three conductors, each with a diameter of 2.5 mm in the aft part of deck 3 B, while in the forward part they were continued with only two conductors, each with a diameter of 1.5 mm (see **Figure 65**).*

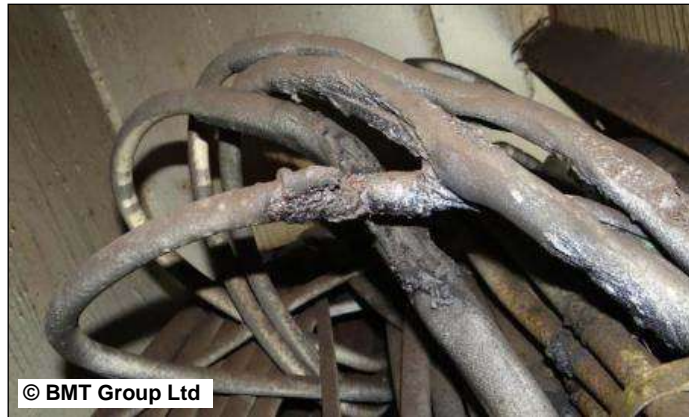
Figure 66: Example of charred cable insulation (1)³⁹

*Such inconsistencies in diameter cause electrical resistances capable of generating heat until the metal conductors are red hot. Traces of such overheated cables and scorch marks can be found at various points on deck 3 B (see **Figures 66 to 68** below).*

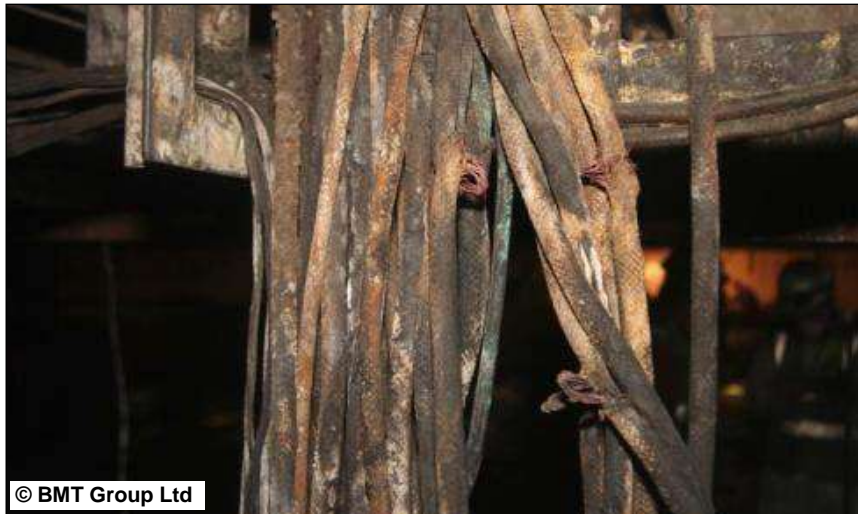
Figure 69: Example of metal conductor protruding from the insulation⁴²

*To demonstrate the existence of the defective wiring, the experts appointed by the cargo insurer also submitted photos that show sharply kinked or pressed in metal conductors protruding from and elsewhere within the protective sheath (see **Figures 69 f.**).*

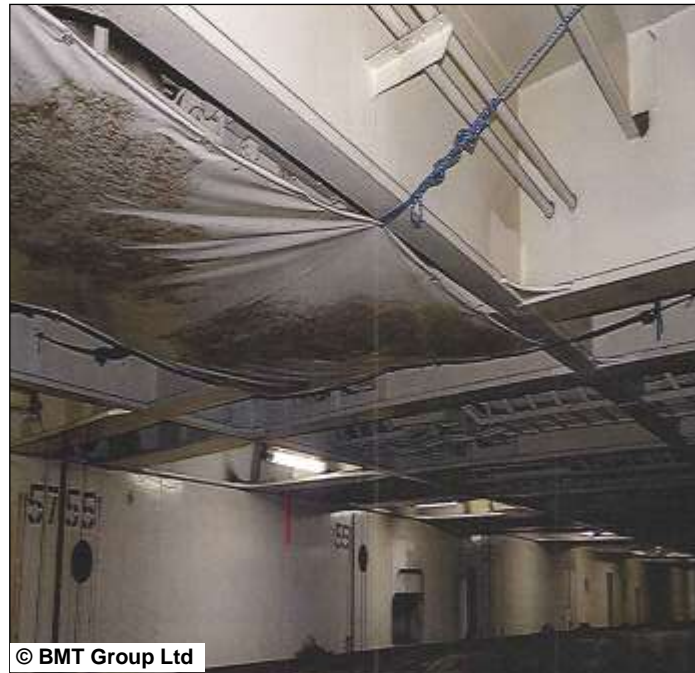
Figure 75: Example of one of the tarpaulins beneath the cargo hold ceiling

vehicles, plastic tarpaulins are hung in certain parts of the ceiling. Their purpose is to prevent droplets of hydraulic oil or lubricant stemming from mechanical components located beneath the ceiling that are needed for raising and lowering the mobile tween decks (see **Figure 75**). The tarpaulins have an exchangeable absorbent layer to soak up fluid discharge (see **Figure 76**).

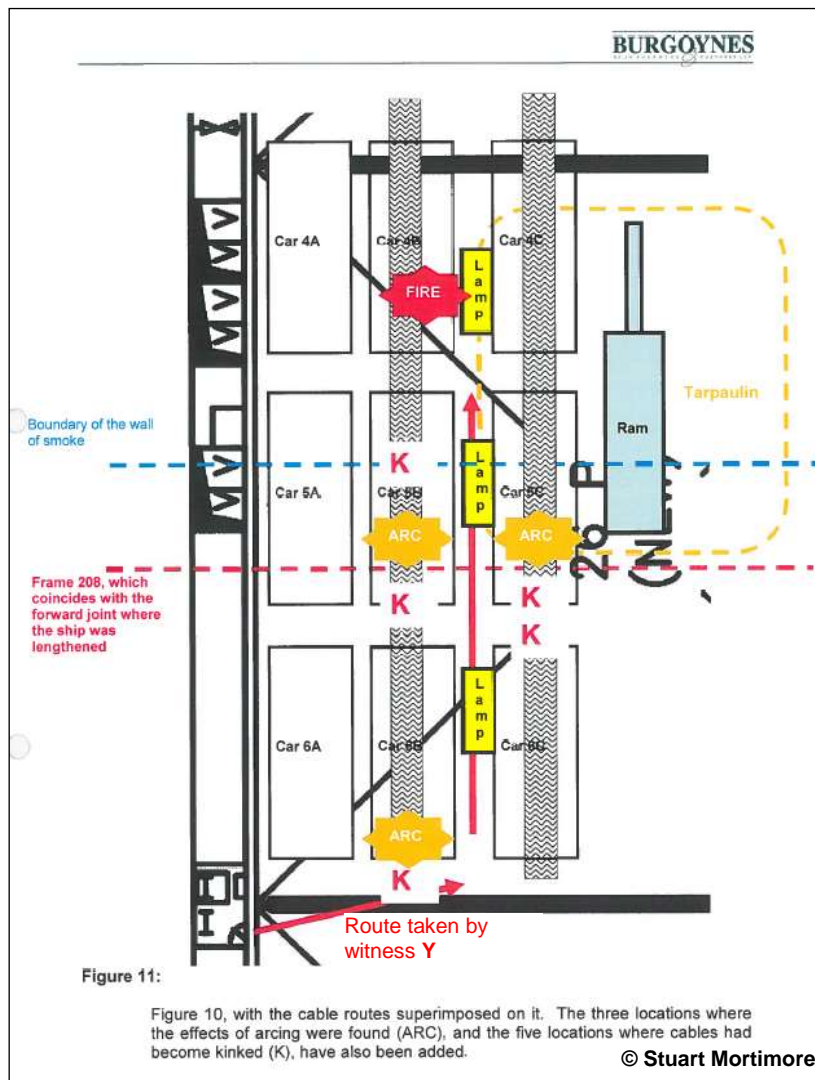
Figure 78: Schematic drawing of selected conditions in the vicinity the seat of the fire⁵¹

*The expert agrees with the respective experts of the cargo insurer and the BSU that the fire spread from the area of the fourth row of vehicles in the forward part of vehicle deck 3 B on the port side. The expert prepared the schematic drawing below to illustrate the specific circumstances and location of the focal points of the investigation in the vicinity of the nine cars most severely affected by the fire (see **Figure 78**).*

The area outlined in yellow at the top right of **Figure 78** above indicates a hydraulic ram in the vicinity of the fourth and fifth vehicle rows, which is needed for raising and lowering the segments of vehicle deck 3 B. To protect the vehicles stowed in the immediate vicinity of this hydraulic ram from oil spills escaping from the ram system, tarpaulins are hung above the vehicles stowed in the areas in question (see **Figures 92 f.** below). These tarpaulins are coated with an exchangeable absorbent textile layer.

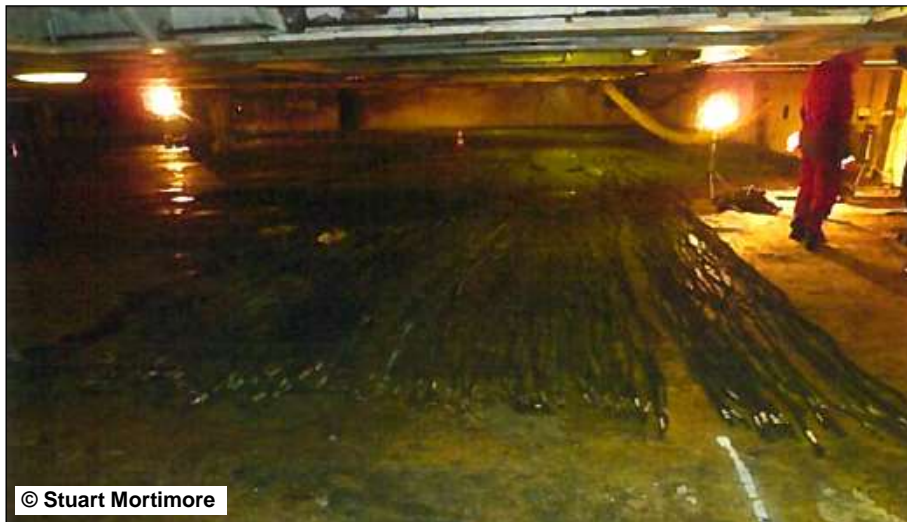
Figure 79: Example of dismantled cable harnesses⁵²

*In the course of the second local investigation after deck 3 B was fully cleared, the entire electric wiring in the forward section, i.e. the section of deck 3 B primarily affected by the fire, including the transition to the aft section of this deck was thoroughly inspected and the parts damaged by the fire then dismantled (see **Figure 79** below).*

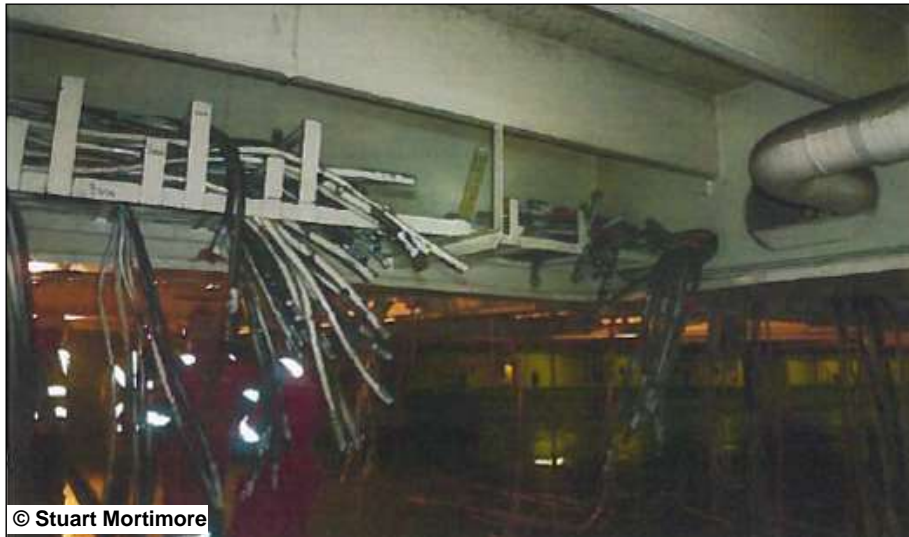
Figure 81: Rear cable splice⁵⁴

*In contrast, the rear cable splice (in the vicinity of frame 207) was located outside the forward section of the vehicle deck, which was affected primarily by the fire and isolated from the rest of deck 3 by the sliding door. Consequently, this cable splice was not destroyed and could be examined in greater detail (see **Figures 81 f. below**).*

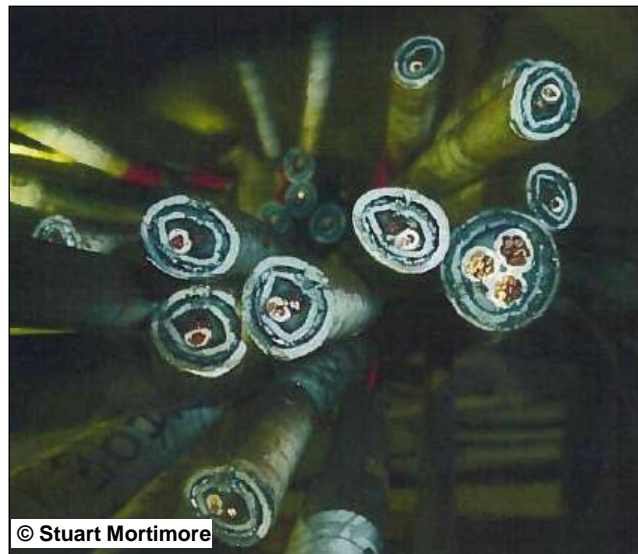
Figure 83: Close-up of the structure/cross-sectional area of single cable harnesses

*No deficiencies were found in the insulation, sheathing or the materials used in this respect (see **Figure 83** below). The sheathing consists of a highly resistant armouring and could only be separated by means of a sharp blade.*

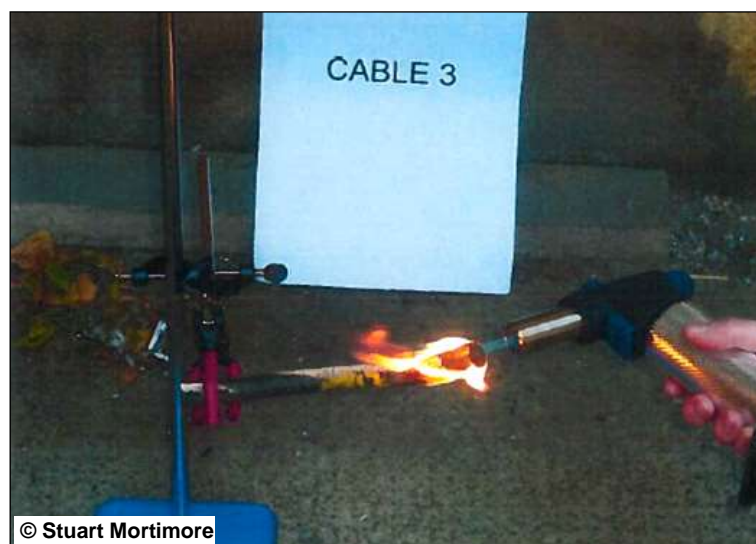
Figure 84: Test setup – ignition and fire performance of a cable sample⁵⁶

*An investigation of the plastic material used for the insulation and sheathing, which was performed in a laboratory, revealed that they both contain fire-retardant additives. The ignition or fire performance of three single cables of different sizes or with different sheaths was tested in a laboratory using a lighter and a blowlamp, among other things (see **Figure 84**). It was not possible to set the various cables on fire with a lighter. While it was possible to ignite two of the three types of cable tested using a blowlamp, the fire extinguished within two or 25 seconds of the heat source being removed. It was also found here that the plastic insulation did not start to drip during the burning phase. Propagation of the fire on the insulation, similar to an ignition fuse, was not evident either.*

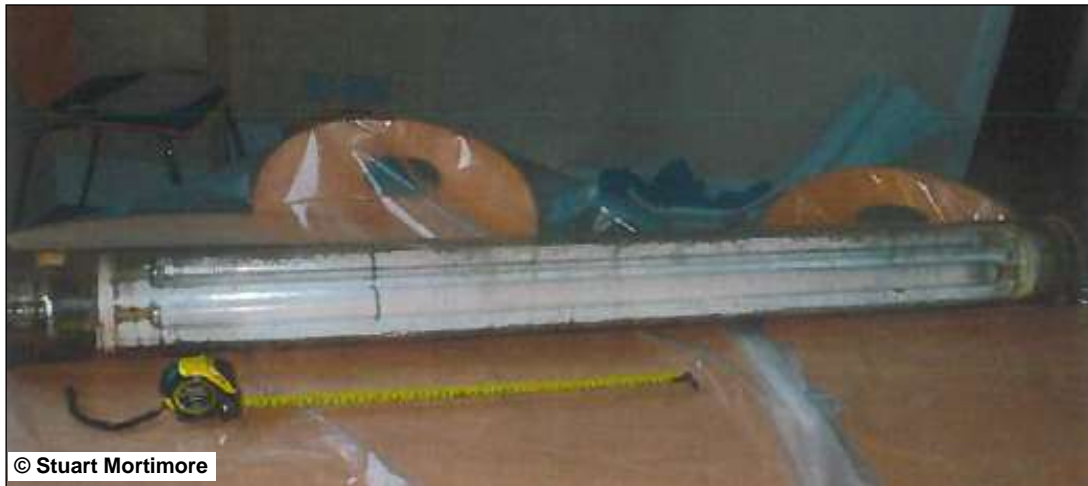
Figure 86: Model of the ceiling light installed in the vicinity of the fire⁵⁸

Since ceiling lights were installed in the immediate vicinity of the vehicle that most probably caught fire first, the possibility that a defect originating from there could have caused the fire received special attention. In that respect, the expert conducted several laboratory tests and also contacted the German lamp manufacturer Sammode Lichttechnik GmbH in Saarbrücken. The manufacturer stated that the lamp model in question is still produced and designed so that a possible electrical fault within the lamp would on no account affect the external environment or lead to the ignition of materials outside of the lamp.

The ceiling lights used were type certified in accordance with international technical standards and classified as 'explosion-proof' in 1969. Accordingly, the lamp should not radiate temperatures of more than 104°C.

Figure 86 below shows the comparison model of the ceiling light tested by the expert. The lamp is 1.5 metres in length and contains two 40-watt fluorescent tubes.

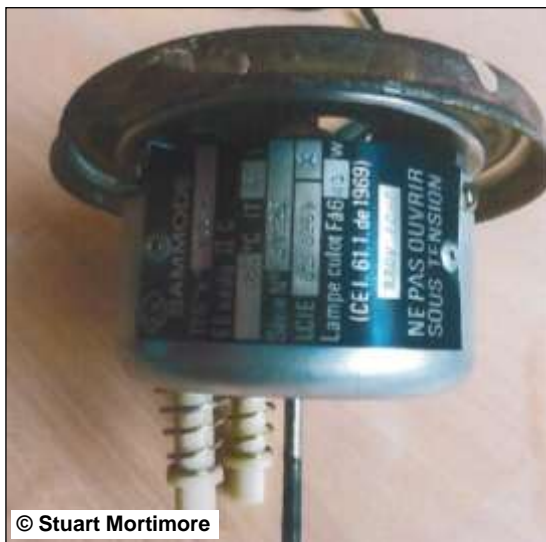
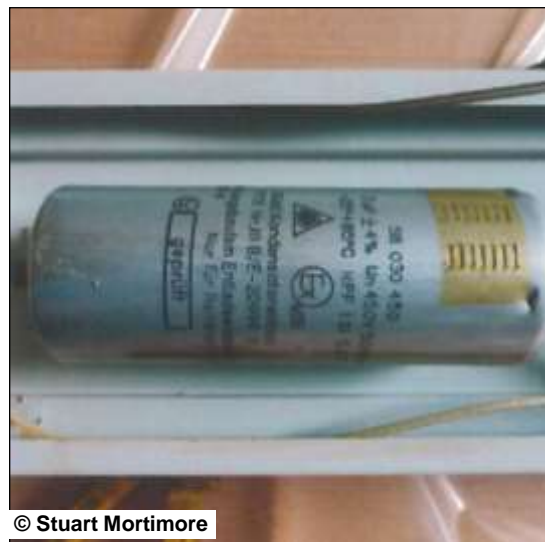
Figure 87: Lamp socket and capacitor⁵⁹

As regards the possible consequences of an electrical fault, the expert also contacted the German manufacturers of the capacitors and ballasts installed inside the lamp. It was confirmed that each component is reportedly designed and certified so that fire is reportedly ruled out in the event of a technical fault.

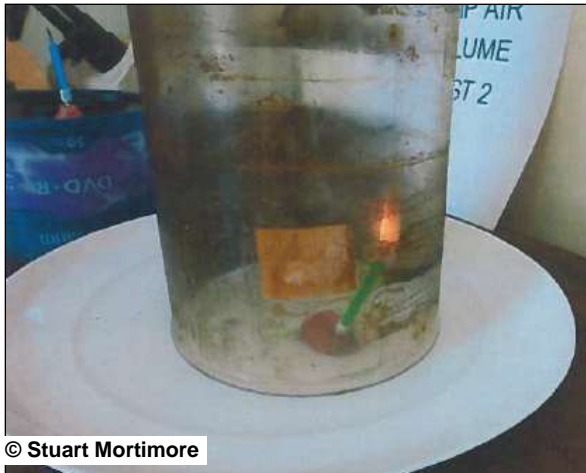
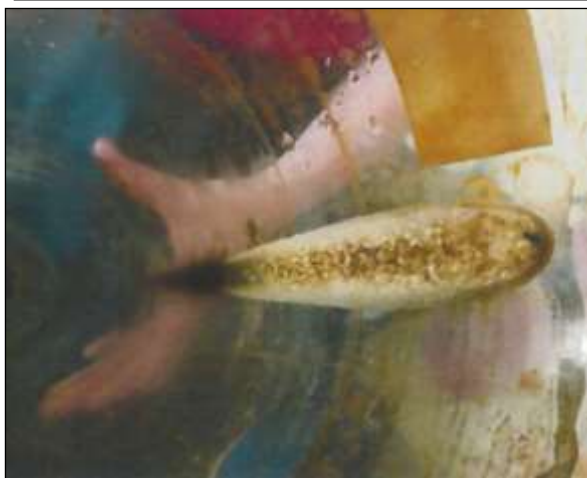
Figure 89: Test to establish the internal flammability of the ceiling lighting⁶¹

Even though it is probably only theoretically conceivable that a flame could form in the body of the lamp due to a defect in the electrical components given the above considerations, the expert still tested the consequences arising from that in a test setup.

The plastic lamp cover holds only an extremely low amount of oxygen because of the airtight seal on the lamp cover. Accordingly, the candle positioned inside the lamp body during the test extinguished after the oxygen was consumed. Even if the candle was leaned against the plastic cover while it was burning, this resulted merely in scorch marks in the area of contact and a reduction in the plastic wall thickness of less than 25%.

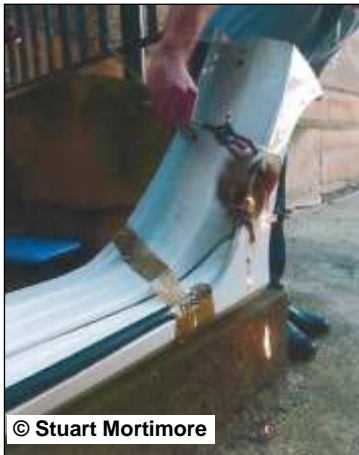
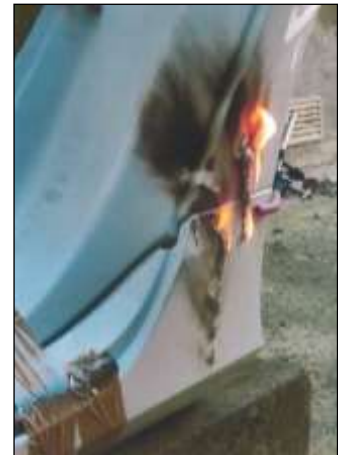
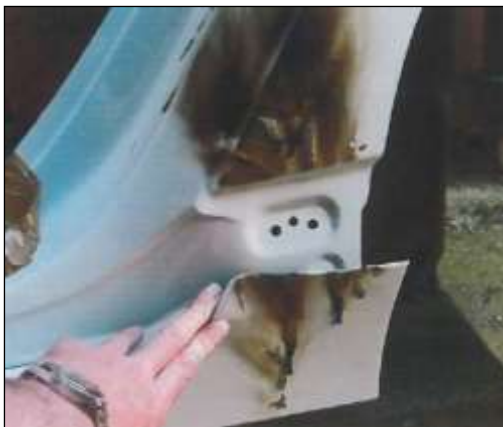
Figure 90: Ignition of the door sill (1)⁶²

*In other tests a small amount of plastic that had been ignited with a blowlamp, which was supposed to simulate a drop falling from the burning ceiling light cover, was applied to the door sill. The burning drop, which slowly ran down the door sill, caused its plastic part to ignite. The fire died some time after the plastic drop had run off of the door sill (see **Figure 90**).*

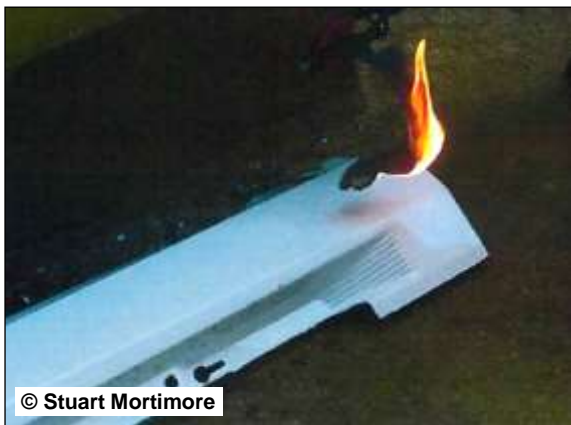
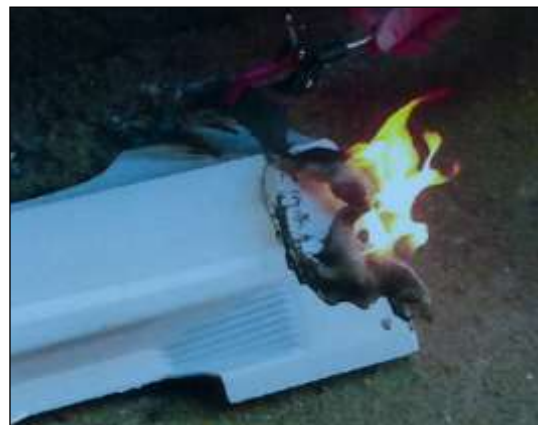
Figure 91: Ignition of the door sill (2)⁶³

Finally, the door sill was laid flat on the floor and the plastic drop applied to it permanently. The plastic under the drop had burnt through after about four minutes and it became apparent that the fire had now taken hold of the door sill so comprehensively that it would no longer extinguish alone (see **Figure 91**).

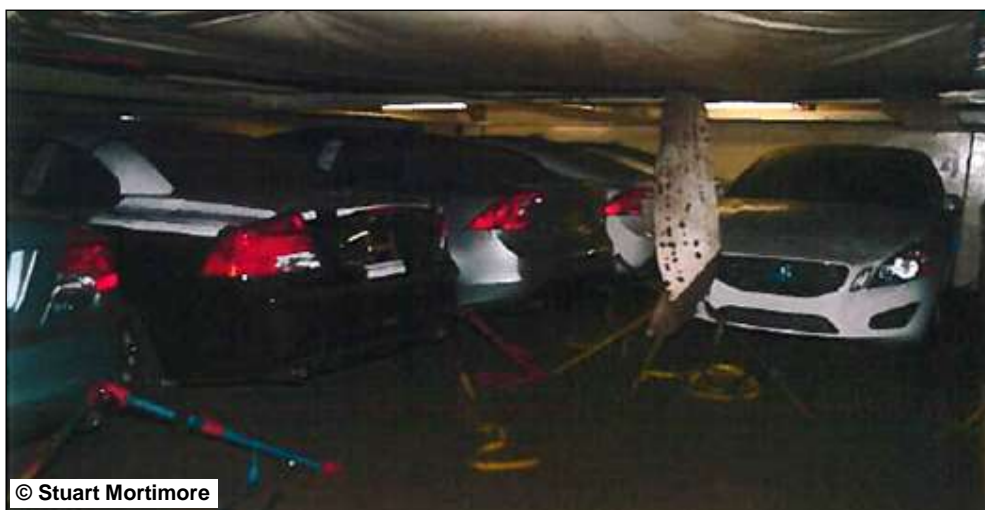
Figure 93: Example of the tarpaulin beneath the ceiling of deck 3 B⁶⁶

The expert examined whether a possible sparkover from a defective cable running above the tarpaulin could have led to the tarpaulin igniting and then to a propagating fire on the vehicles stowed below.

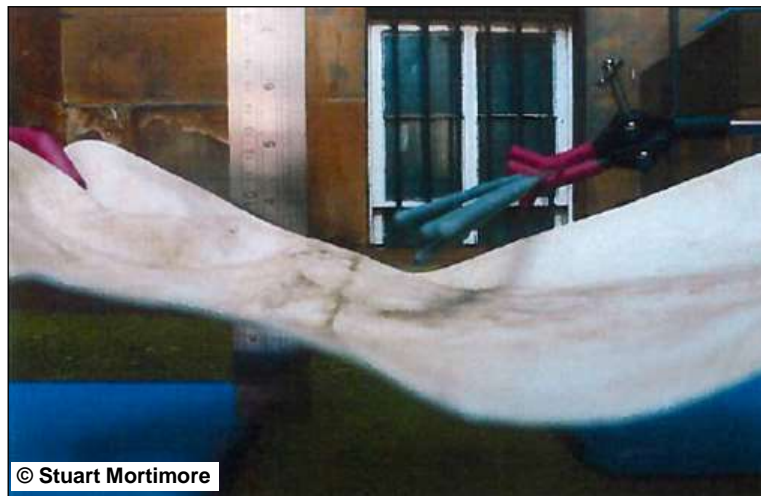
Figure 94: Test setup to establish the flammability of a tarpaulin⁶⁷

In the course of the tests, sparklers were ignited a small distance above the tarpaulin to simulate a sparkover. It was not possible to ignite the tarpaulin in this manner.

The expert stressed that if a cable overheated to temperatures beyond those of a sparkover because of an electrical fault, then this could result in molten metal dripping onto the tarpaulin, theoretically causing it to ignite. Heating to such temperatures due to an electrical fault would require an extremely high flow of electricity through the cables. At the time of the accident, the flow of electricity on board the ship was reportedly very low, however. What is more, its effects would diminish because of the distance between the power generator and the area of the ship affected by the fire.

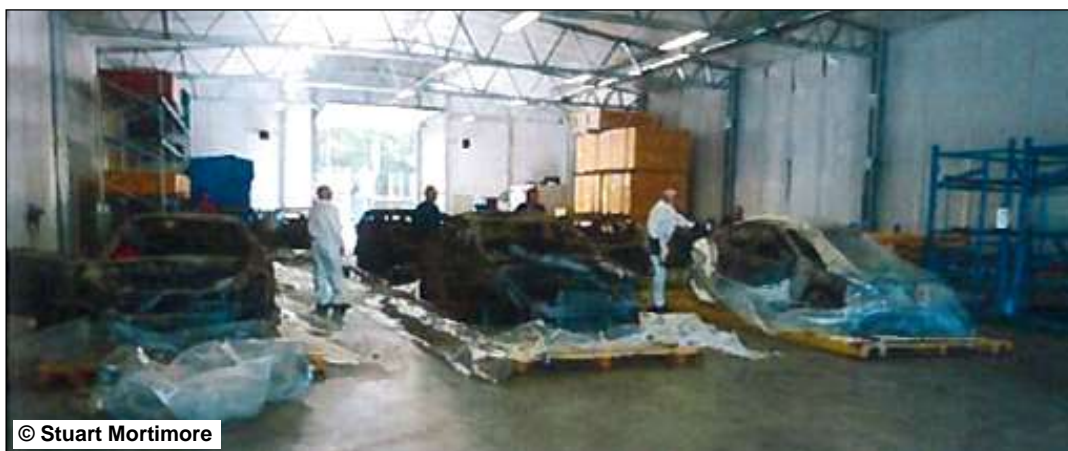
Figure 95: Inspection of the cars at the manufacturer⁶⁸

During the period 26 August to 2 September 2013, the nine cars most severely affected by the fire underwent a detailed inspection at the manufacturer's plant in Sweden with the involvement of various experts.

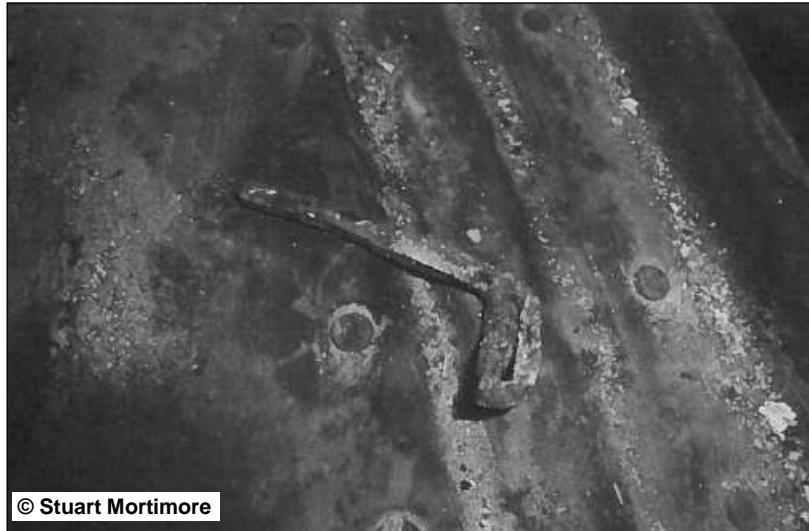
Figure 96: Remains of a vehicle ignition key⁶⁹

With the exception of one car, an ignition key was found in each vehicle (see **Figure 96**).

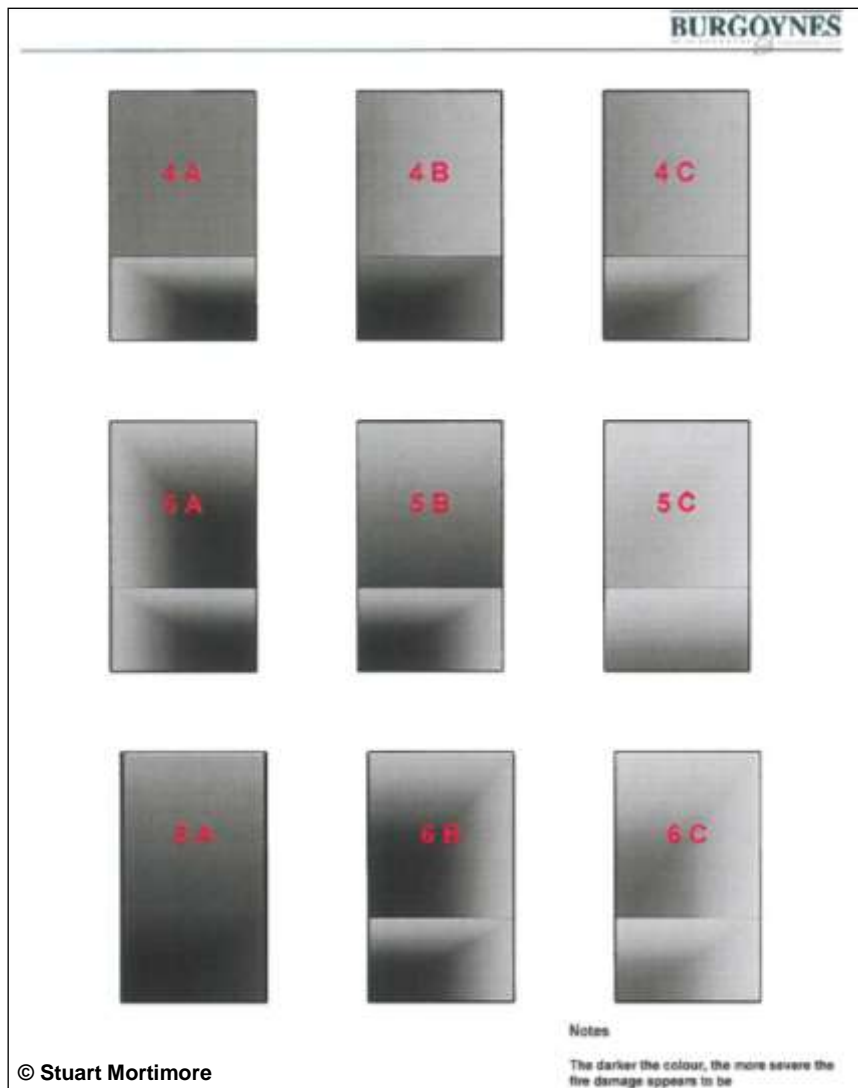
Figure 97: Fire spread patterns relating to the nine cars that had suffered the most destruction⁷⁰

Using the specific fire traces on each vehicle, the experts attempted to determine which vehicle could have burst into flames first. The expert appointed by the owner enclosed the image below with his opinion to illustrate the findings (see **Figure 97**), but to that extent stressed that this only concerns his subjective assessment and a simplified graphic representation. Consequently, definitive conclusions on the actual course of the fire spread between individual vehicles could not be drawn from the image.

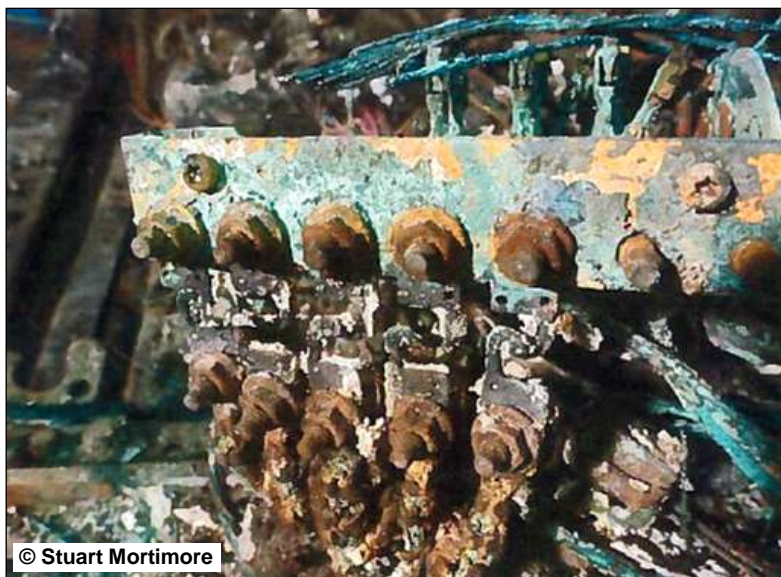
Figure 104: Close-up of the fuse box in the engine compartment of vehicle 5 A⁷⁷

In the course of the detailed inspection of the vehicle fuse boxes, during which partly intact but largely destroyed fuses were found, it was not possible to determine whether the fuse elements, which melt at temperatures upwards of about 200°C, were destroyed by the effects of electricity or as a result of the fire on the vehicle deck.

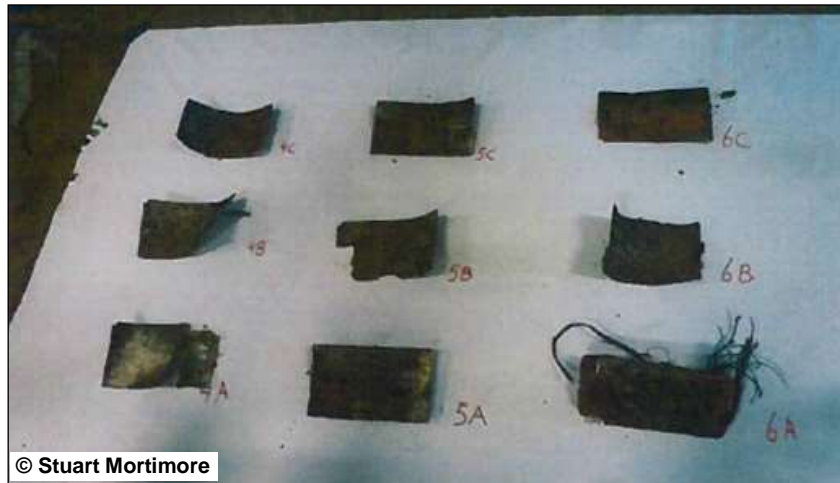
Figure 105: Disassembled main boards from the automotive electronics⁷⁸

The main boards on the central electronic modules from all the vehicles were also disassembled and examined. All the boards were severely damaged (see **Figure 103**). Nevertheless, the expert appointed by the owner believes that the destruction pattern of the boards belonging to vehicles 4 B, 4 C, and 5 C is consistent with the effects of arcing activities between the layers of the boards. (see **Figure 106**).

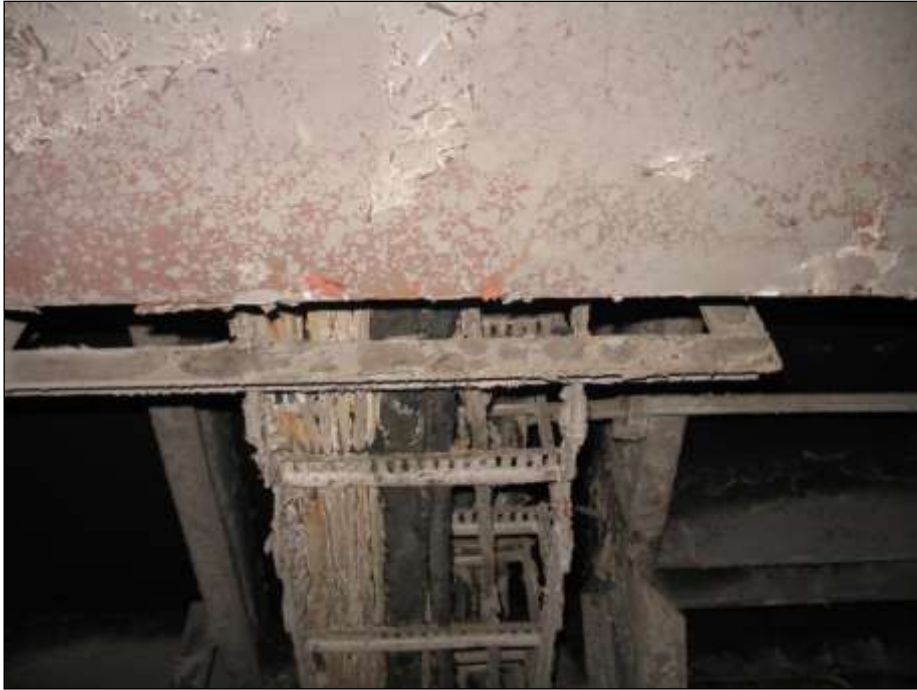
Figure 107: Cable harness above the seat of the fire; uniform fire exposure

All the cable harnesses exhibit typical patterns of an external ignition. There are hardly any open wire strands or droplets visible.

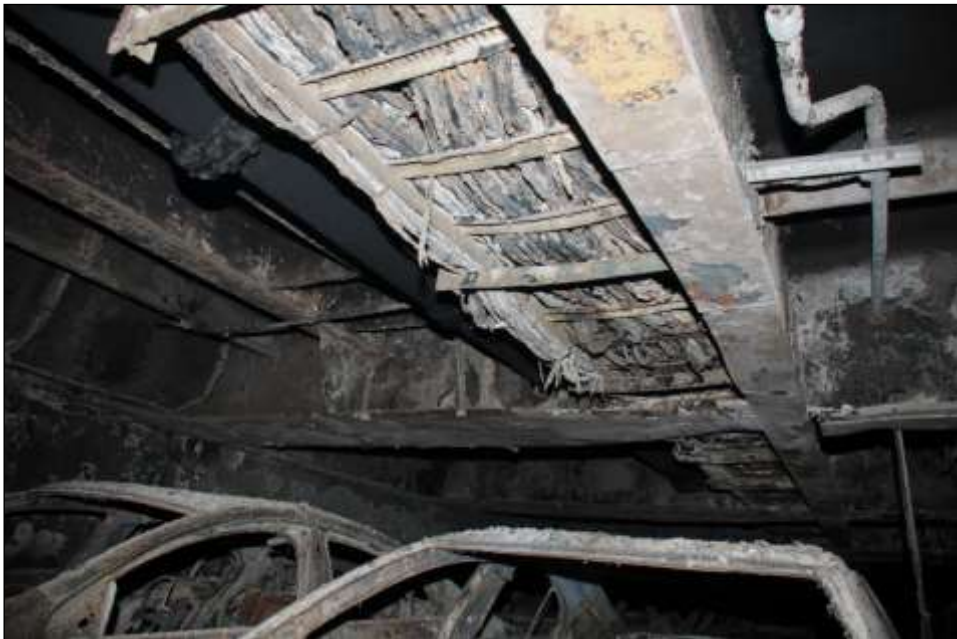
Figure 108: Cable routing above car 4 B

*Similarly, the destruction patterns visible in **Figures 109 ff.** below indicate that the fire developed from a car towards the ceiling and not the other way round from the ceiling towards the car.*
