Investigation Report 99/13

Serious Marine Casualty

**Fire on the con-ro carrier
ATLANTIC CARTIER on 1 May 2013 in the Port
of Hamburg**

9 October 2015

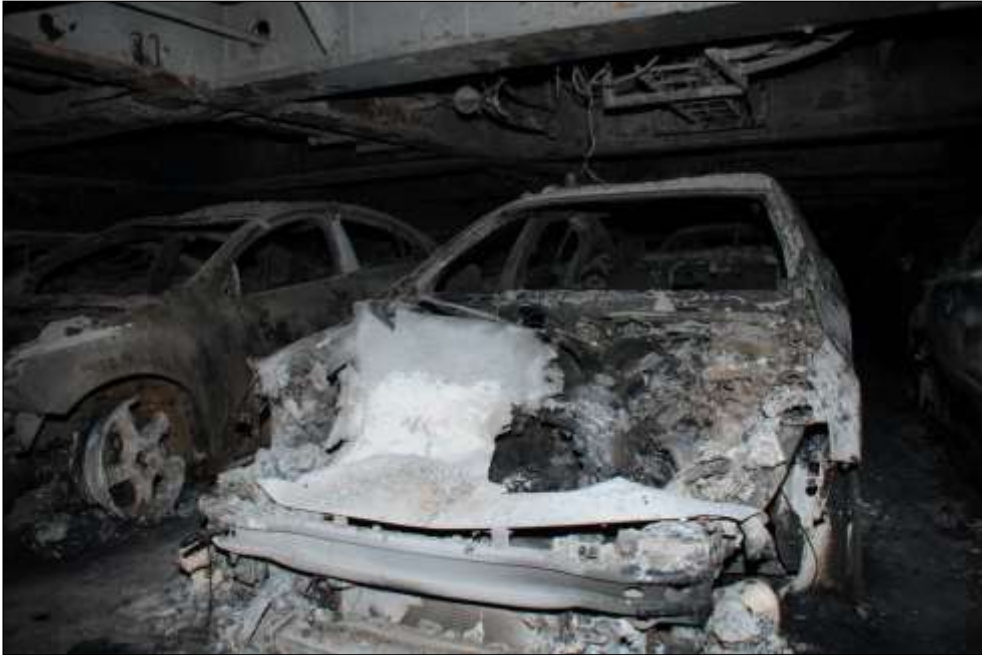
Figure 109: Car 4 C below the cable rack with fire pattern from the engine compartment

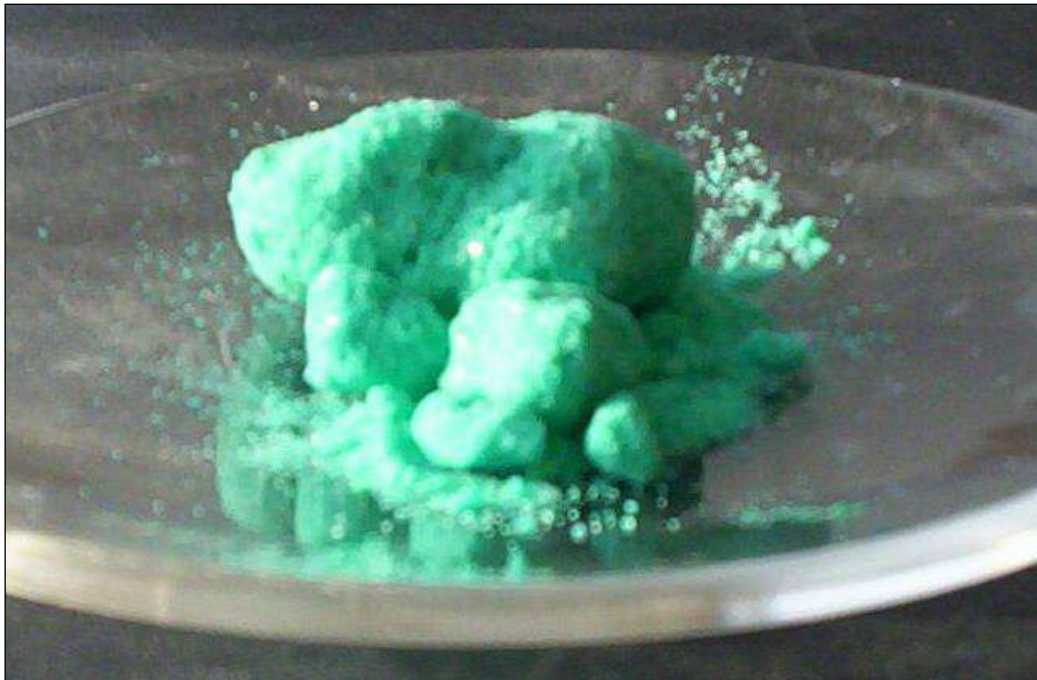
*Burning PVC (primary constituent of the cable insulation) produces gaseous hydrogen chloride, which in combination with water or humidity forms hydrochloric acid. Inter alia, copper chloride forms on the copper cores exposed by fire, which turns into basic copper(II) chloride during subsequent oxidation. The compound is highly hygroscopic. The bound crystallisation water produces green salt crystals. The salt (NaCl) and copper compound shown in **Figure 112** below is merely the product of simple electrolysis in the laboratory.*

Figure 112: Copper(II) chloride dihydrate $\text{CuCl}_2 \cdot 2 \text{H}_2\text{O}$

The crystallisation water dissolves at temperatures upwards of 100°C and Cu Cl_2 forms again. Such traces are usual for cable routing after exposure to fire and consequential destruction of the insulation.
