REPORT C 1993:57

**Air Traffic Accident
on 27 December 1991
at Gottröra, AB county**

Case L-124/91

The Board of Accident Investigation (SHK) has investigated an aircraft accident which occurred on 27 December 1991 at Gottröra, AB county, involving an aircraft with registration OY-KHO.

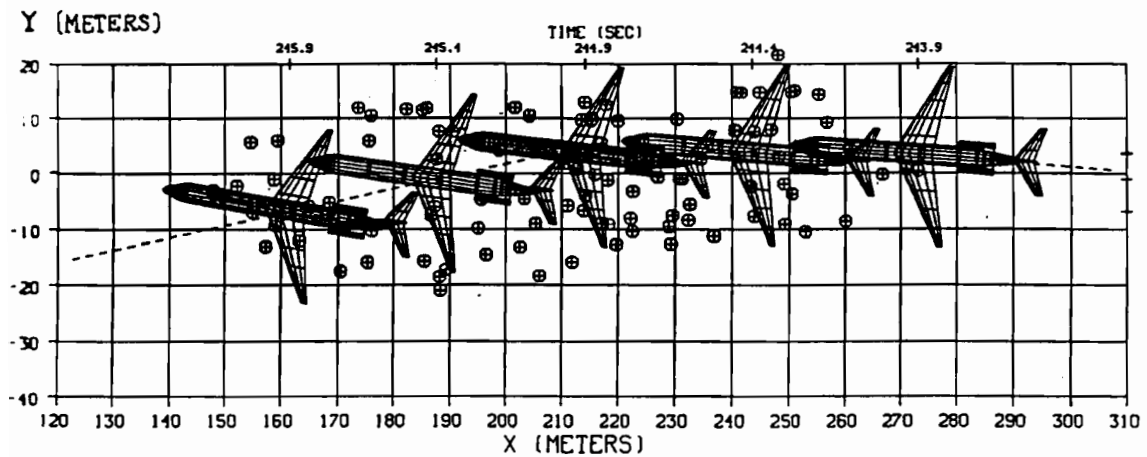
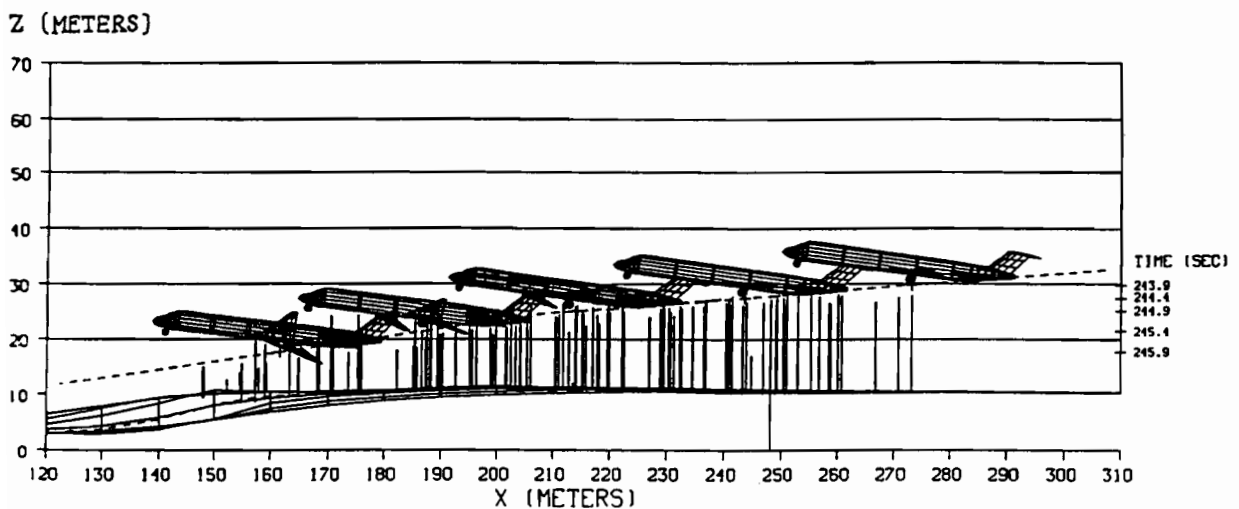
The final phase of the flight

Four minutes and seven seconds after rotation the aircraft hit sloping ground, first with the tail. On impact, a right bank of 40.1° was recorded. After impact the aircraft slid along the ground about 110 m before stopping. The fuselage was broken into three on impact and during the subsequent braking along the ground. There was no fire. All 129 on board survived. Except for four persons, all made their way out of the aircraft themselves.

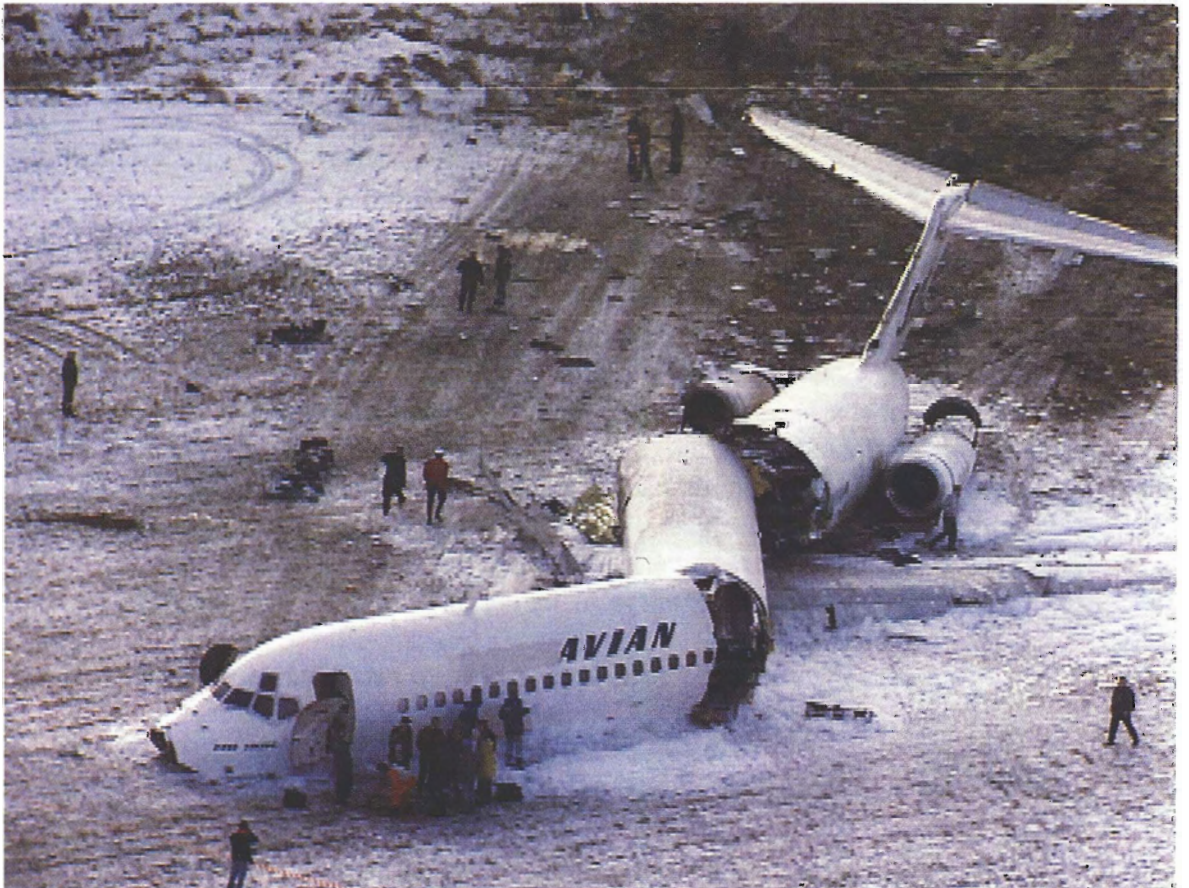
The aircraft wreckage

The underside structures were much damaged in the forward part of the wreck. The indentations were largest in the left of the front part – approx 80 cm – and smallest in the right rear part – approx 18 cm. Damage to the underside structure in the middle and rear parts was limited. The cabin floor had limited damage. Apart from damage in the areas of the breaks, the floor structure was ruptured only at row 5 on the right side.

The major part of the right wing had separated from the fuselage. Wing parts lay spread out along the path of the crash. The underside of the left wing was severely damaged.

In the forward portion of the passenger cabin the overhead bins and their mountings had been damaged. The two modules on the left had parted completely from their mountings and fallen down onto the backs of passenger seats. On the right side the modules had parted from their ceiling mountings but not from the wall mountings. The modules from row 3 and rearwards were resting on seat backs. A number of bin lid locks had broken and the lids had come open. The cabin divider – which was between rows 3 and 4 – had fallen down together with the bins. In the middle portion of the wreck the damage was limited to the break areas. At the forward break the forward part of the left bin had fallen. At the rear break the bins on both sides had fallen. A number of bin lid locks had broken. According to available information, the bins were not excessively loaded with baggage.

In all three parts of the wreck most of the PSUs had loosened from the bin structures and were hanging either by their outer hinges or by wiring. Many of the oxygen masks had been released from the PSUs and some had also been activated. Some of the cabin crew oxygen masks had also been released.

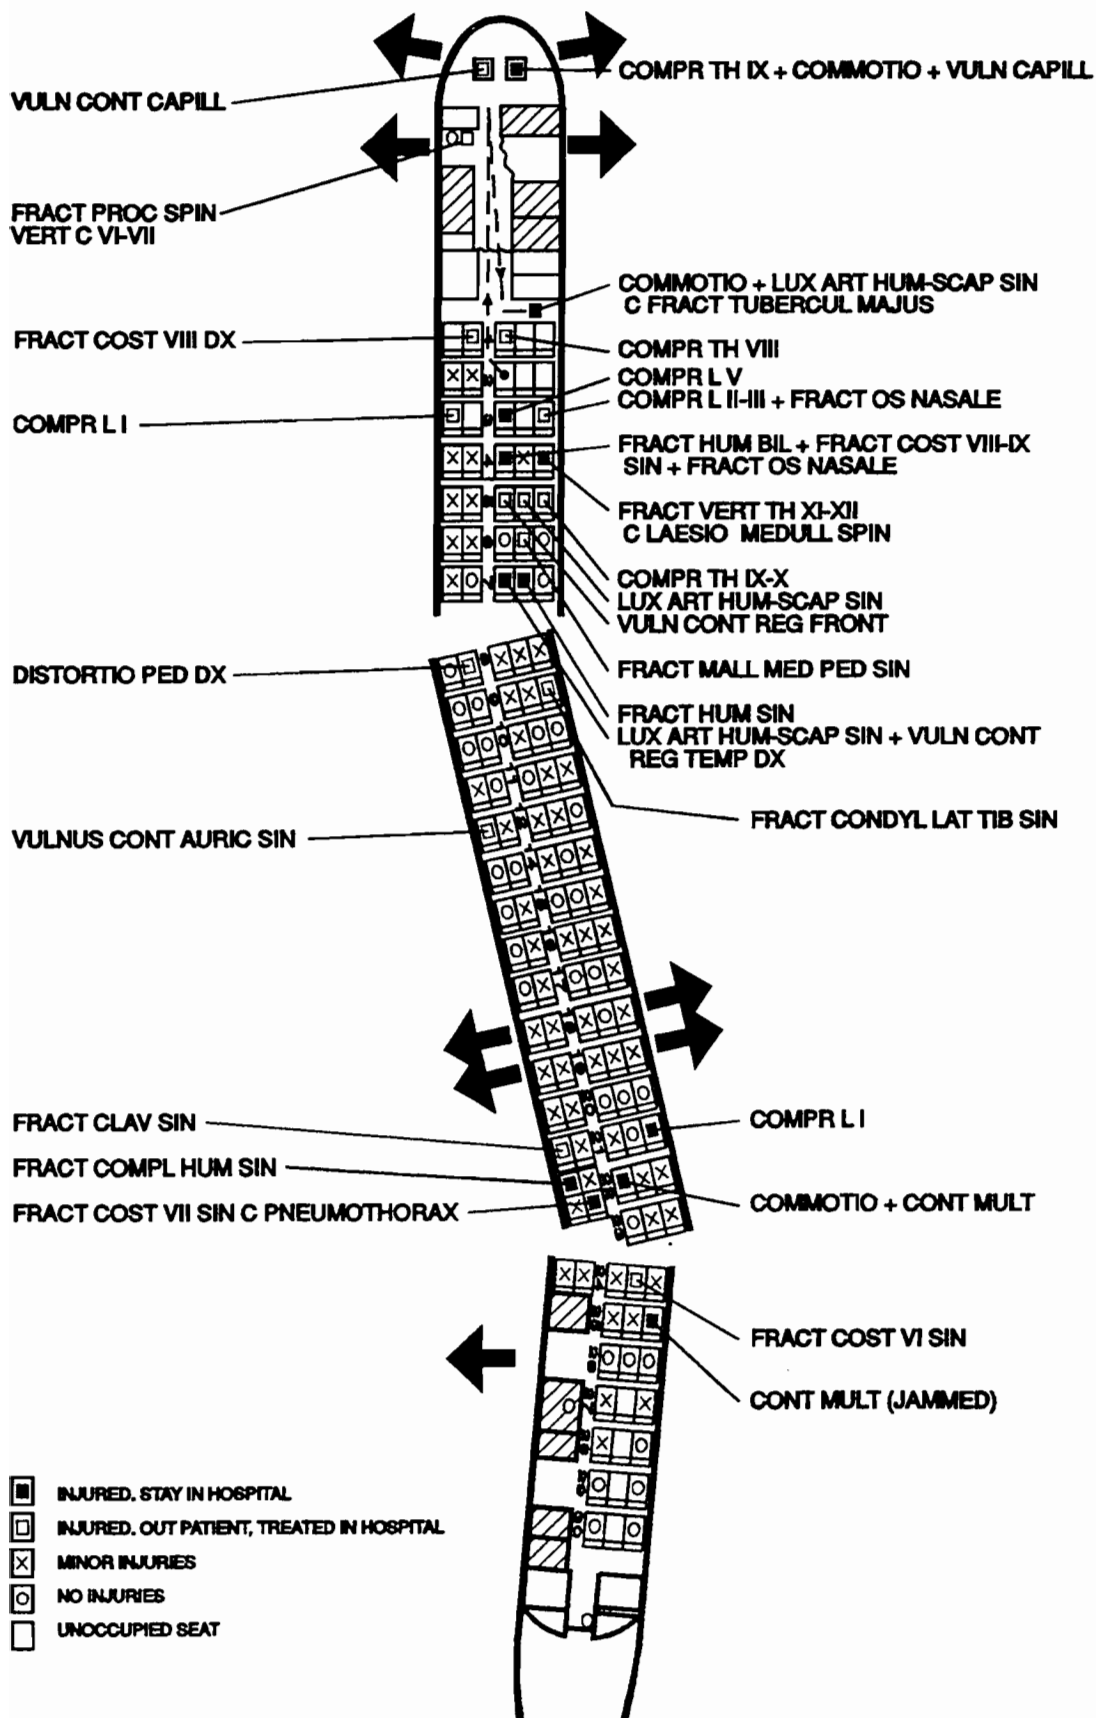
Injury profile

Most of those injured, and those with the most serious injuries, were sitting in the forward part of the aircraft, with a concentration to the right side. Here there were eight of totally nine cases of back injury and five of totally seven shoulder and arm injuries. Another concentration of injuries was among those sitting near the rear fuselage break. Those sitting in the middle and rear parts of the aircraft sustained slighter injuries or were uninjured.

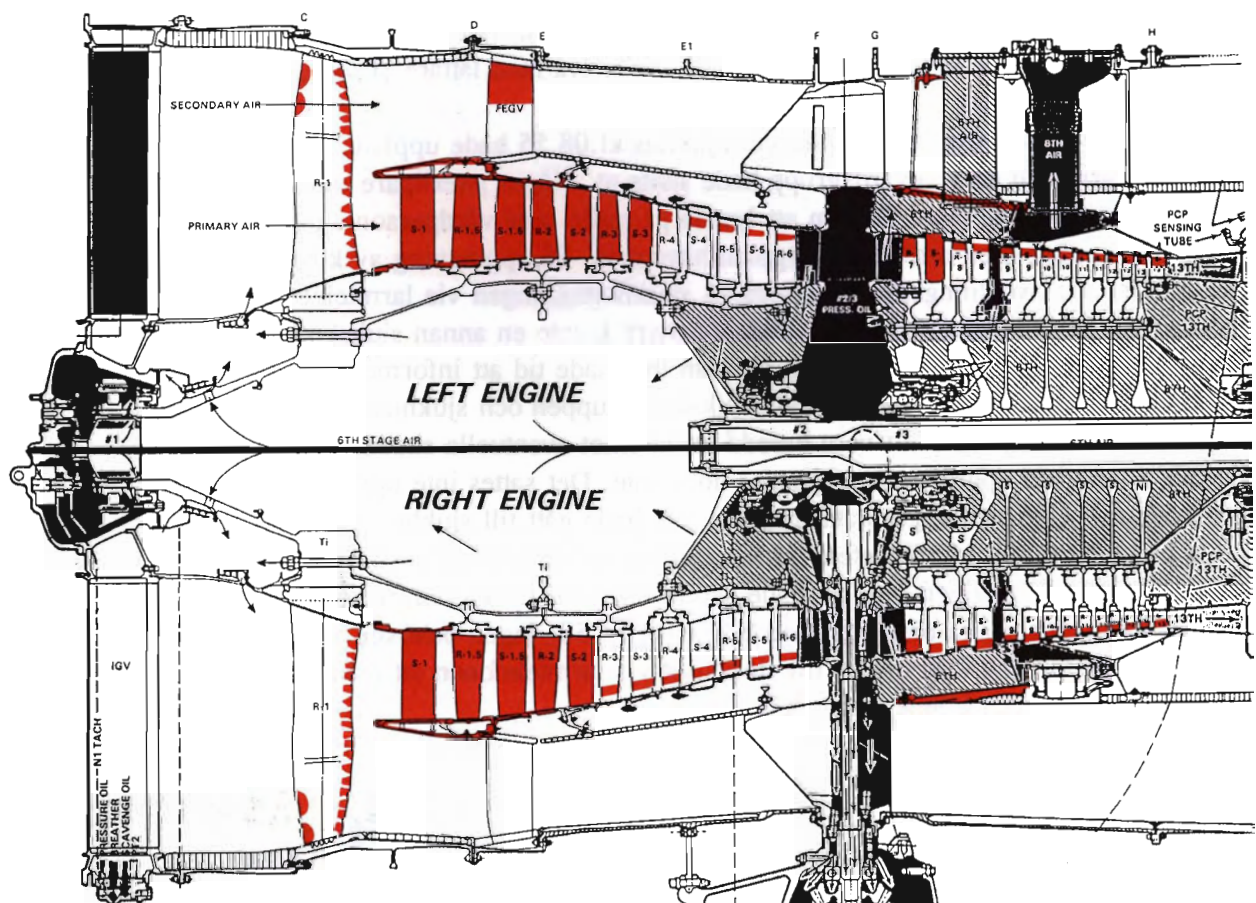
Fan- and compressor-damages

Of the fan's 34 blades eight, relatively evenly distributed, had up to 15 mm-deep and 50 mm-long soft indentations in the concave sides of the leading edges. The damage was in an area from the blade tips and 175 mm in towards the centre. Its appearance is typical for impact damage from "soft objects" (birds, ice and similar).

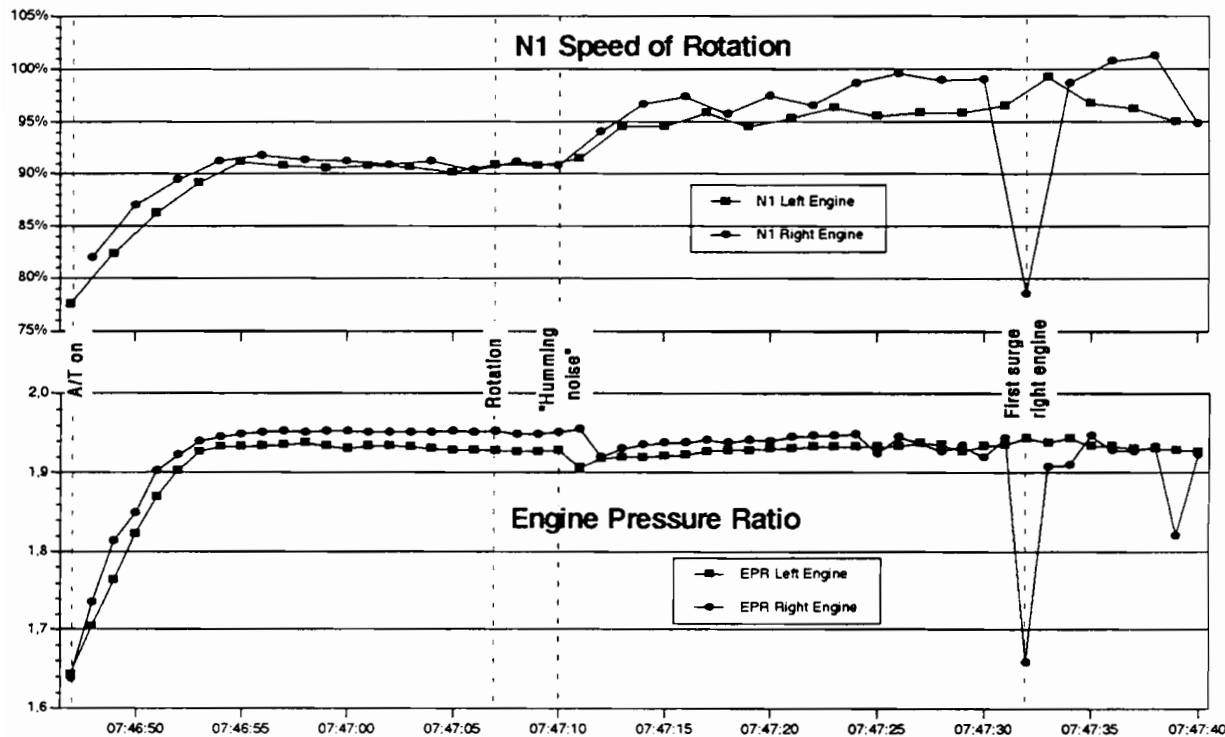
Shift in N_1 and EPR at liftoff

At liftoff an increase in engine N_1 rotation speed by 4% in the left engine and 6% in the right engine was recorded in the QAR. At the same time EPR sank by 0.03 and 0.02 units respectively. These recordings have been compared with corresponding values from earlier takeoffs with OY-KHO and with other MD-81's. The comparison shows that the values at the relevant takeoff were not normal.

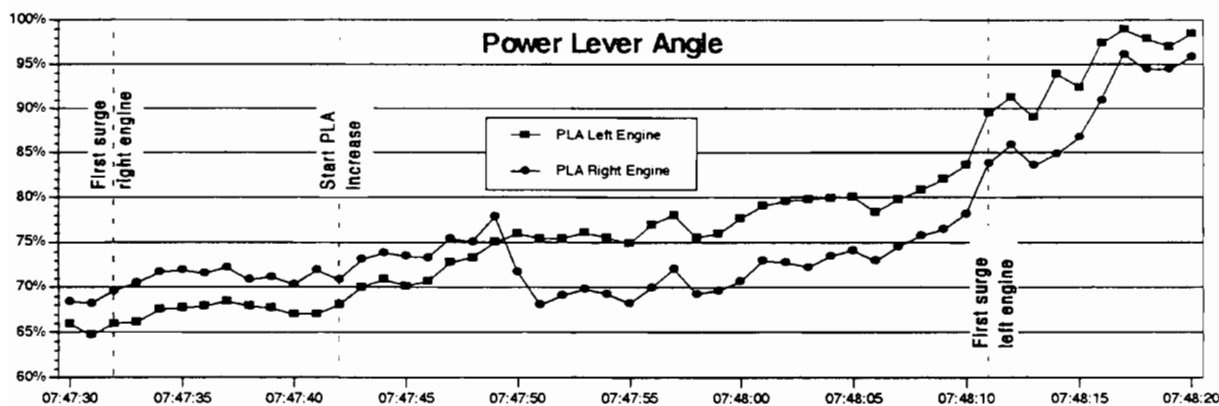
Automatic PLA increase

As the ATS went over to G/A it started to increase the throttle to enable engine thrust to attain the new higher EPR that applied for G/A. Since this EPR rose with increasing flight altitude, the throttle increase for both engines increased successively during the climb.

As will be shown under 2.3.2 the damage to the engines' fan stages caused aerodynamic disturbance which led to the engines' EPR decreasing somewhat in relation to the other performance parameters. This meant that more throttle than normal was required for the engines to attain G/A EPR.
