AIRCRAFT ACCIDENT REPORT

N98610 (USA-REG)

CESSNA 340A

HISINGEN, GOTHENBURG

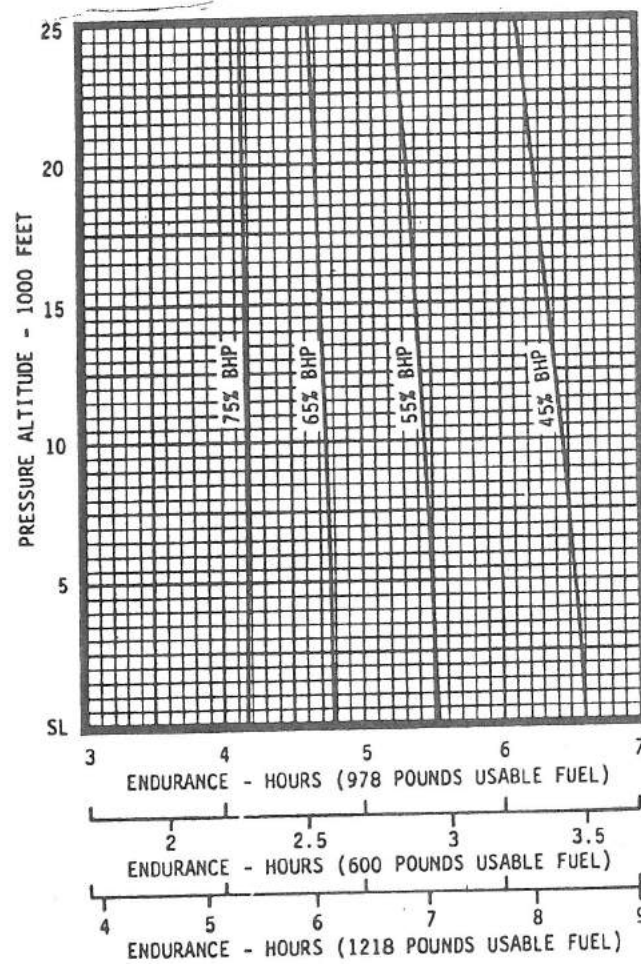
Fig 5. Endurance at maximum take-off weight.

The maximum endurance taking into consideration fuel for take-off, climb, descent and 45 minutes holding is shown in Fig 5.

According to Fig 5, an increase of power from 65 % to 75 % decreases the maximum endurance of the aircraft approximately 12 %, i.e.the fuel consumption increases 12 %. Fig 6 shows that the consumption at 65-75 % power may increase more than 25 % if the mixture is changed from the leanest to the richest. According to Fig 5, the mean fuel consumption is approximately 120 litres/hour with the leanest mixture. This includes fuel for take-off, climb, flight at constant altitude and approach for landing. At 75 % the diagram shows approximately 134 litres/hour. The calculation is valid for heights between FL 100 and 200.

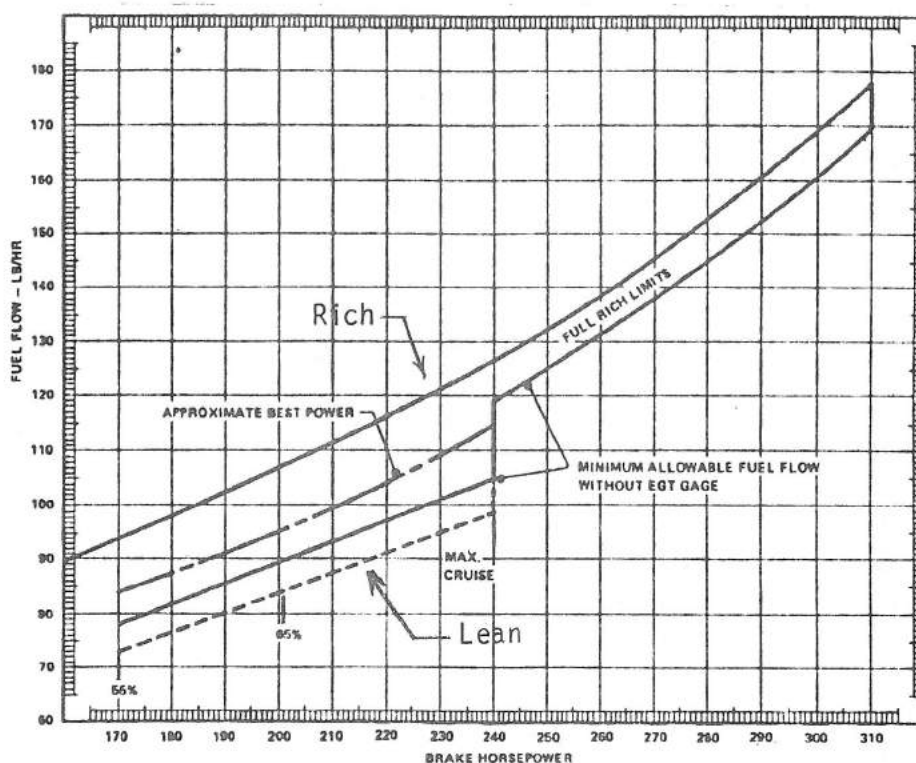
Fig 6. Fuel consumption as a function of engine power at ground level for TS10-520-N. Observe the effect of fuel/air mixture on consumption.

Fig 6 shows the fuel consumption in pounds/hour as a function of engine power at ground level for a Continental TSI0-520-N-engine. The figure illustrates how the fuel consumption at different power settings is affected by the fuel/air mixture (rich = rich mixture and lean = lean mixture).

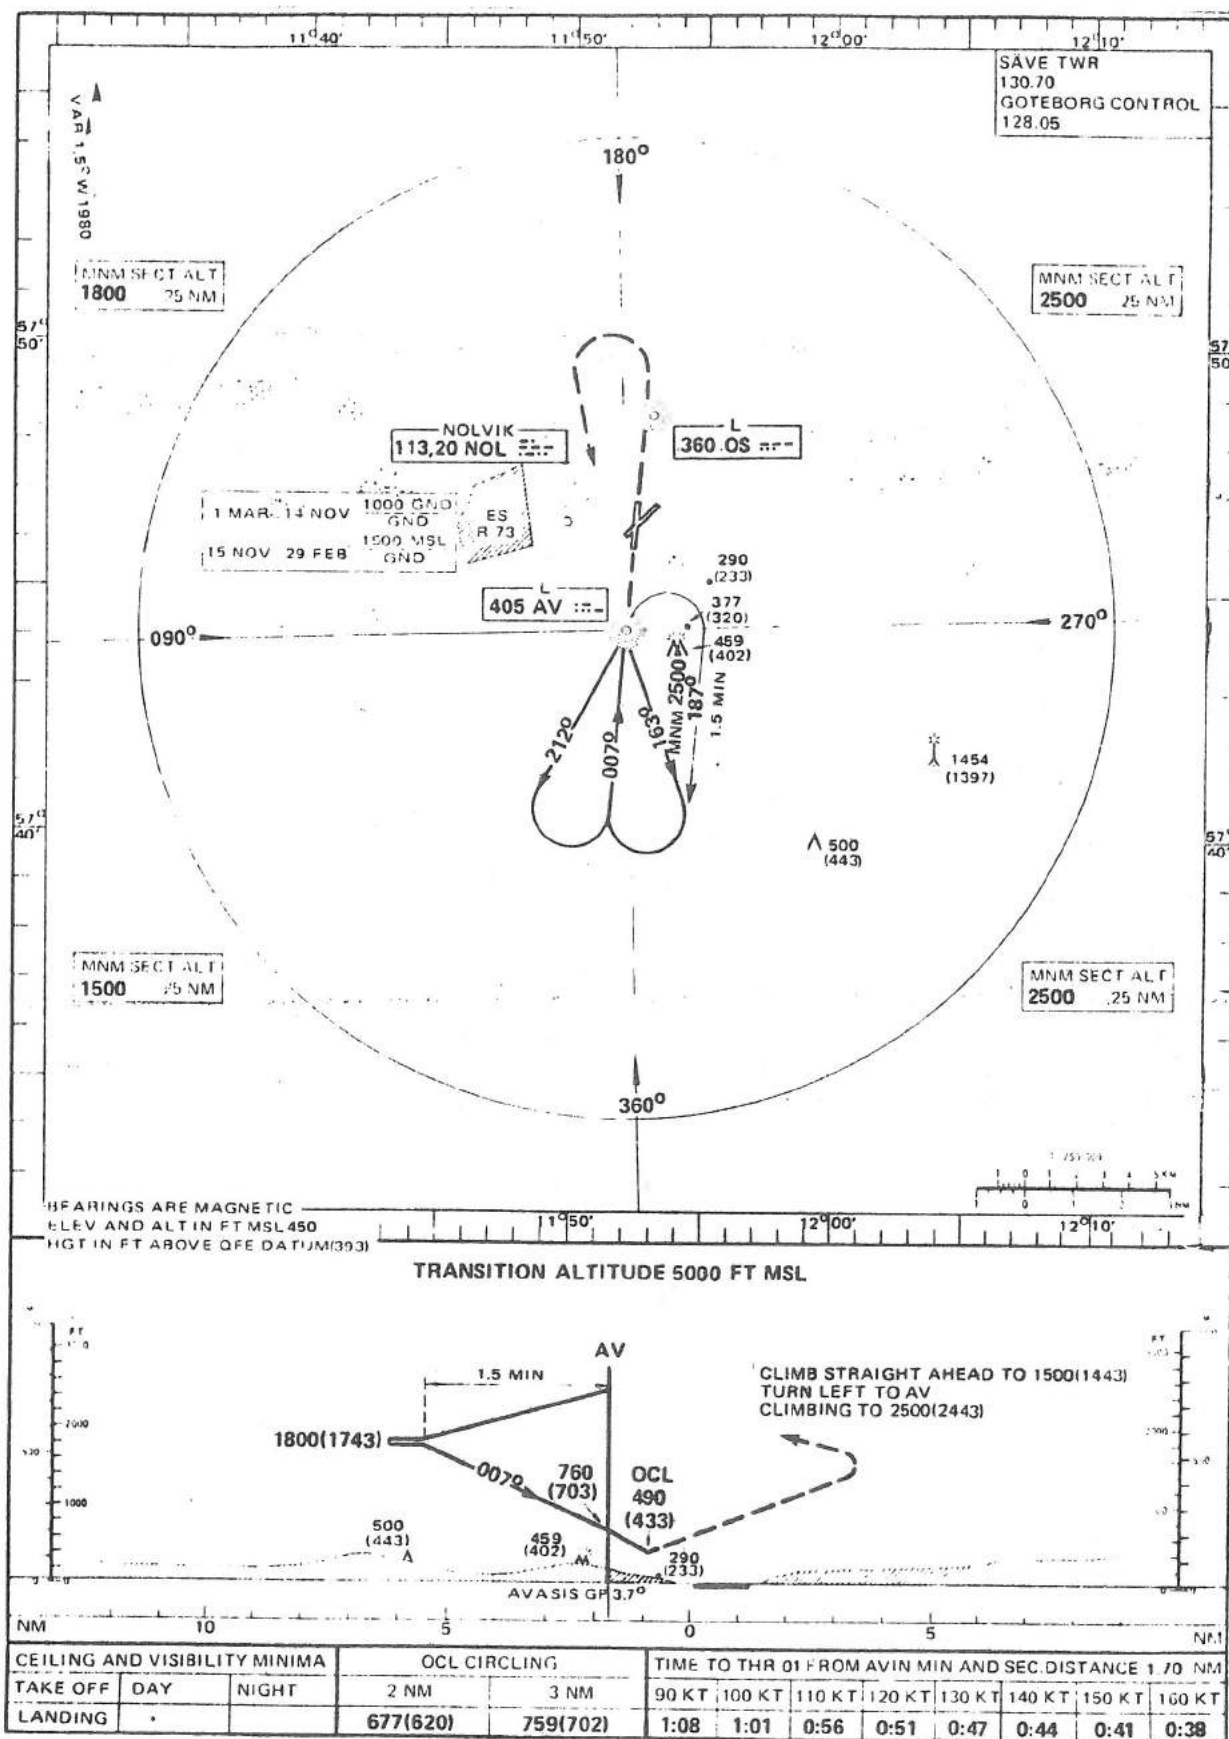
Fig 7. The approach to Säve.

Gothenburg/Säve Airport is a former military airbase, which is used for general aviation traffic. Runway 01/19 is asphalt covered, 1 565 m long and 45 m wide. The approach equipment to runway 01 are an AVASIS with 3,7⁰ glide-slope and an NDB-beacon (405 AV) located approximately 1,7 NM from the runway end. The airport is situated in forest, covered with low hills terrain. In the area there are a number of illuminated roads and road crossings. According to the flight controllers at Säve the high intensity runway lights are flashed when required even in clear weather in order to help the crew of approaching aircraft to distinguish the runway from the illuminated roads. Runway 01 has no approach lights. The airport coordinates are lat 57⁰ 46' N, long 11⁰ 52' E. The altitude above sea level is approximately 20 m (66 ft). VOR-beacon Nolvik is located approximately 2,6 km west of runway 01, see Fig 7.
