Final report *SHK 2023:03e*

Accident at Örebro Airport, Örebro County, on 8 July 2021 involving the aeroplane SE-KKD of the model DHC-2 Mk III, privately operated in connection with parachute operations

File no. L-47/21

2023-01-30

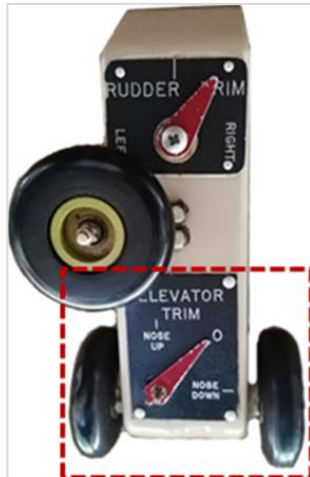
Figure 7. The trim panel in the ceiling between the pilot's seats. The elevator trim is highlighted with a dashed red box. The pointer indicates 0.

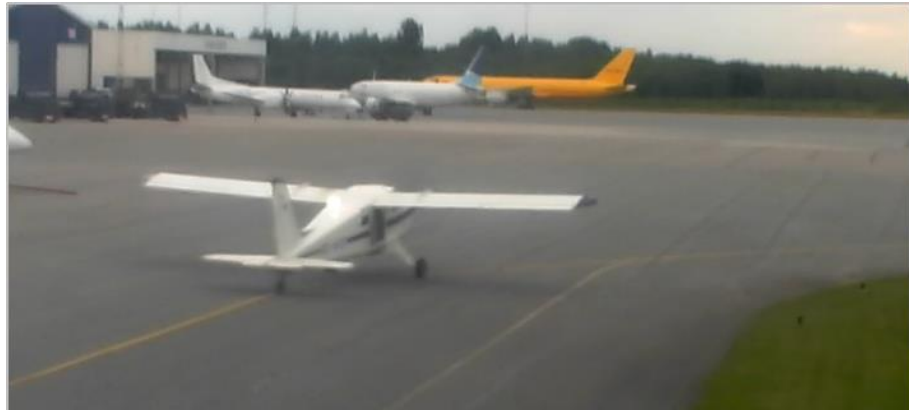
There were two cameras at the airport that recorded the aircraft during taxi out before take-off. One camera was located at the refuelling facility and pointed south and the other camera was located at the terminal and pointed west. The pictures show that the wing flaps were retracted and the elevator trim was in an abnormal position for take-off.

Figure 21. Image from surveillance footage from a camera located at the refuelling facility. Image: Örebro Airport.

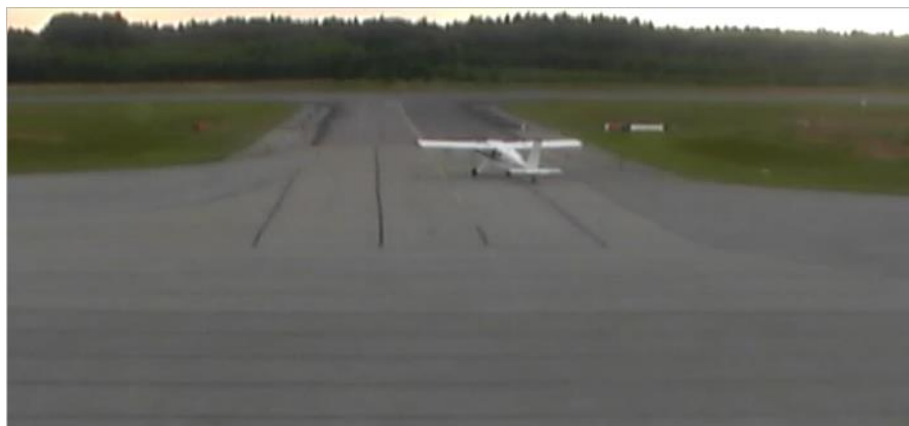
Figure 22. Image from surveillance footage from a camera located at the airport's terminal. Image: Örebro Airport.

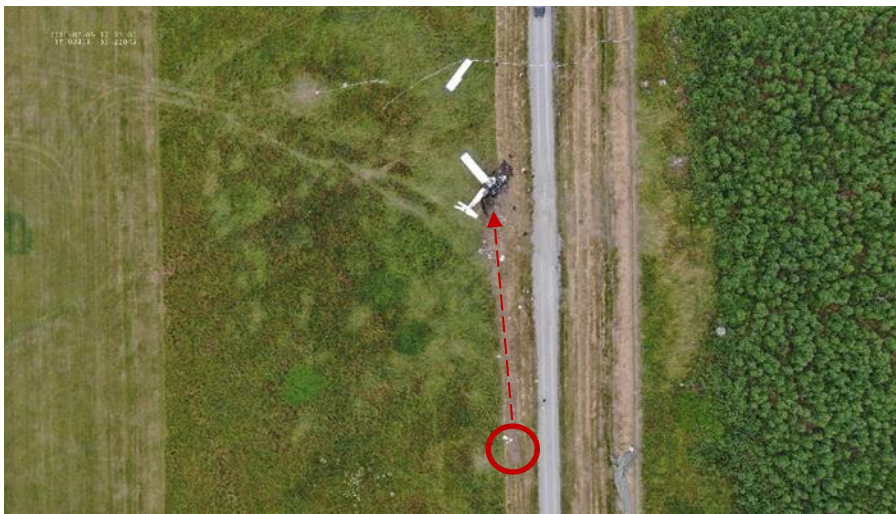
The final position of the aircraft was next to a road within the fenced area to the east of the runway, 142 metres from the centre line and 1,540 metres from the end of runway 19.

Figure 23. The impact site marked with a red circle and the aircraft's final position.

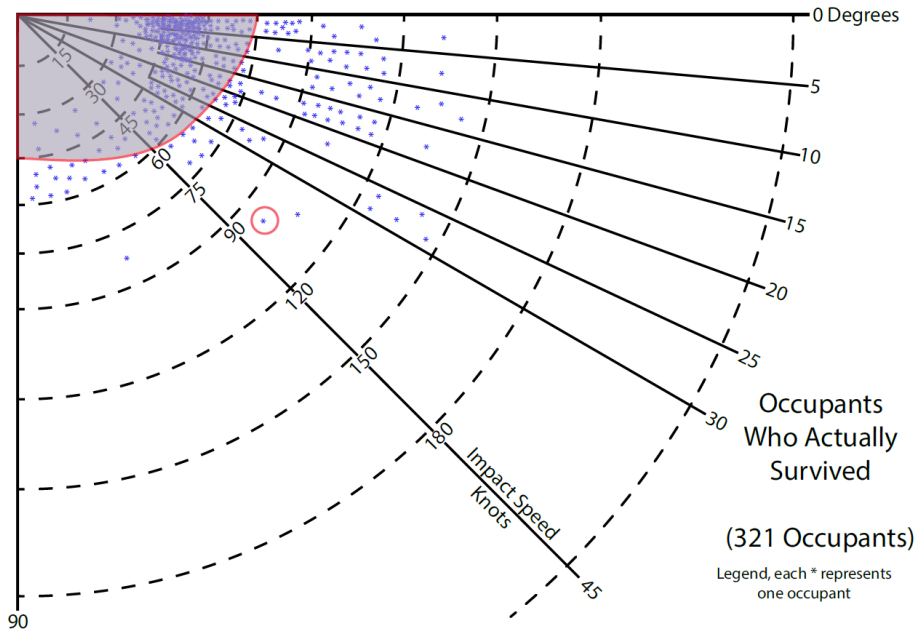
According to the graph, the possibilities of survival in the current accident were very small.

Figure 29. Graph based on data from NTSB. The survivable area is marked in grey within the red line. Each reviewed accident is marked with a blue star. The red ring shows the calculated angle and speed at the actual accident.

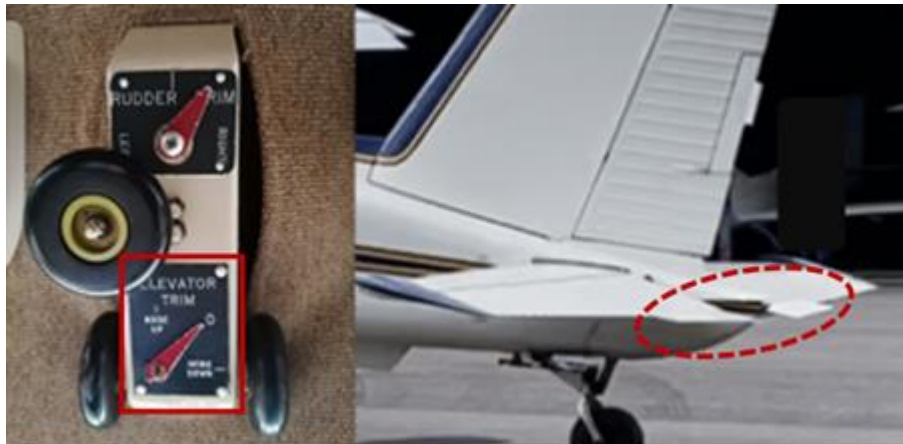
The left image in Figure 31 present an elevator trim setting which, according to other pilots, is normal for take-off with a pilot and parachutists on board. The right image shows the elevator trim tab position before take-off at one of the earlier flights during that day. The trim position on the panel in the figure corresponds with the trim tab position in the figure.

Figure 31 Trim panel setting and elevator trim tab position before take-off with a pilot and parachutists on board. Right picture: Örebro Skydivers Club.

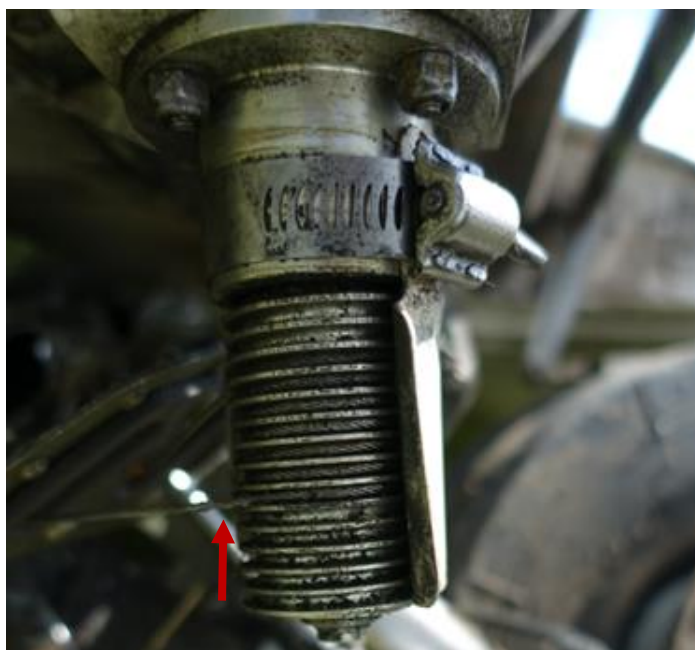
With the help of the type certificate holder, SHK has analysed the aircraft's trim rudder position after the accident. The analysis has been carried out based on the position of the trim rudder cable on the cable drum which indicates the position of the elevator trim tabs. Based on the assumption that the rigging was carried out according to specification of the control system and elevator trim system, the position of the elevator trim tab was calculated to have been 16.5 degrees nose up, with an accuracy of ± 0.5 degrees.

Figure 32. Elevator trim cable position and connection on the cable drum.

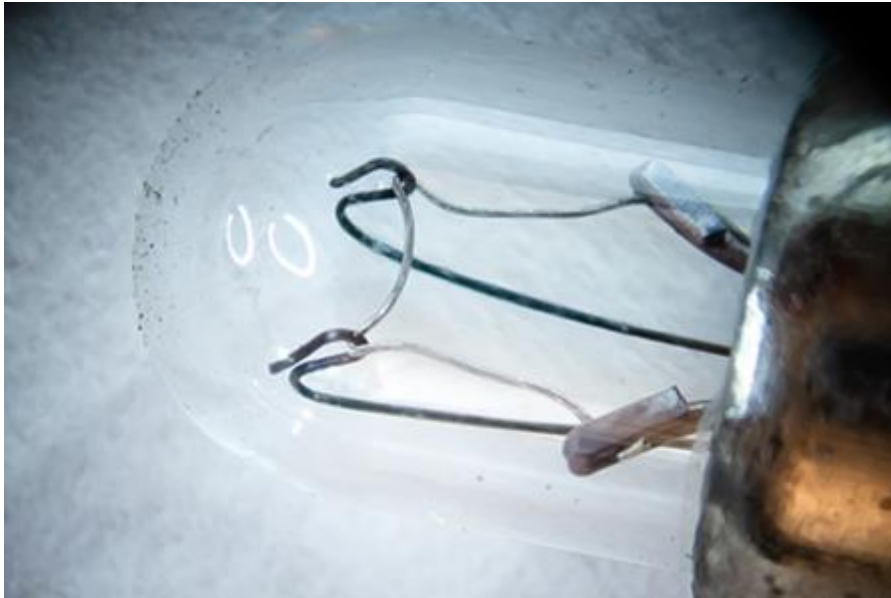
Figure 43 present a reference bulb with an intact filament without deformation. This indicates that the particular light had been switched off at impact.

Figure 43. Intact filament without deformation.

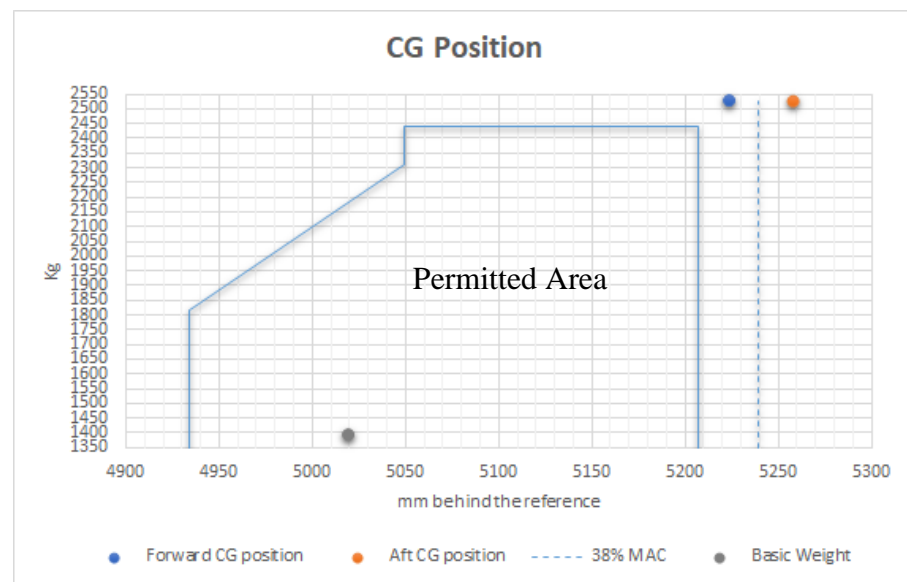
In all calculations, the position of the centre of gravity was outside the permitted mass and balance area. According to the calculations, the position of the centre of gravity was somewhere between the front (blue) and the rear (orange) dot, i.e. the aircraft was more tail-heavy than allowed, (see Figure 44).

Figure 44. Mass and balance envelope. The vertical axis shows the mass of the aircraft and the horizontal axis shows the centre of gravity position of the aircraft. The 38 % MAC line present the center of gravity position where the aircraft tended to roll without a nose-lowering tendency during the certification.

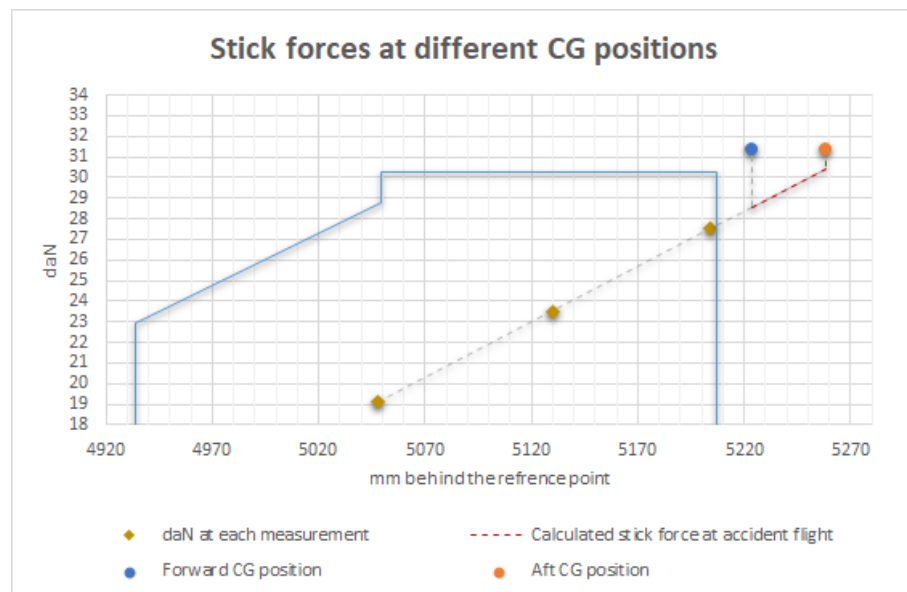
In the graph below, calculations of stick forces are presented based on the results of the reference flight with elevator trim position 16.5 degrees nose up and flap position for take-off (35 degrees). Based on the reference flight, the stick force has been calculated to be between 28.6 and 30.4 daN, (see Figure 45).

Figure 45. The graph present stick forces (daN) in relation to the centre of gravity position. Yellow markings present the measurement points during the reference flight. The centre of gravity position has according to calculation been somewhere between the front (blue) and the rear (orange) dot. The red dashed line shows stick forces within the calculated balance area at the time of the accident.

An aircraft must be controllable in all flight phases according to the current European design regulations for CS-23¹⁸. As a reference to the calculated control forces, it can be mentioned that the control forces for controlling the aircraft in pitch should not temporarily exceed 22.2 daN with one hand on the steering wheel and 33.4 daN with two hands on the steering wheel.

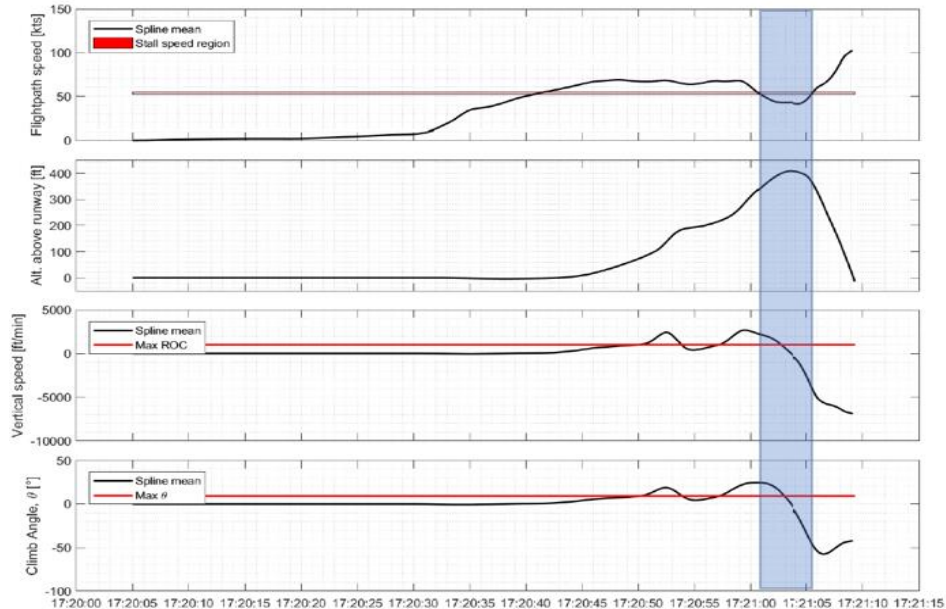
Figure 46. The graph presents calculated speed through the air, altitude (above the airport reference point), vertical speed and angle of climb/descend. The blue marked area points out the time during which the speed has been below the stall speed according to the flight manual.

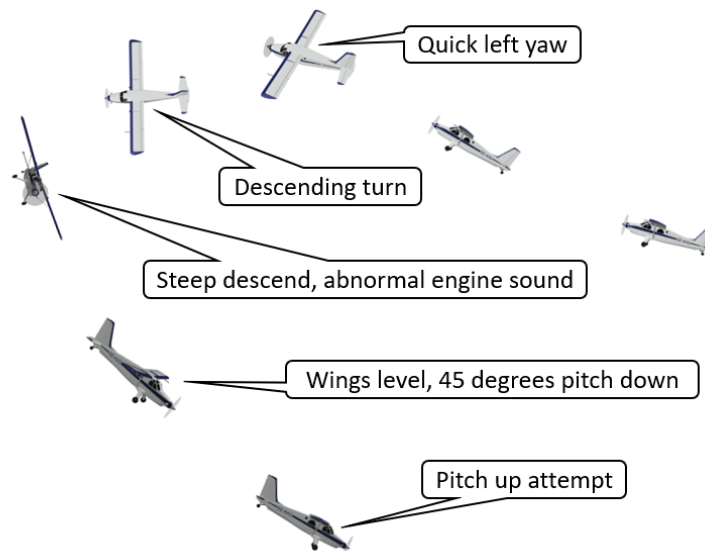
At 400 feet above the ground, the aircraft yawed sharply to the left (see Figure 53).

Figure 53. Compilation of the flight path based on statements from several witnesses.

It has not been possible to determine what caused the yaw. It may have been a deliberate action by the pilot but it may also have been due to the pilot losing control over the aircraft.

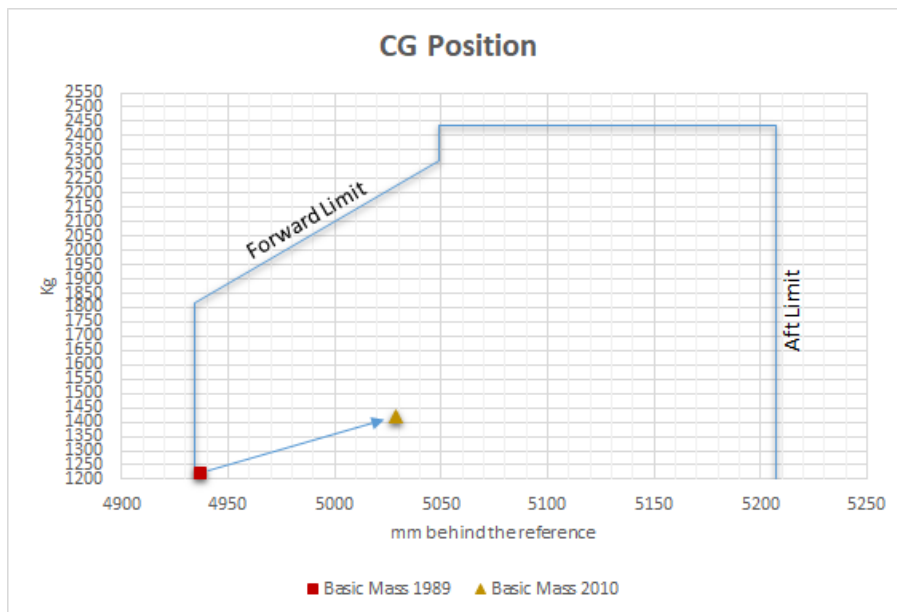
In order to obtain the basic empty weight and centre of gravity position of the aircraft, weighing has been carried out and documented in weighing protocols. When comparing the different weighing's, it can be stated that the mass of the aircraft has increased and that the centre of gravity has ended up further back. There are several reasons for the change, but what has affected the centre of gravity the most is the installation of a ballast in the rear of the aircraft (see Figure 54).

Figure 54. The change of the centre of gravity after installation of ballast. Direction of change illustrated by arrow.

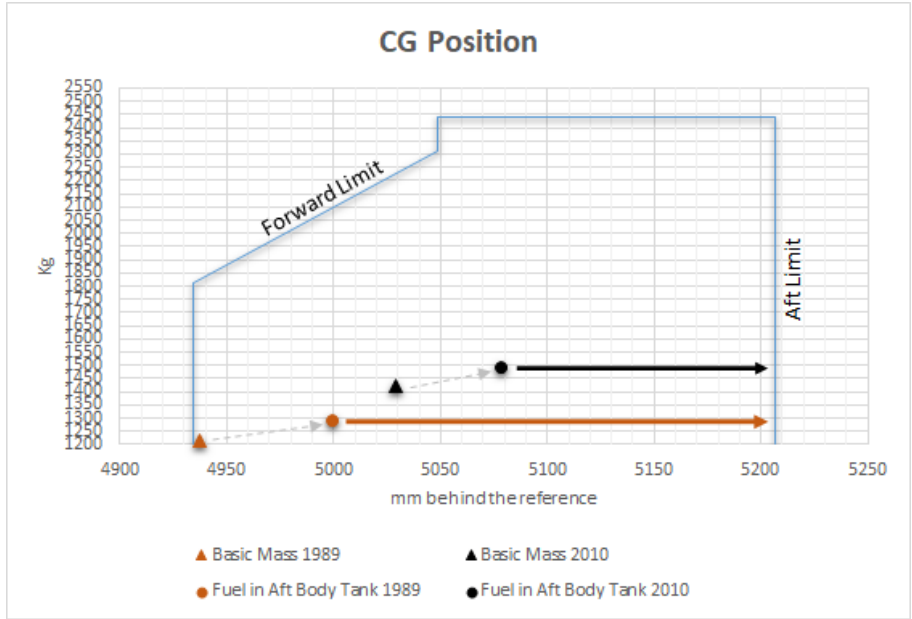
With the installation of the ballast, the basic conditions for the calculation of centre of gravity changed and the margin to the aft centre of gravity limit was reduced. In the image below, the margin to the aft limit is illustrated in each year with an orange and black arrow. (see Figure 55).

Figure 55. The change of the centre of gravity after installation of ballast and with fuel in the aft body tank. The orange and the black dot illustrate the starting position for the respective years before the load of parachutists.

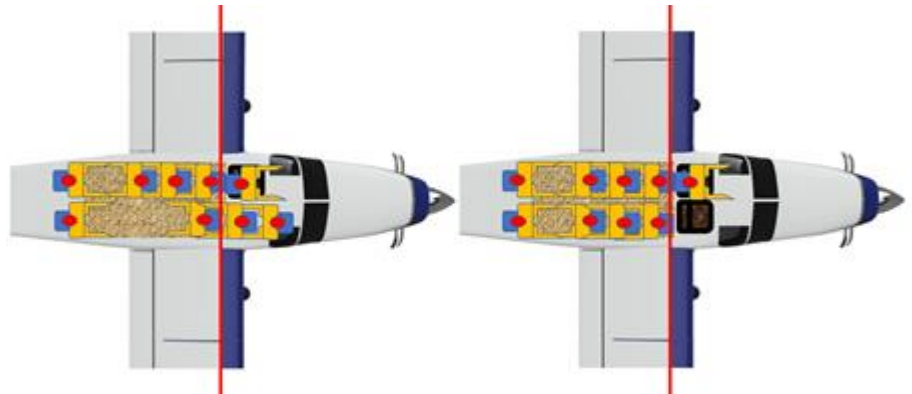
To distance the pilots from the parachutists during the Covid-19 pandemic, the pilots flying the aircraft had replaced the parachutists' bench to the right of the pilot with a pilot's seat. This meant that two parachutists who would normally be placed on the front bench now had to sit further back in the cabin, which even further shifted the position of the centre of gravity to the aft (see Figure 56).

Figure 56. The left picture present how the aircraft was originally loaded and the right present how the aircraft was loaded with the right pilot seat installed. The red line shows the centre of gravity according to the load instruction at standard empty weight.

A combination of ballast being installed and the parachutists being placed further back in the aircraft resulted in that the risk of getting behind the approved aft limit for the centre of gravity increased.
