Report RO 2001:04e

**Bus fire following traffic accident at
Fjärdhundra on national route 70,
C county, Sweden, 21 November 1998**

Case No. O-10/98

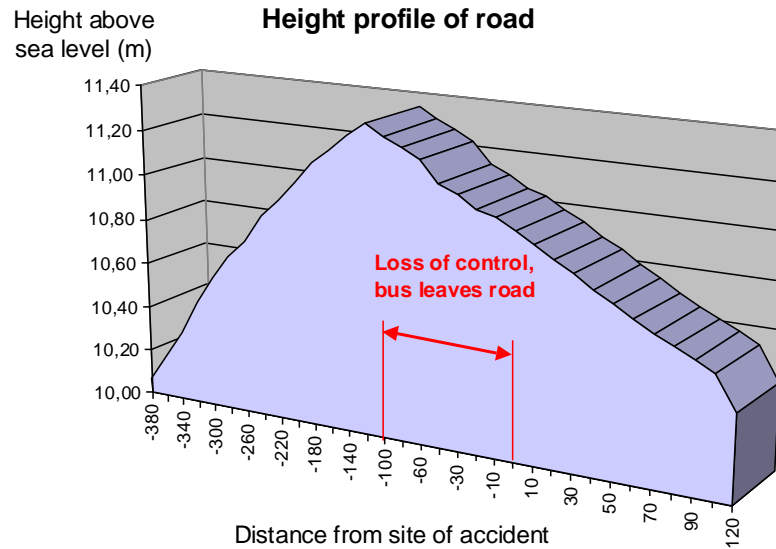
1.11 Road data

The height profile of the road at the road section in question is shown in the diagram below.

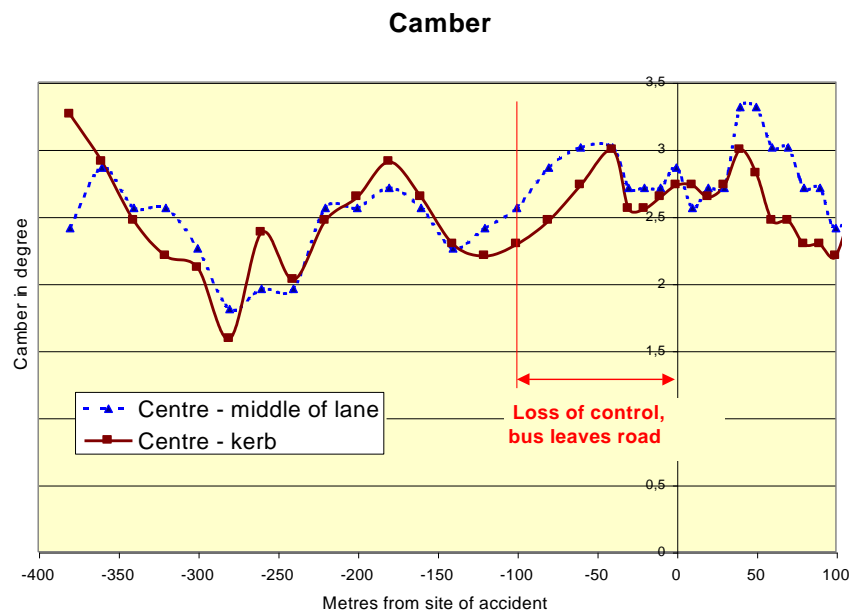
The metalled road surface is 13 metres broad in total. Lane lines are marked on each side 3.8 metres from the centreline. At the spot where the bus left the road there was a grass verge of about 0.8 metres in breadth between the edge of the metalling and the slope. In the diagram below, the camber has been drawn in for the road section before and after the site of the accident.

At the time of the accident the road was covered with an approximately 1–2-cm layer of wet snow.

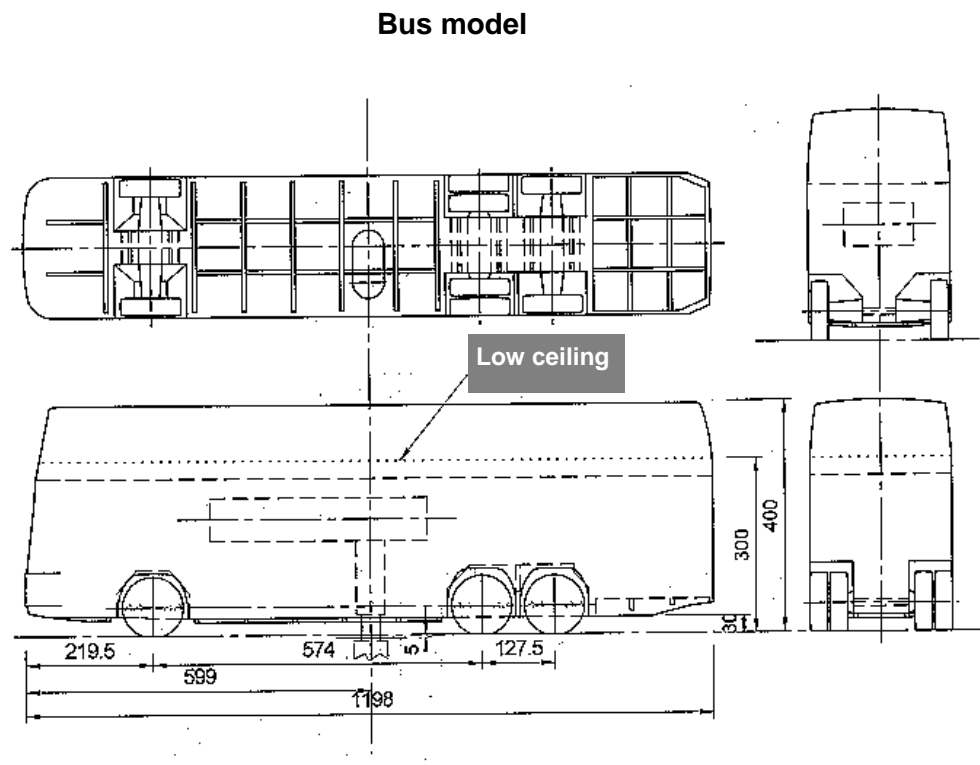
1.15.2 The model

For the trial a wooden model of the bus type in question was made on a scale of 1:10. The model was to scale regarding external geometry but small details such as window frames etc. were not represented. Rear vision mirrors were omitted. The geometry of the wheelhouses was modelled. Holes were drilled between the right and the left wheelhouses to simulate the air flow through the bus chassis. Mudguards were included. The chassis was not modelled in detail, a framework of strips simulating approximately the same “crudeness” as in the real bus.

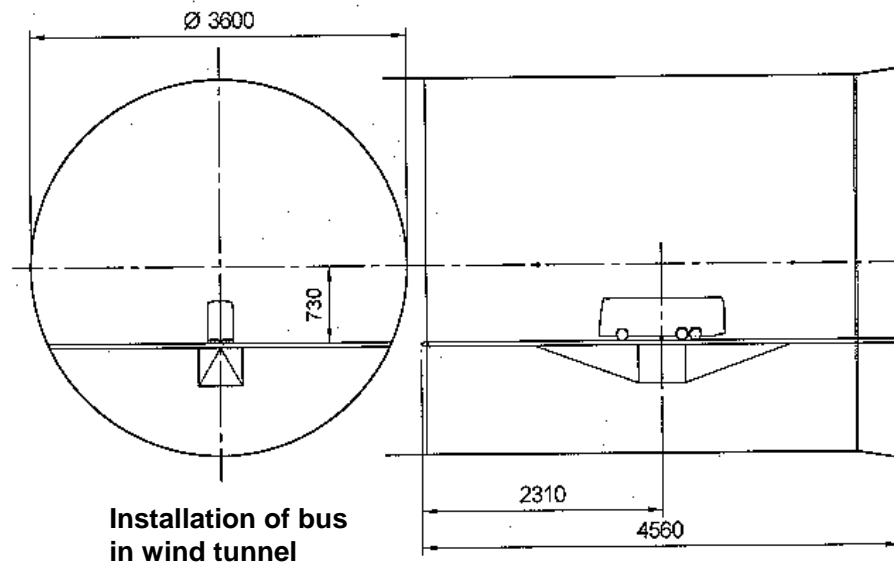
As well as measurement of forces arising, the air stream around the bus was visualised using a smoke generator. These trials were documented with photography and video filming.

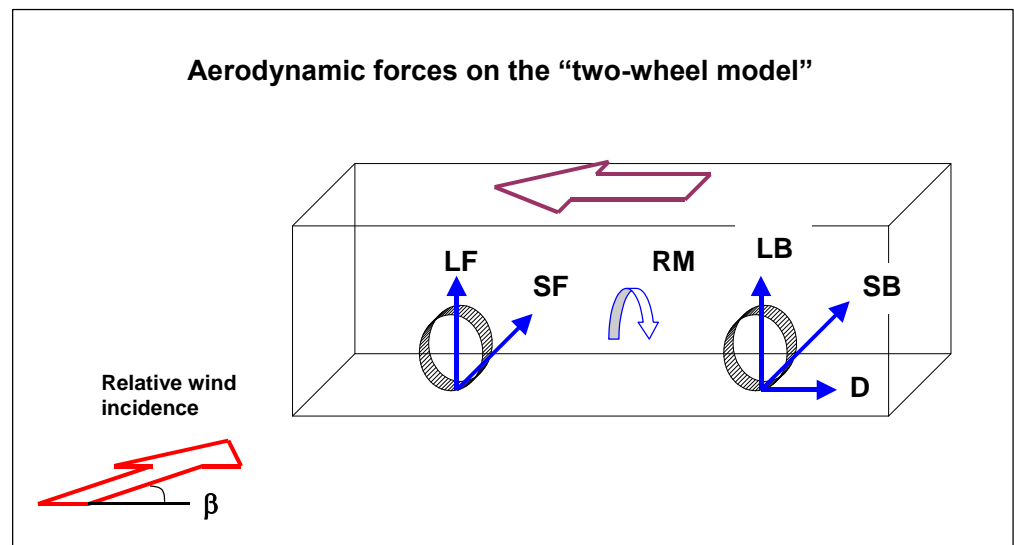
A common method of studying directional stability in vehicles is to simplify the vehicle in the calculation to a two-wheel model since otherwise account must be taken of factors such as: load distribution between wheels on the same bogey, wheel suspension stiffness, non-linearity in tyre friction, etc. In the calculation model produced for the present investigation a front fictitious wheel on the bus served to represent the front wheels and a rear fictitious wheel represents all rear wheels in the bogey. The fictitious wheels are placed at the centre of gravity for the wheels they represent. See figure below.

In motion the bus is affected both by the head wind and possible side wind. The resulting relative wind gives rise to aerodynamic forces on the bus which depend on the resulting wind speed and its direction, β . Once the total strength of the aerodynamic forces is known it can be calculated what this represents for forces at the contact surface between the road surface

and the wheels. In the figure above the lift and lateral forces for front and rear wheel, respectively, are defined as LF and SF, and LB and SB, respectively. The force D, caused by aerodynamic resistance in the direction of travel, has been ascribed to the rear wheel since the bus is rear-wheel-driven. The aerodynamic forces also cause a torque RM about the bus' longitudinal axis, which however is of negligible significance in calculations according to the two-wheel model.

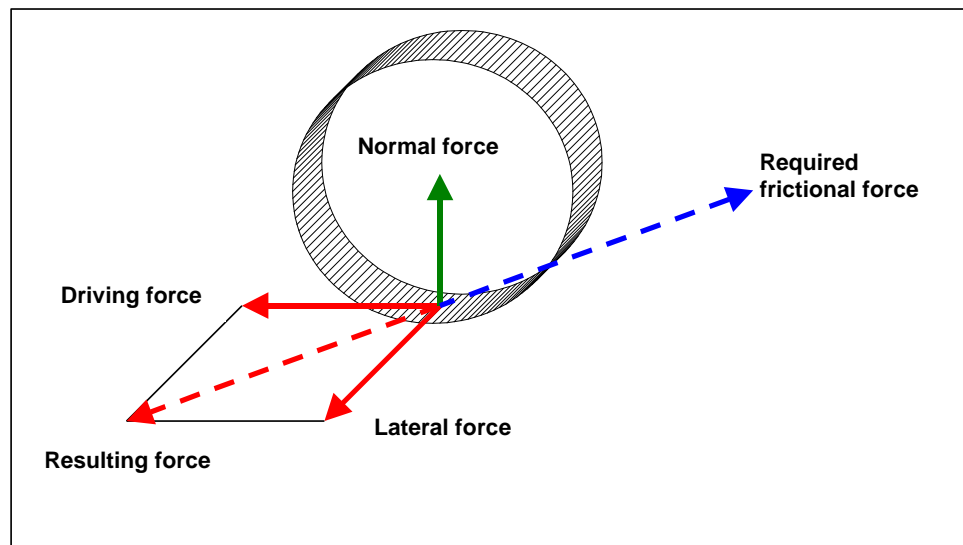
For a vehicle's wheels to be able to maintain their "grip" on the road surface the frictional forces at the wheel must be greater than the aerodynamic forces and the dynamic forces that may arise while the vehicle is in motion. Regarding the aerodynamic forces, in a rear-wheel-driven vehicle, the front wheels are affected only by lateral forces, while the rear wheels are affected by both lateral forces and the driving force required to overcome the air resistance in the direction of travel. The frictional forces on the rear wheels must therefore be greater than the resulting lateral and driving forces according to the sketch below.

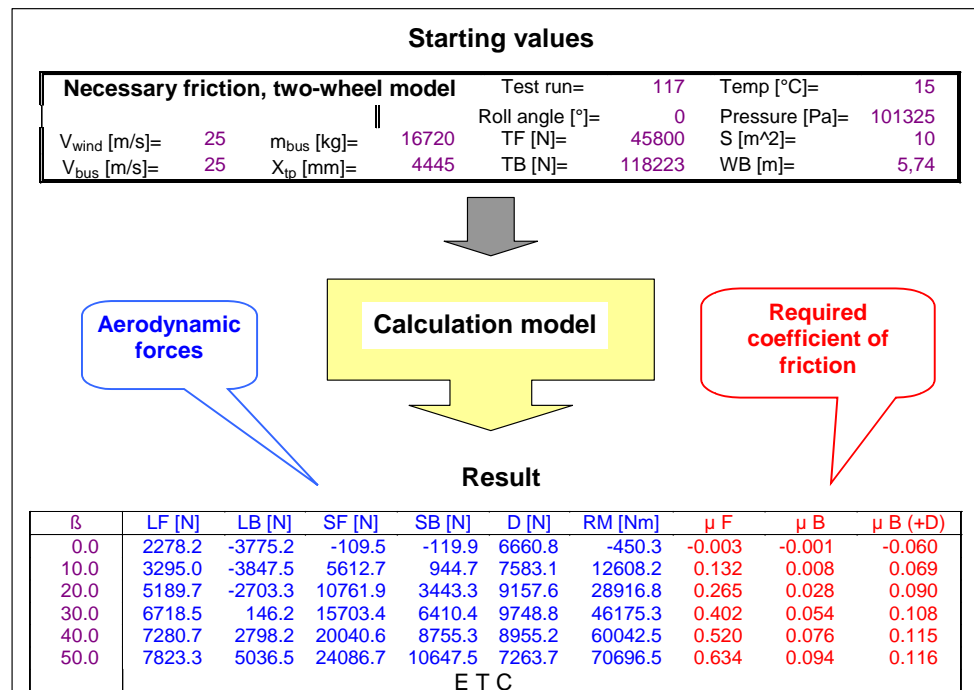
The principles for using the calculations models are shown in the sketch below.
