# Rejected take-off involving SAAB 340B, VH-ZRC

Flinders Island Airport, Tasmania on 4 November 2022

Aviation Occurrence Investigation (Short)

AO-2022-054

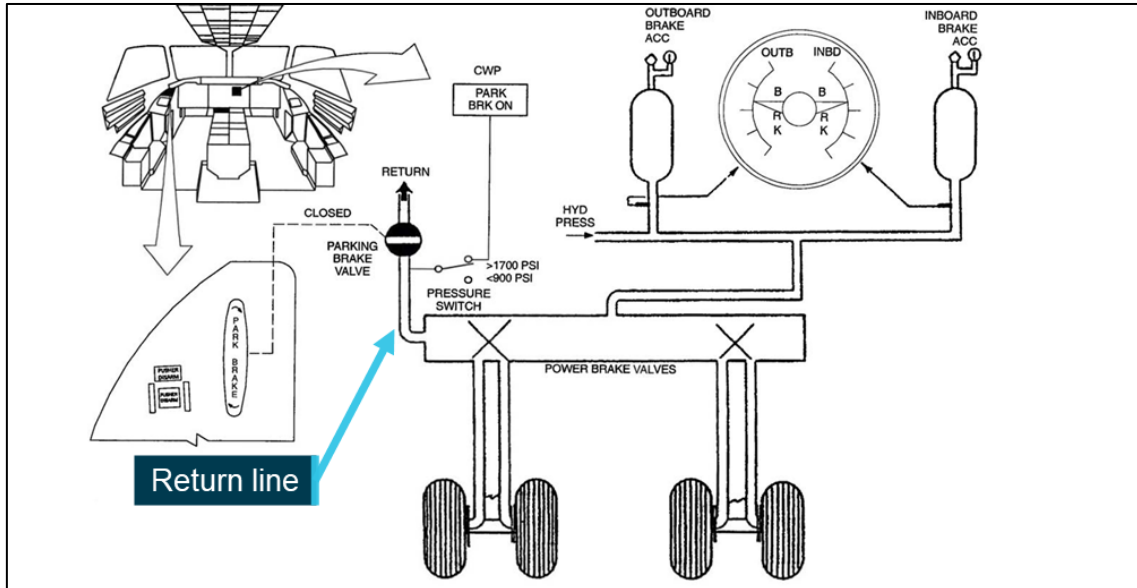
**Figure 6: Brake system schematic**

The parking brake is controlled by a handle on the left pilot's side panel (Figure 6). The handle is attached via a push-pull cable to a parking brake valve located in the brake hydraulic circuit common return line. The parking brake is set by pulling up on the handle whilst depressing the brake pedals. This action closes an internal valve against spring pressure inside the parking brake valve, retaining hydraulic pressure in both brake circuits and maintaining brake application. The handle is then locked in the UP position by rotating the handle 30° clockwise. When the parking brake is set, the pilots reported that it is usual for there to be a firmness felt in the toe brakes on the pedals.

An amber PARK BRK ON annunciator light on the pilot’s Central Warning Panel, located in the centre of the dashboard, illuminates when parking brake hydraulic pressure exceeds 1700 psi (Figure 6). The light goes off when the parking brake handle is pushed down and/or the pressure reduces below 900 psi. The pilots recalled that there were no warnings or cautions on the Central Warning Panel prior to take-off.
