## *Final report RL 2014:08e*

**Accident 85 km north of Kiruna on  
September 26, 2013 involving the  
helicopter SE-JHH of the model EC 120 B,  
operated by Kallax Flyg AB.**

File number L-136/13

6/11/2014

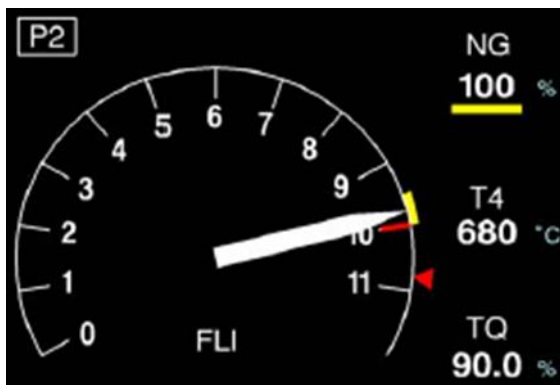
Figure 1. The FLI.

The pilot has declared that the expected positive increase in speed was obtained initially. Thereafter, an unexpected height reduction was experienced, which was countered by maximum power output corresponding to the red radial mark on the FLI (see Figure 1). The reason why more power was not used was that the pilot considered the situation not to demand it.

The FLI is an instrument that, in flight, displays the most limiting of three operating values, namely NG (gas generator RPM), T4 (gas generator temperature) or TRQ (torque). The FLI scale is graduated from 0 to 11, while the respective operating values are displayed on the instrument's right side. At the value of 10, there is a red radial mark indicating the maximum take-off power, and at the value of 10.8, a red triangle indicating the maximum transient power (see Figure 1).

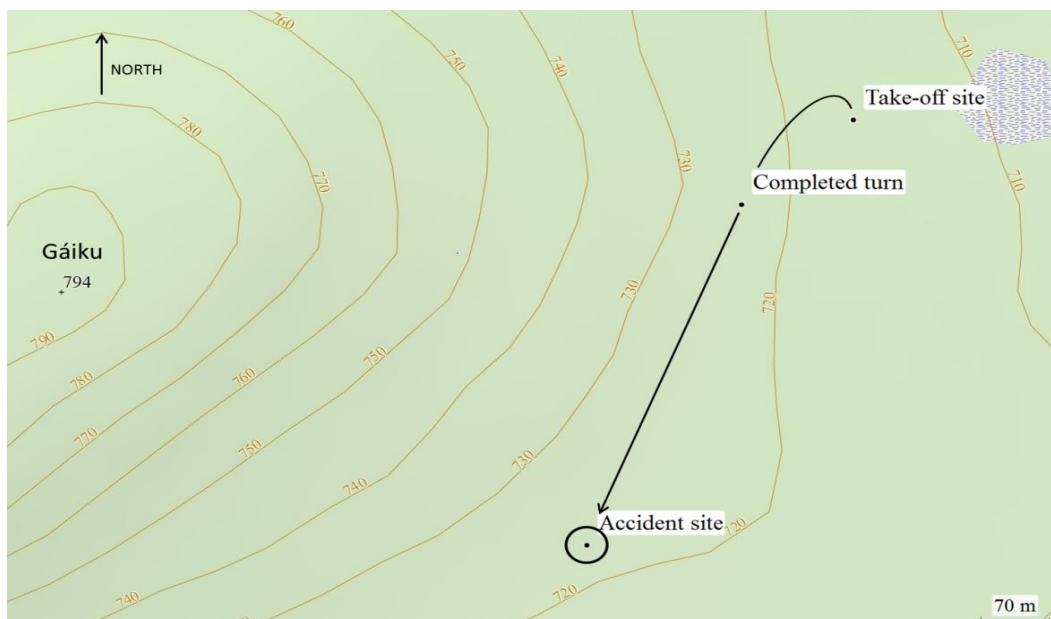
Figure 3. Map with route based on GPS data and contour lines. Image from Garmin BaseCamp and Recreational map Pro v3. Map data © Lantmäteriet Dnr R61749\_13002.

The accident site is located in low mountainous terrain, about 85 kilometres north of Kiruna, east-southeast of the Gáíku peak. Figure 3 below shows that the route from the completed turn up until the accident site went between the contour lines for 730 metres and 720 metres above sea level.

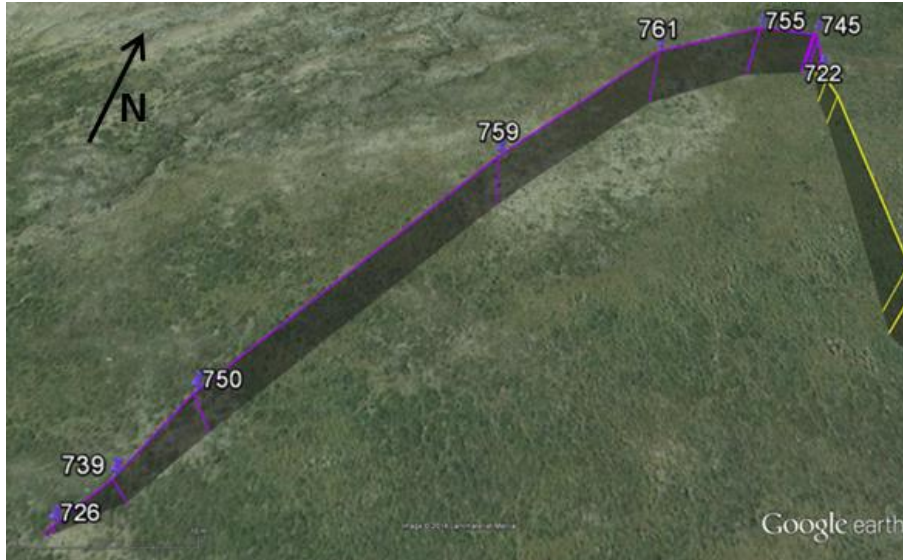
Figure 5. Visualisation of GPS data. The crash site is in the bottom left. Image from Google Earth. Map data © Lantmäteriet Ref no R61749\_13002.

Data from the GPS unit has been analysed by the BEA and converted into a file format that makes it possible to visualise the GPS track with the programme Google Earth (see Figure 5 below). Specified heights taken from GPS data are given in metres above sea level and are not accurate enough to be considered as precise values. The flight in question is shown in purple and the preceding landing in yellow. The GPS track of the flight in question shows that the route from the completed turn up until the accident site has a direction of approximately 200 degrees.
