## **Report RL 2001: 20e**

***Accident involving aircraft SE-KGH  
north of Ljungby/Feringe airport, G county,  
Sweden, on the 1<sup>st</sup> of December 2000***

**Case L-115/00**

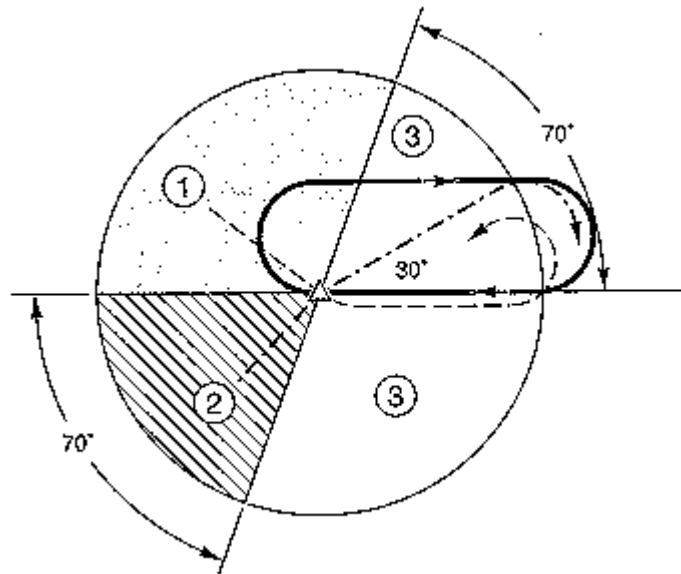
The NDB-procedure at Ljungby/Feringe involves the aircraft passing overhead OF at the lowest sector altitude. In the case in question they should have joined the procedure through a so-called offset or teardrop entry (line 2 on the figure below) at 2,400 feet. Thereafter they were to fly

on a heading of 346 degrees during 1.5 minutes, with correction for the force and direction of the wind, while descending to 2,000 feet. The inbound turn towards OF was to have been initiated after 1.5 minutes. When the aircraft was established on the inbound approach course ( $\pm 5^\circ$ ) they were to descend down to 1,800 feet until overhead OF. After passing OF a new timing was to have been initiated. Different elapsed times are applicable, depending on the speed of the aircraft during the final approach, when a missed approach is to be initiated if one does not have visual contact with the runway. In the case at hand the minimum altitude chosen was 940 feet (310 m) and the time 1 minute and 55 seconds.
