## Report RL 2002:11e

***Infraction of minimum separation  
between the aircraft SE-KOL and SE-ISV  
at Stockholm/Arlanda airport, AB County,  
Sweden, on 28 November 2001***

Dnr L-085/01

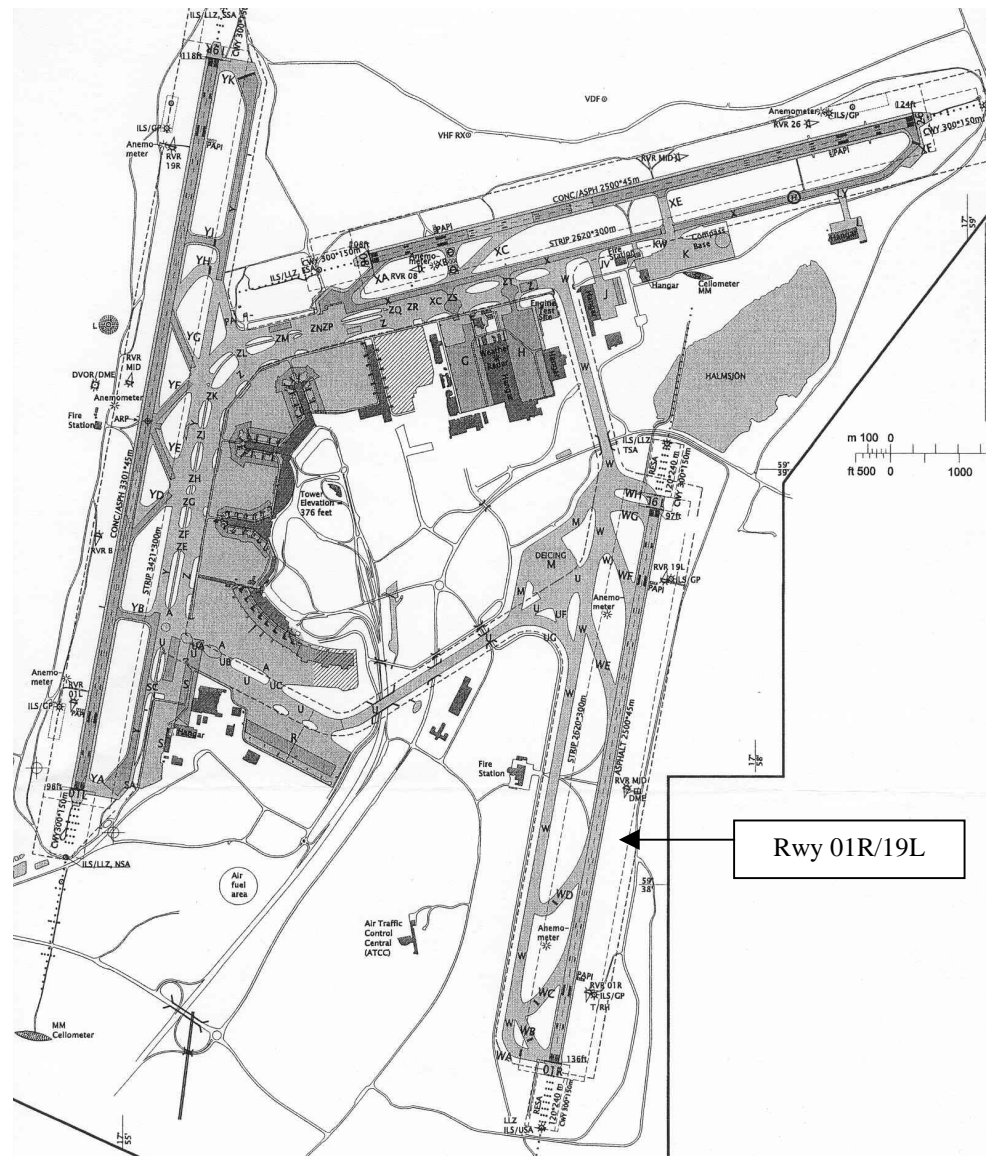
## 1.10 Aerodrome information

At the time of the occurrence Stockholm/Arlanda airport was for scheduled traffic using runway 08 for departures and runway 19R for arrivals. Air traffic was then still controlled from the old low tower.

On and around the new third runway construction work was still in progress and therefore the runway and its taxiways were not within the airport's maneuvering area. At a controlled airport the maneuvering area normally consists of runways and taxiways. However aircraft parking stands and similar surfaces normally are not included in the maneuvering area.
