Statens haverikommission
Swedish Accident Investigation Board

Report RL 2003:47e

***Incident involving aircraft LN-RPL
and a tow tractor at Stockholm/
Arlanda airport, AB County, Sweden,
on the 27th of October 2002***

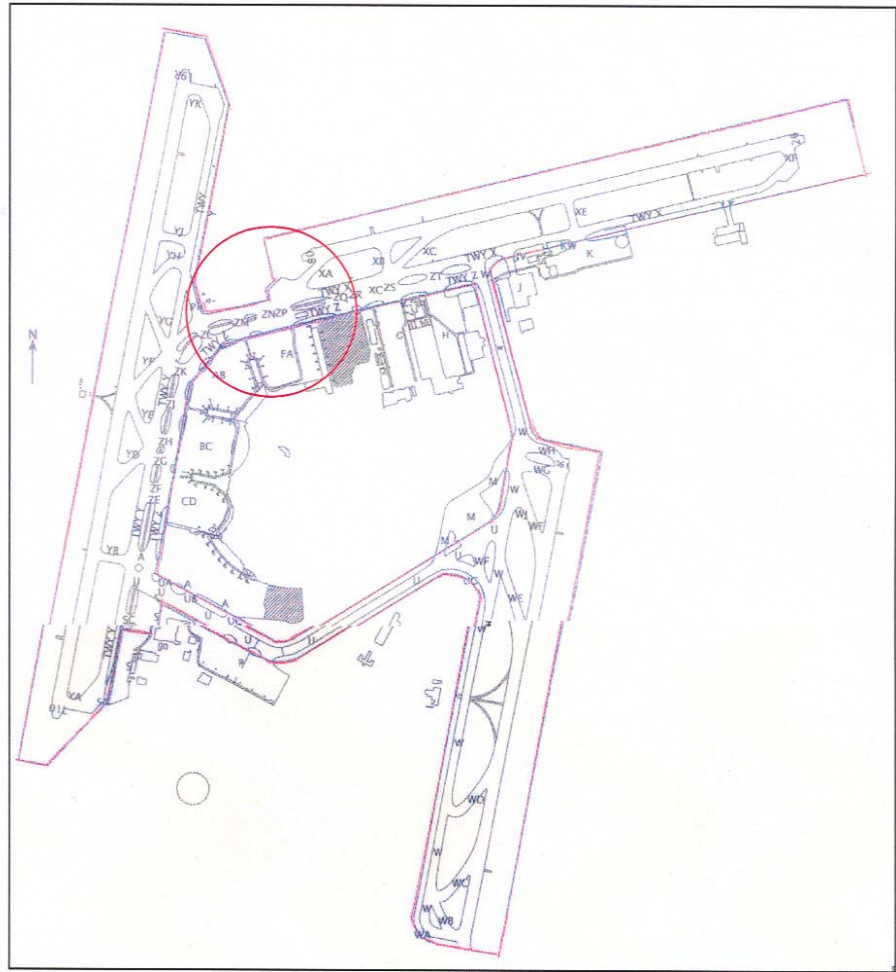
Even the combination sign that the pilots observed within the "roundabout" lends itself to misinterpretation.

In the opinion of SHK, it is these ambiguities that taken together caused the pilots to misinterpret the chart and taxi the wrong way.

The Swedish Civil Aviation Administration is recommended to revise the present regulations concerning the design of taxi charts in the Swedish AIP and that of information signs, with respect to the risk of misinterpretation. (*RL 2003:47e R1*).
