## Report RL 2001:41e

***Incident onboard aircraft SE-DRE  
during flight between Stockholm and Malmö,  
M county, Sweden, on 12 November 1999***

Case L-102/99

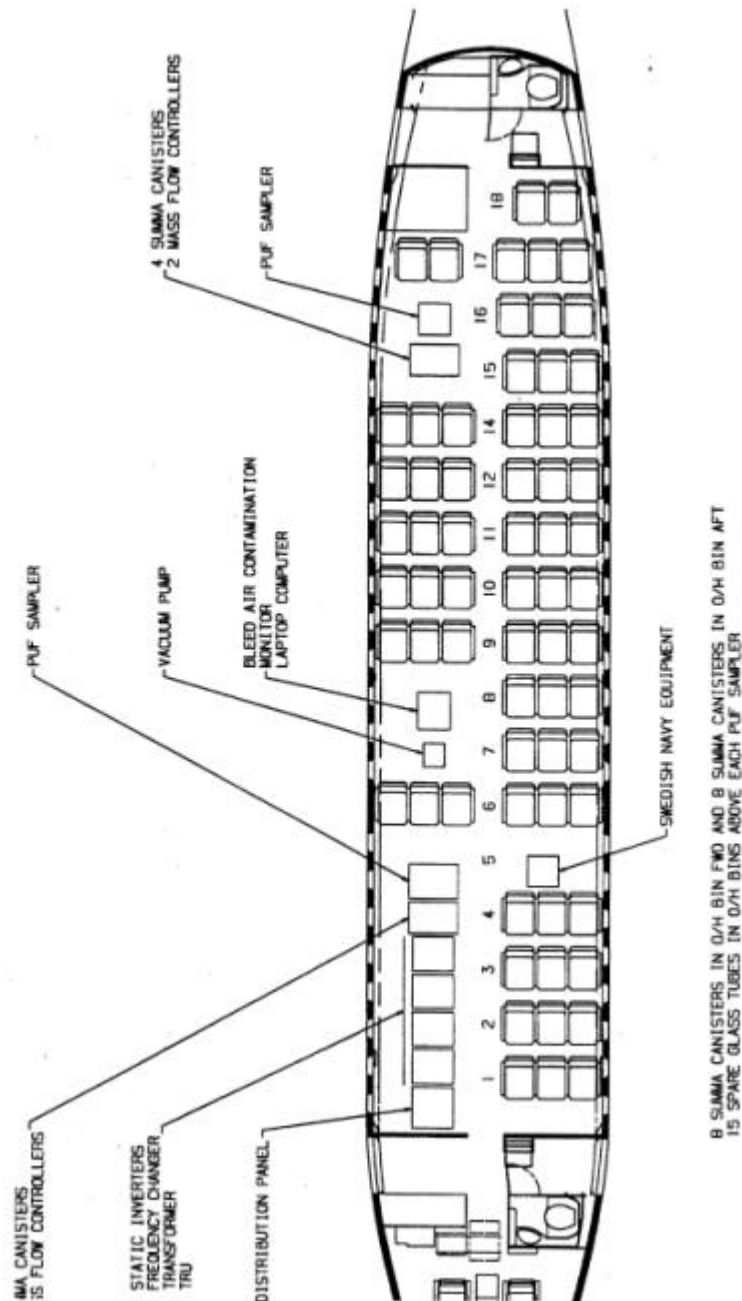
The results showed that the concentrations of carbon dioxide, carbon monoxide, hydrocarbons, oil degradation products (such as formaldehyde) and ozone were within the stipulated and generally accepted limits respectively. The concentrations of aldehydes, semi-volatile gaseous substances, and volatile organic substances were consistently low. There are no limits established by the FAA or the JAA<sup>9</sup> for these substances. A review of "the ventilation equipment's various settings" did not show any noticeable changes in the results of the cabin air analysis whether it was ventilated with fresh air or if the cabin air was re-circulated.

Installation of measuring equipment in the aircraft
