Report RL 2005:15e

Accident involving paraglider Gin Boomerang III in Valle de Bravo, Mexico, on 22 January 2004

Case L-01/04

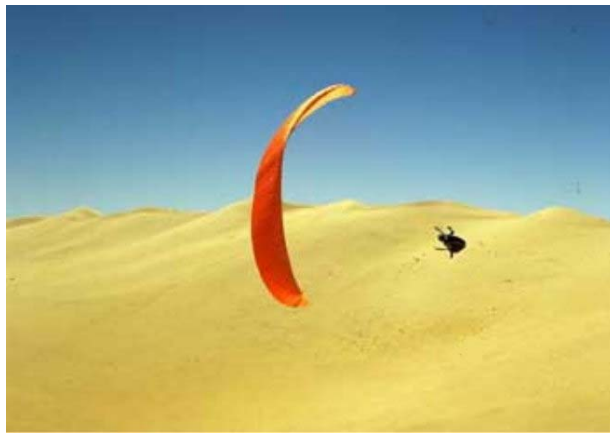
Spiral

The pilot was a member of a group of European paraglider pilots visiting Valle de Bravo in Mexico for training flights and competition. The accident flight, a training flight, started at about 11.25 hrs local time. When after flying for some three hours the pilot was approaching the landing area he still had excess altitude. He therefore initiated a spiral, i.e. a continuous turn with a large load factor and high rate of sink. After a few turns he increased his angle of bank somewhat. Shortly thereafter the lines on one side between the pilot's harness and the canopy broke, whereupon the paraglider collapsed. The pilot released his emergency parachute. According to witnesses this did not open but came loose from the harness and the pilot fell helpless to the lake beneath. His altitude was then about 100 metres.

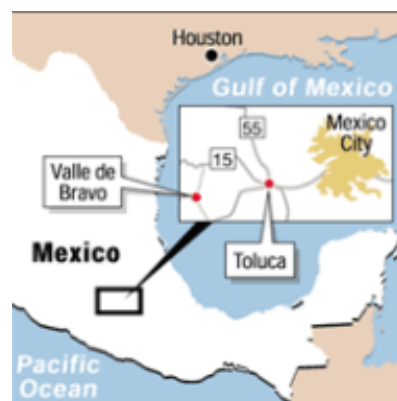
Presa Valle de Bravo is an artificial fresh-water reservoir. The settlement of Valle de Bravo is on the eastern side of the lake.
