**Statens haverikommission**  
Swedish Accident Investigation Board

## ***Report RL 2006:14e***

**Aircraft accident involving SE-DYX  
at Stockholm-Arlanda Airport, AB county,  
Sweden, on 1 December 2004**

Case L-50/04

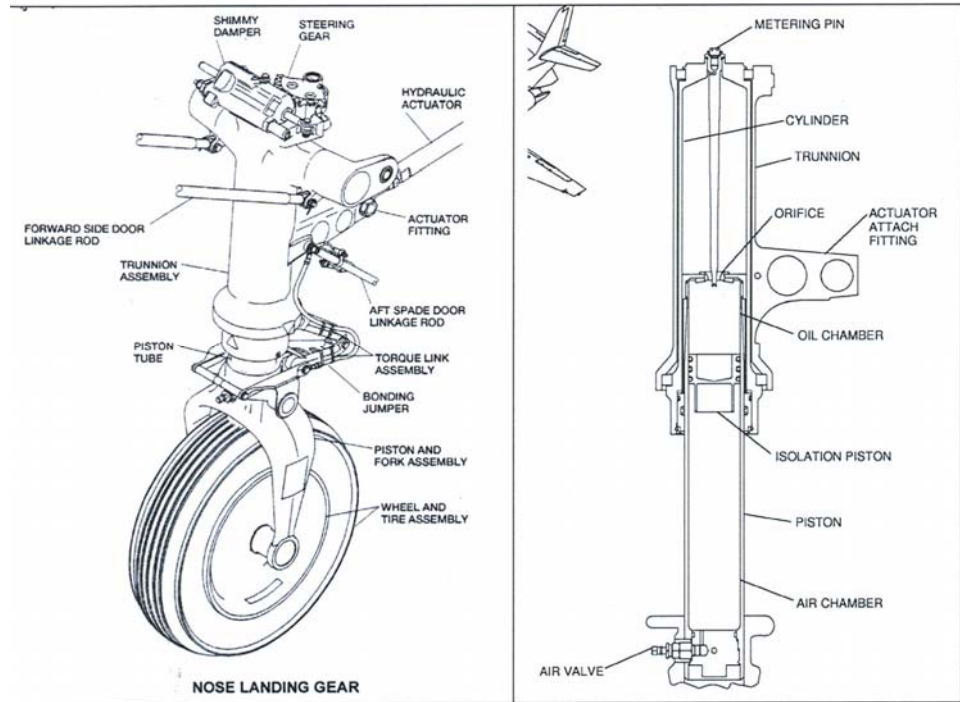
The nose gear has a gas/hydraulic suspension which are built-in in the landing gear strut. Simplified the upper part of the nose landing gear strut function as an outer cylinder and the lower part constitute a piston which moves up and down in the upper part. The space between the upper and the lower part is filled with gas and hydraulic oil. When the lower part is pressed into the upper part the gas is compressed which gives the spring function. The system contains also components implying shock absorber function. One of this is a movable piston (isolation piston) in the lower part of the landing gear strut as separates gas in the upper part of the struts and oil in the lower part of the strut. (See figure below.)

Adjustment of the nose gear spring pressure is performed through drain or refilling of gas which is performed through a nipple in the lower landing gear strut (air valve).

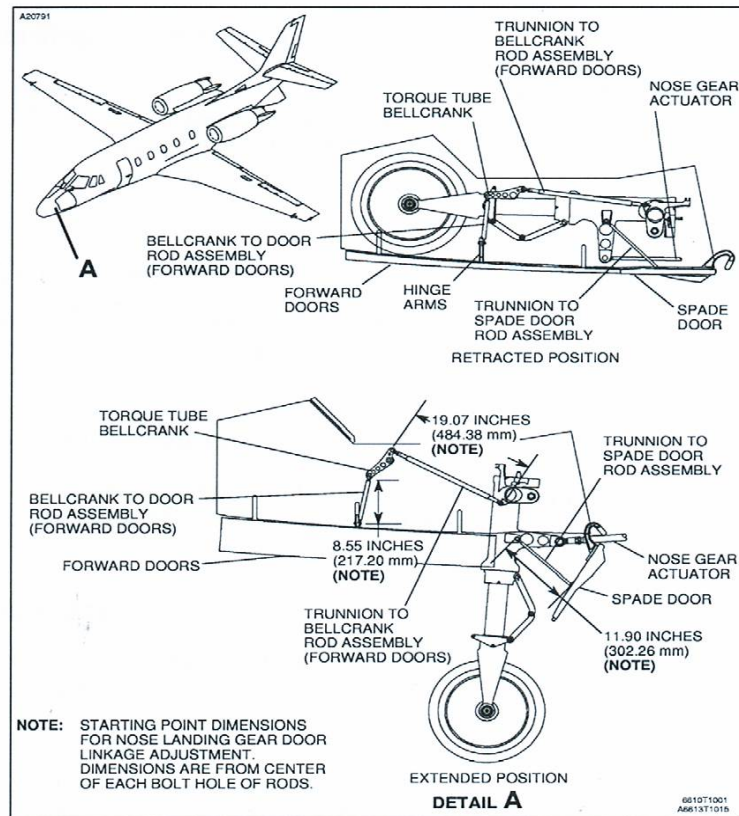
1.6.4 *Nose gear retraction mechanism.*

Retraction of the nose gear is by forward motion, with use of a hydraulic cylinder. To allow the landing gear and the nose wheel to fit into the nose wheel bay in the aircraft forward part the shock strut must be fully extended which is normal as soon as the nose wheel has left the ground. Mechanically linked to the retraction mechanism are two gear doors (forward doors) which opens respectively closes in connection with the extension and retraction of the landing gear.

The nose gear retraction mechanism has been checked and tested. At the tests it has been established that one condition for the nose gear to be fully retracted and locked, it is that the gear strut is fully extended. If this is not the case the nose wheel get stuck between landing gear doors hinge arms, and remain jammed so tight that it is not possible to extend it again with ordinary system. Landing gear function inclusive linkage to flaps and stabilizer trim worked without remarks. See 1.6.5 regarding fault indication of the stabilizer trim.
