***Report RL 2008:09e***

**Aircraft accident to OE-KLA in international  
waters south of Trelleborg on  
16 October 2006.**

Case L-31/07

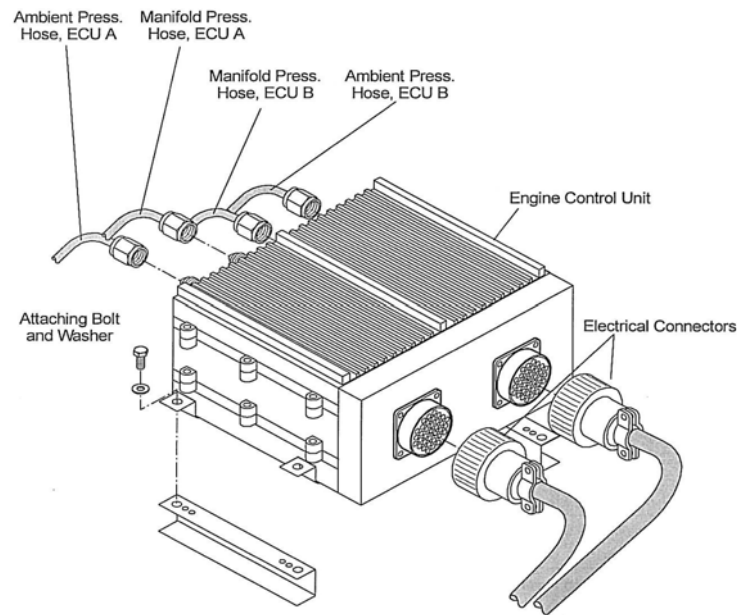
Fig 9. Drawing of the engine FADEC

Once the aircraft wreckage had been located, the FADEC unit could be found and recovered. During the recovery it was seen that the unit had some external damage, but was generally in relatively good condition. After recovery the FADEC unit was preserved in water and taken together with the other wreckage to the hangar at Malmö/Sturup which SHK was able to use for the purpose. A representative from AAIB collected the unit for transport to the engine manufacturer's laboratory in Hamburg for analysis.

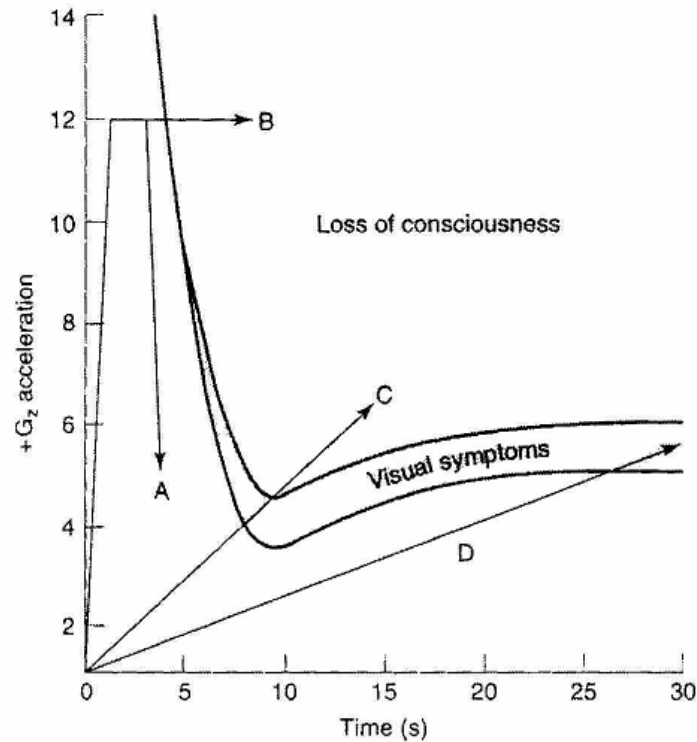
Fig 13. G load symptoms.

In the diagram at Fig. 13 above, it can be seen that the symptoms of G loading depend greatly on the duration. Differences in the symptoms and reactions relate to the following alternatives:

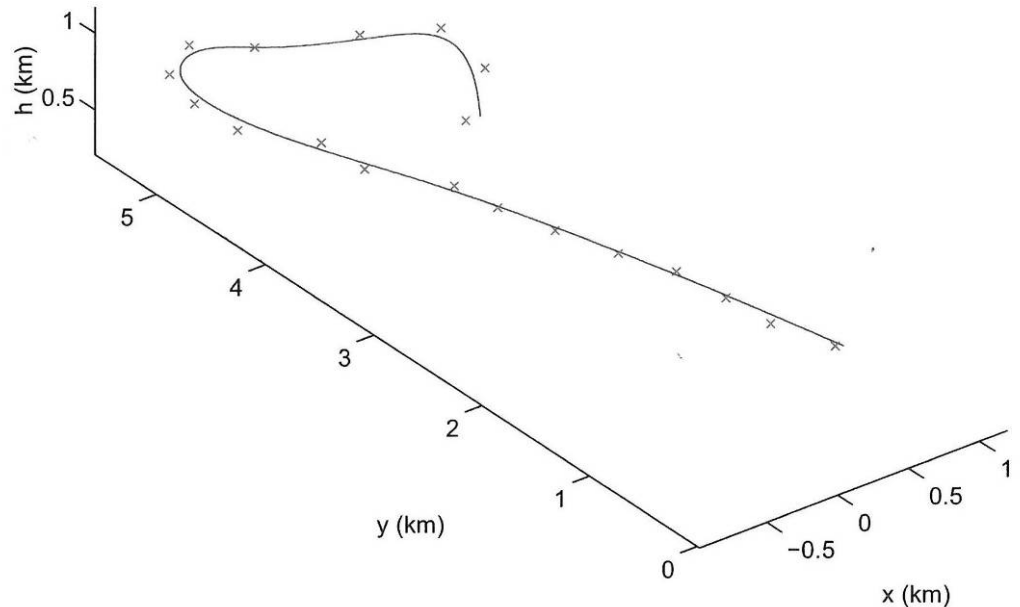
Fig 14. Model of the theoretical flight path with the radar co-ordinates inserted. Graphic source: KTH

Taking into account the fact that the recorded radar data has a certain margin of error, a calculation shows that the aircraft speed reached 200 knots in theory, which is a condition for arriving at 11 G, the maximum that the elevator, according to the manufacturer, could generate. The acceleration calculation did not however indicate any high G loads, since the calculated values are equivalent to a load of about 2 G.

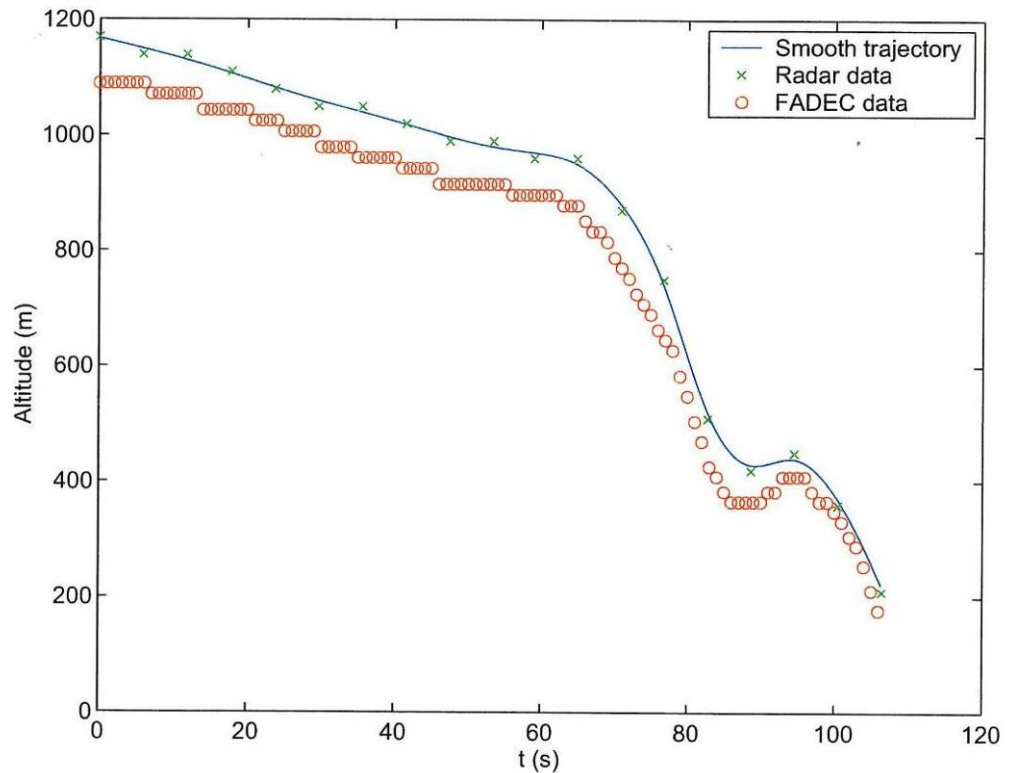
Fig 15. Graph of altitude against time using data from the FADEC and radar respectively. Graphic: KTH.

The calculation of the aircraft altitude curve that was obtained from the ambient air pressure recordings in the aircraft FADEC, show close agreement with the equivalent values from the radar data. There are a greater number of points shown in fig. 15 above from the FADEC recording, as these are recorded every second. The equivalent values from the radar station were only recorded at every sweep, which occurred every 6 seconds.
