Statens haverikommission
Swedish Accident Investigation Board

Report RL 2007:8e

**Aircraft accident to SE-GIT
at Umeå airport, AC county, Sweden,
on 13 March 2006**

Case L-06/06

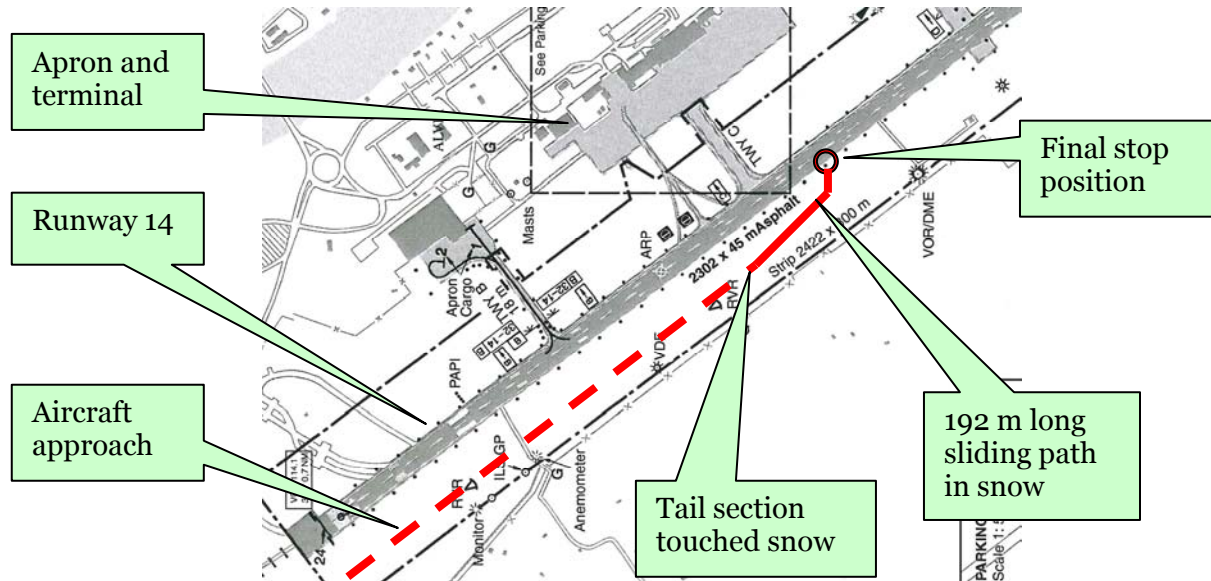
Fig. 3.

The sketch above is a section of the airport chart in the AIP of Umeå airport. The place where the aircraft landed is a grassed area parallel to the asphalted runway, and at the time of the incident was covered by 30-50 cm of snow. The size of the area is 2422 x 300 m and can be used as an emergency landing strip, in the case for example of the ordinary asphalt runway being obstructed. The area has a relatively even surface, but is traversed here and there by for example access roads to various airfield installations.
