Report RL 2007:05e

**Incident involving aircraft SE-LIP
at Stockholm/Arlanda airport, AB county,
on 1 June 2006**

Case L-11/06

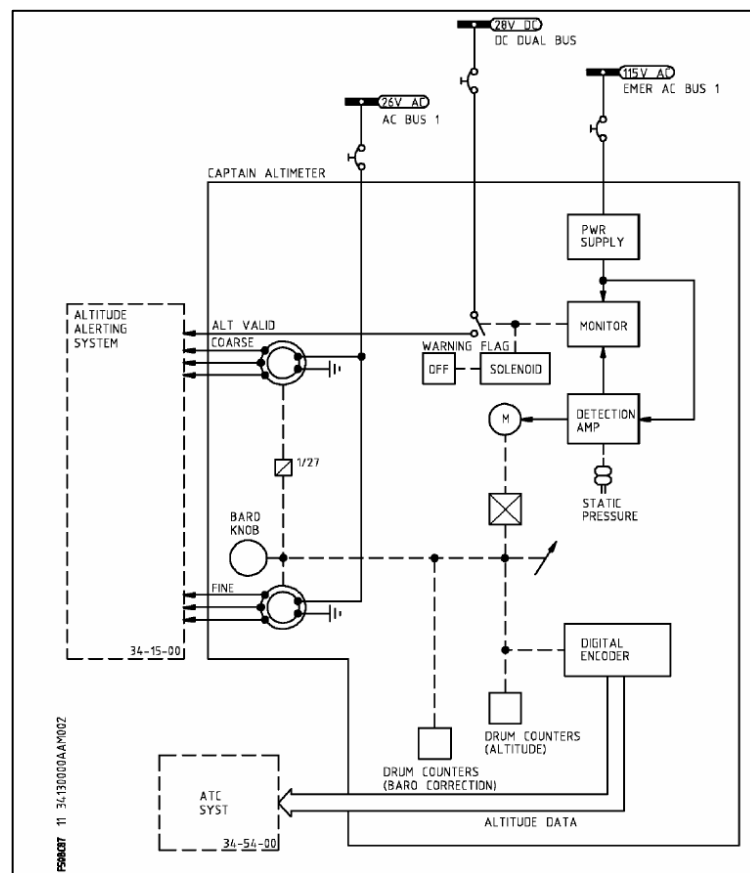
The standard altimeter for the left pilot's seat is of an electromechanical type with both analogue and digital presentation, manufactured by THOMSON-CSF with P/N 60121-001-1, S/N 256. Apart from presenting the height to the commander, the instrument provides digital height

Schematic diagram of the standard left altimeter
