Rapport RS 2007:5

Olycka med fartyget MT PROSPERO i Milford Haven, Wales, Storbritannien, 2006-12-10

Report on the investigation of
the loss of control of product tanker

Prospero

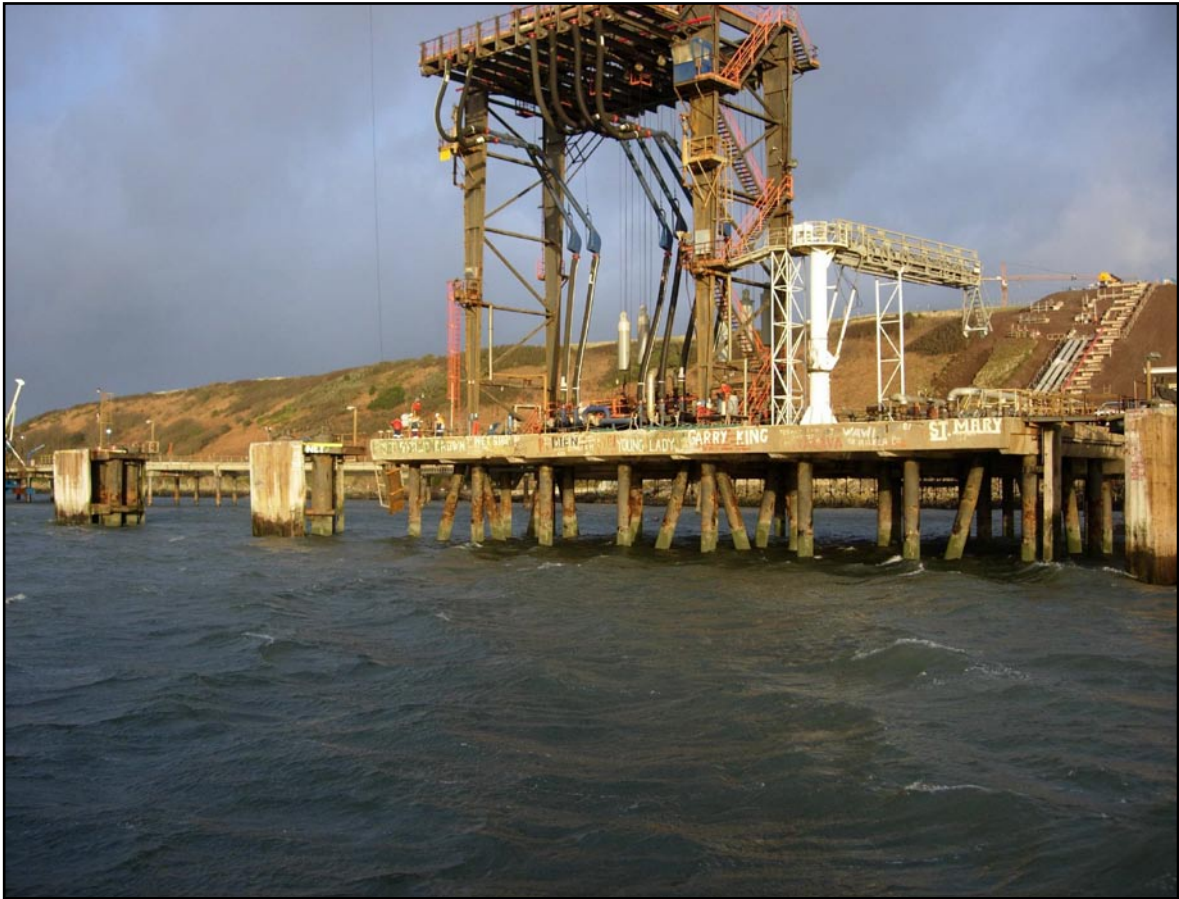
Figure 1

The master attempted to pull the control lever back to zero, but the power remained at 70%. The vessel was now so close to the jetty that impact occurred with the vessel swinging to port. *Prospero's* stem landed heavily on the concrete decking at the head of the jetty before the flare of the bow made contact with the steel gantry supporting the oil loading arms (**Figures 1, 2, 3 and 4**).

SemLogistics jetty No.2, Milford Haven

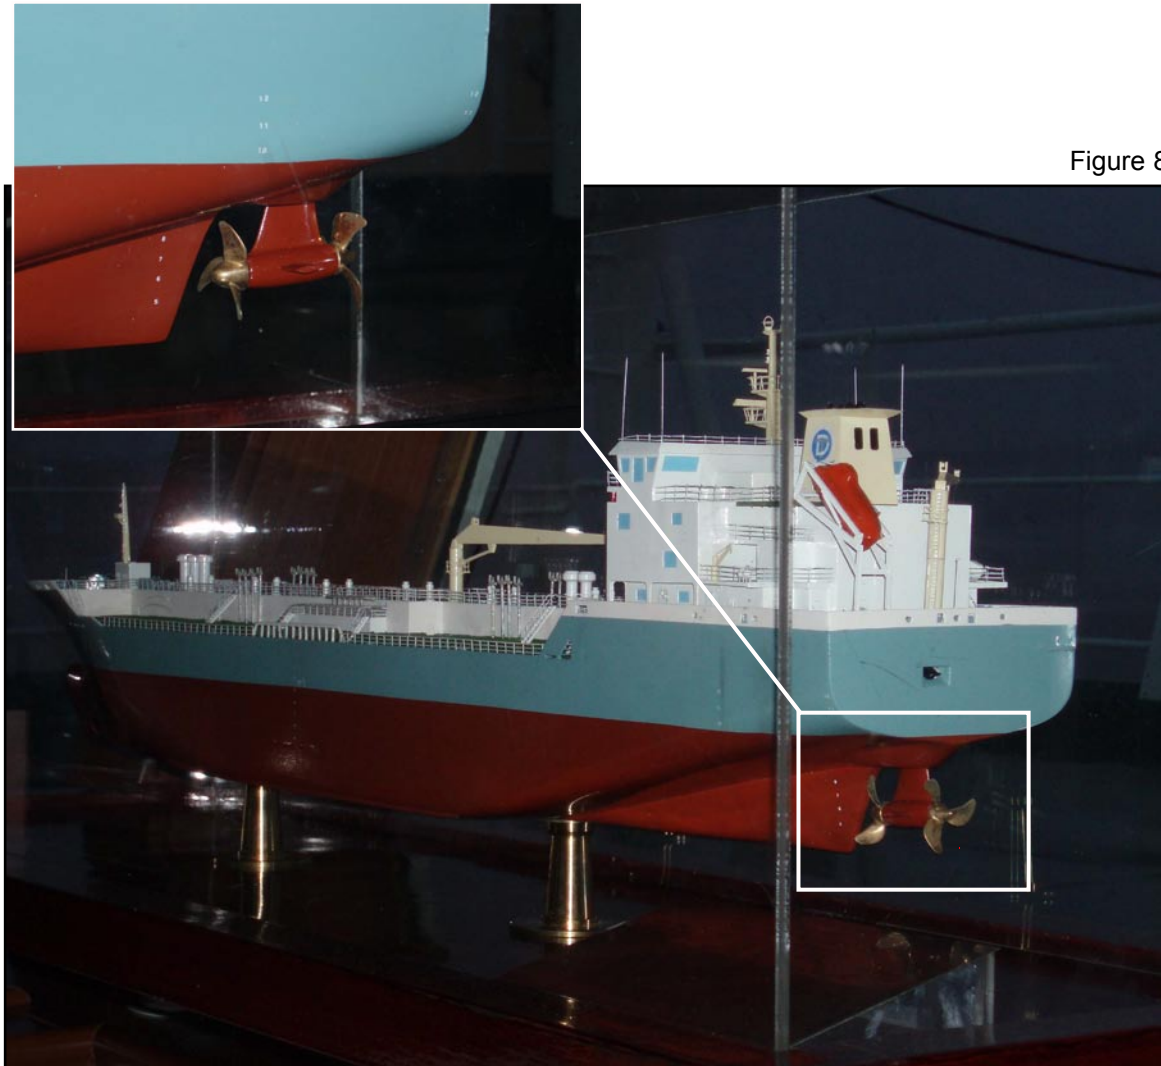
Figure 8

A general overview of *Prospero's* propulsion system can be obtained from the photograph of the builder's model (**Figure 8**).

Builders model of *Prospero*

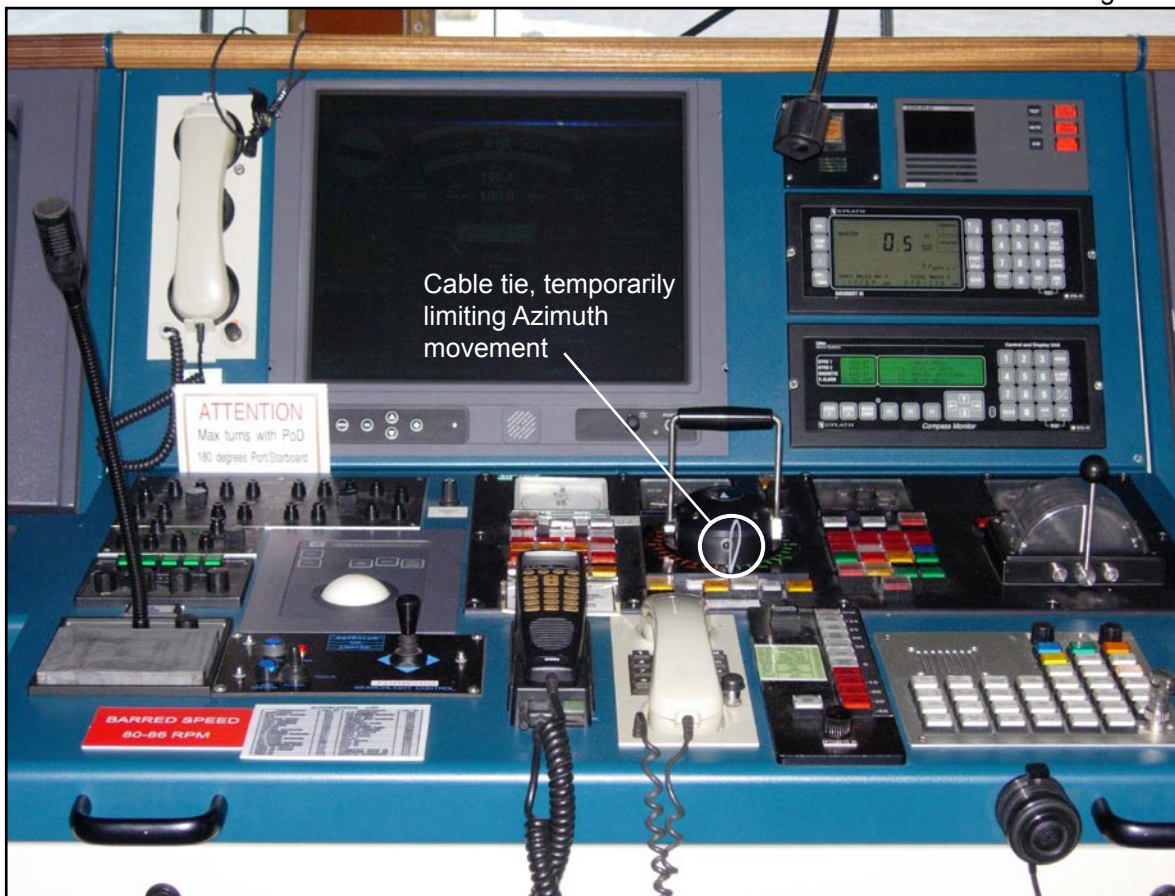
Figure 9

Prospero had an enclosed wheelhouse with manoeuvring control consoles in the centre and on the port and starboard sides (**Figures 9, 10 and 11**). The centre console was the dedicated steering position which was fitted with a conventional ship's wheel and rudder angle indicator, auto pilot, and compass repeater.

Wheelhouse centreline console

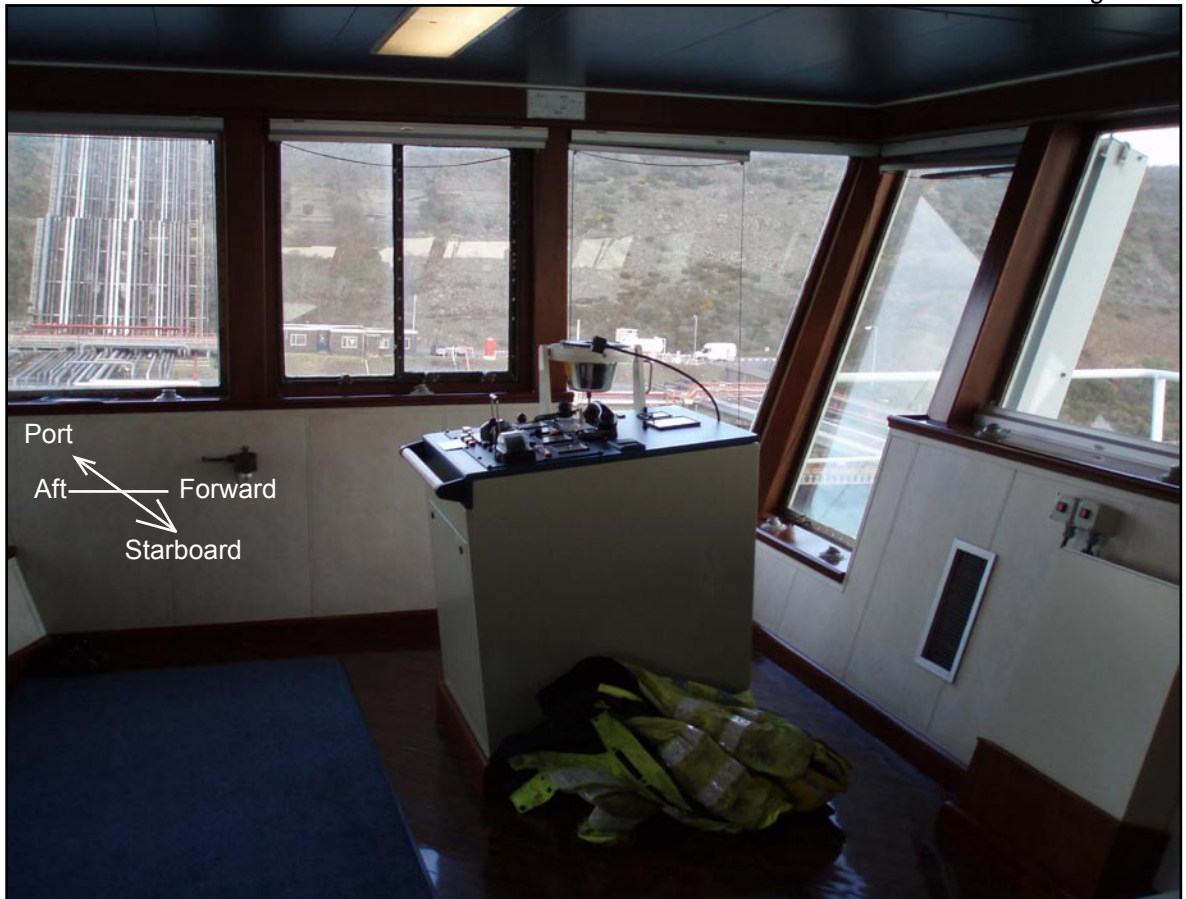
Figure 10

Wheelhouse port side console.

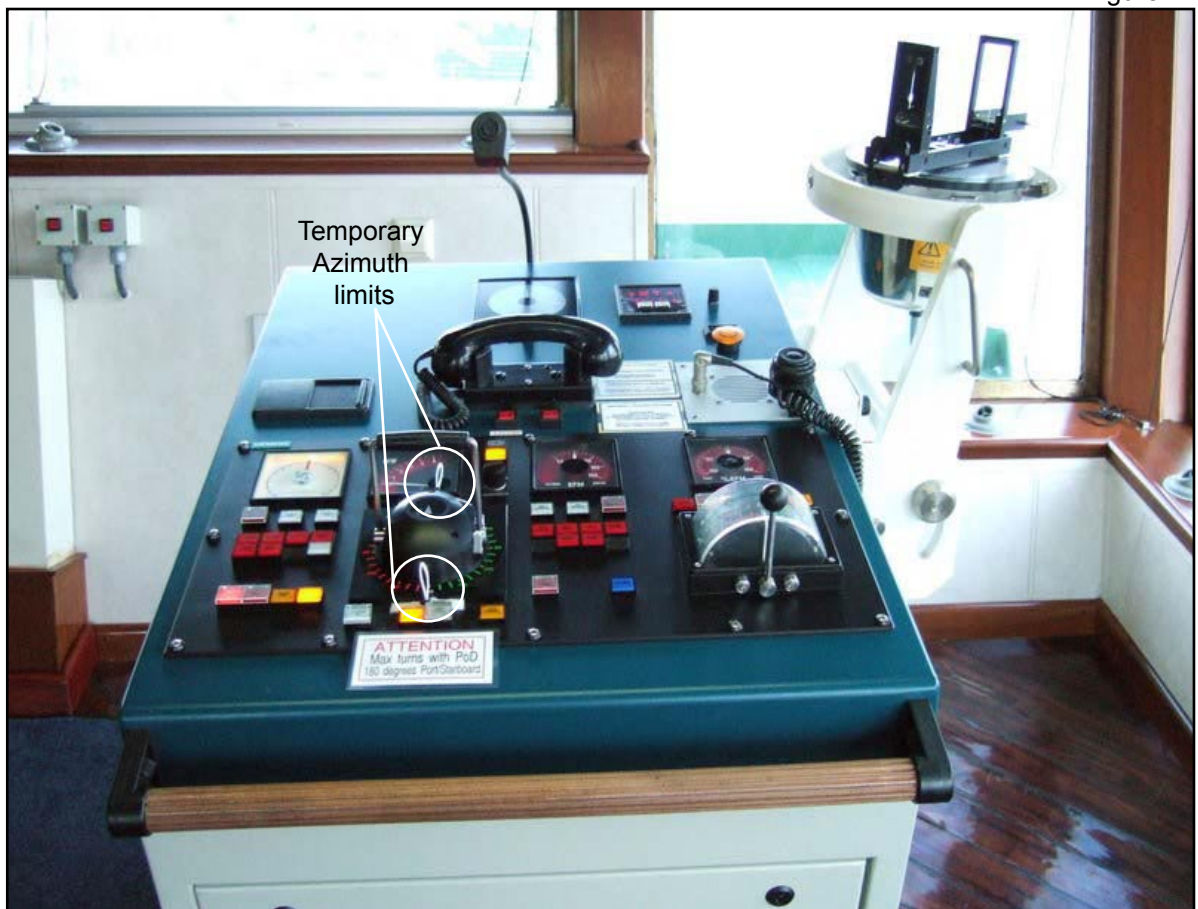
Figure 11

Wheelhouse starboard side console

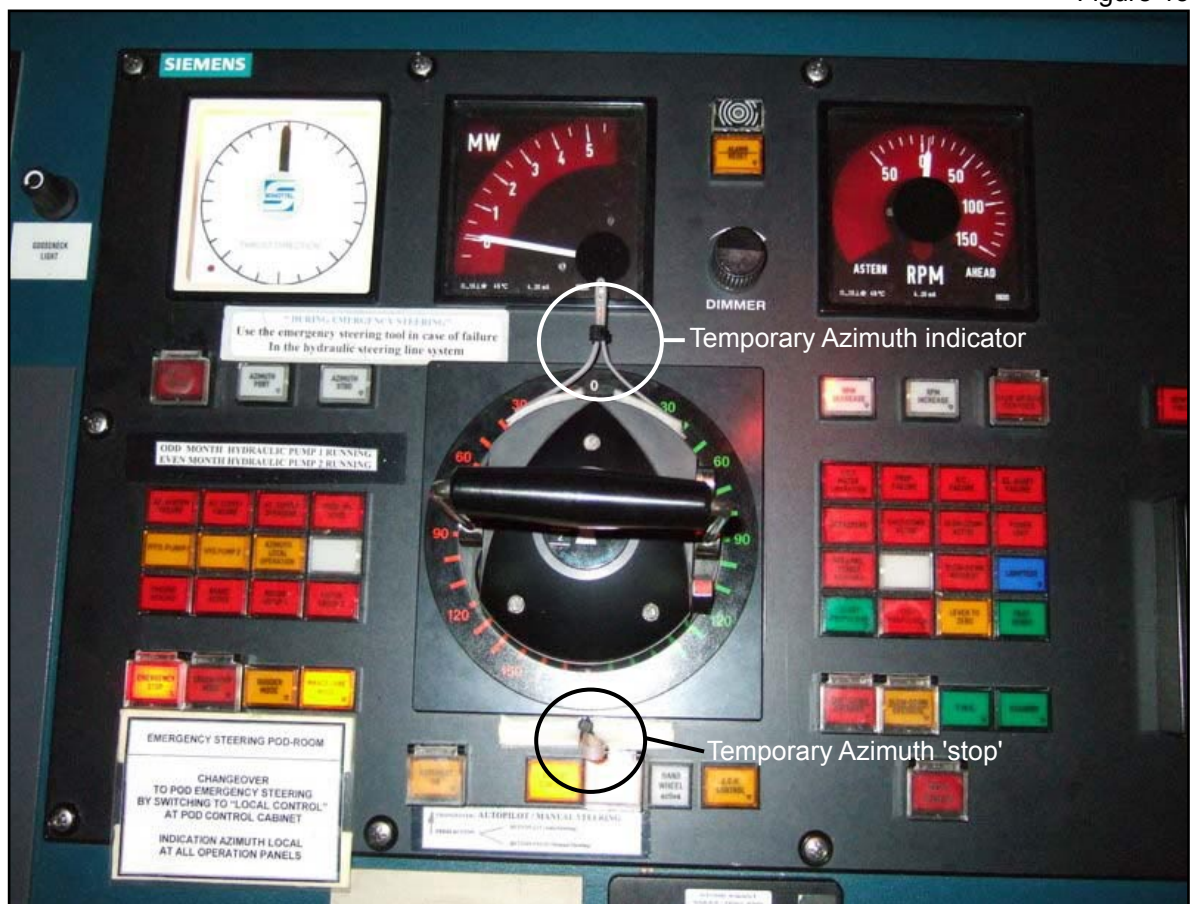
Figure 13

The pod controls at each console had an identical layout for ease of operation (**Figure 13**). This figure also shows the cable ties attached to the pod control levers as a result of the gauss transmitter failure on 19 September 2006. All the pod control levers were electrically driven to match the position of the 'in-command' control lever. Control levers which were not 'in-command' provided physical feedback to the operator through increased resistance to movement and automatically returning to the 'in-command' setting when released. There was, therefore, no need to set the lever to zero before transferring control which was instead achieved by pushing a button. Transfer of control of the pod between the wheelhouse and the ECR was also achieved by the push of a button.

Close-up of wheelhouse console

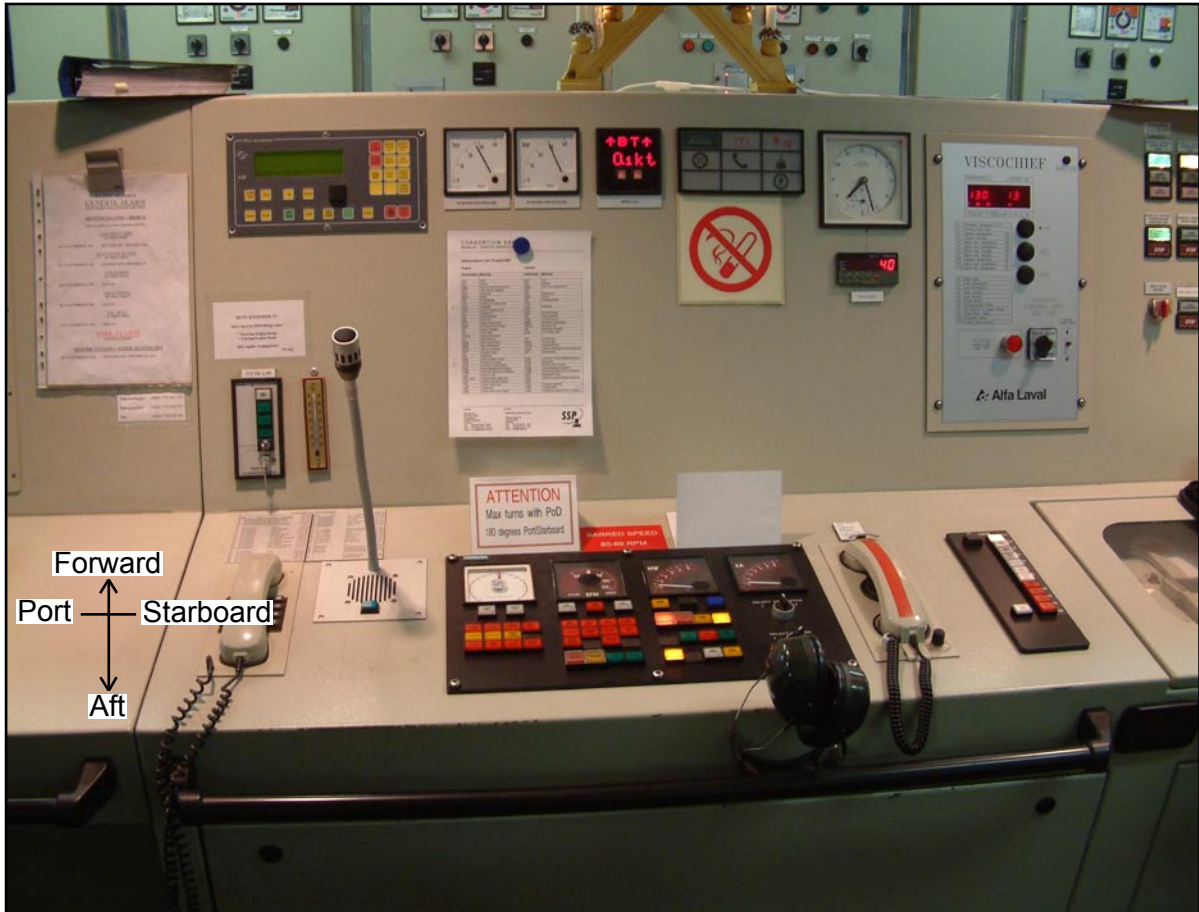
Figure 14a

The ECR pod control panel was similar to the wheelhouse panel but without the primary pod control lever system. The ECR display allowed the engineer to watch the azimuth movement of the pod and propeller revolutions, but there was no representation of pod control lever input, and therefore no way of checking that the pod was following bridge control commands (**Figures 14a and 14b**).

ECR control console.

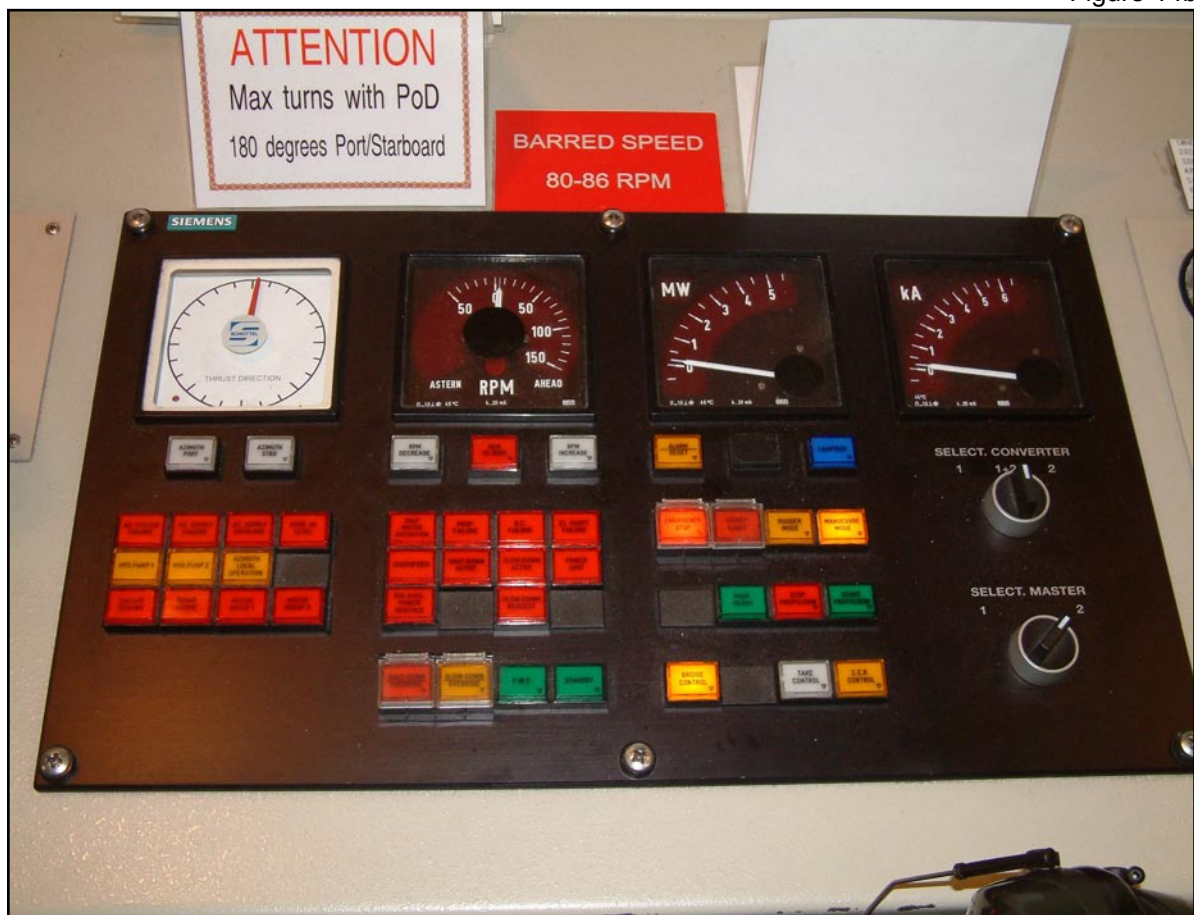
Figure 14b

ECR control console, close up showing pod controls.

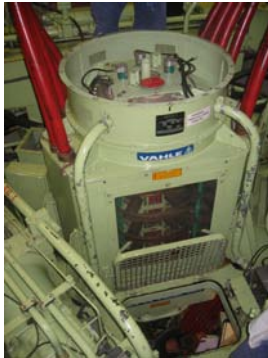
Assembly as original (cover taken off) above pod room deck.
