***Final report RM 2013:02e***

**Accident involving a Royal Norwegian Air Force aircraft of type C-130 with call sign *HAZE 01*, on 15 March 2012 at Kebnekaise, Norrbotten County, Sweden.**

Ref no M-04/12

22/10/2013

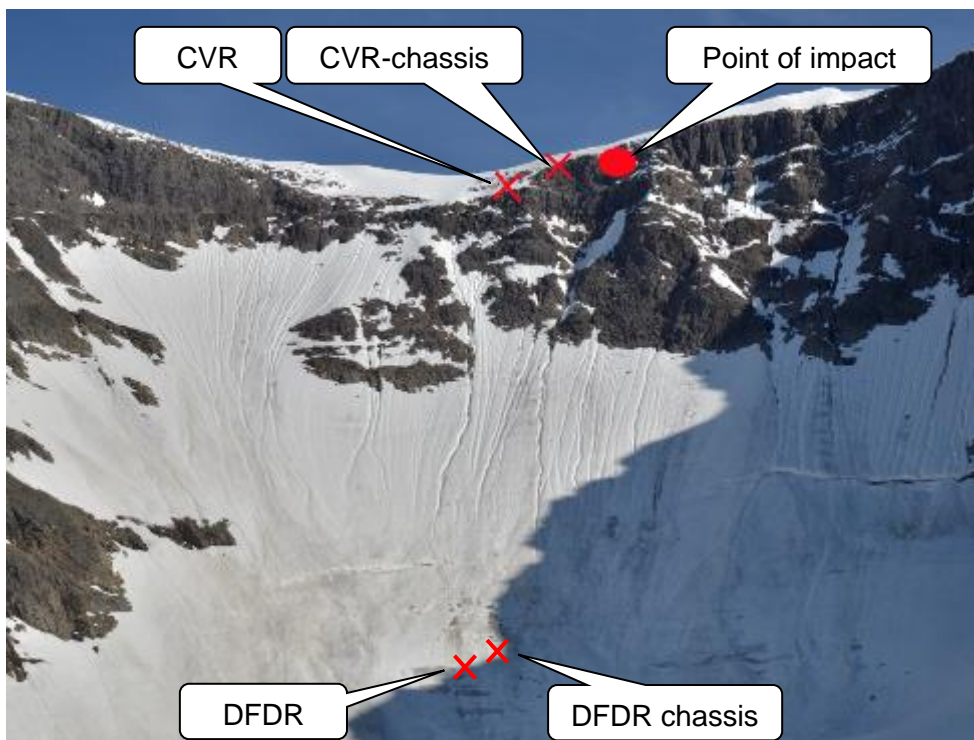
In August 2012, the *DFDR* and *CVR* were recovered from the site of the accident. The memory units had separated from their chassis – see fig. 22 – but still had their underwater transmitters.

Fig. 22. Sites where *DFDR* and *CVR* and their chassis were discovered. (Image SHK.)

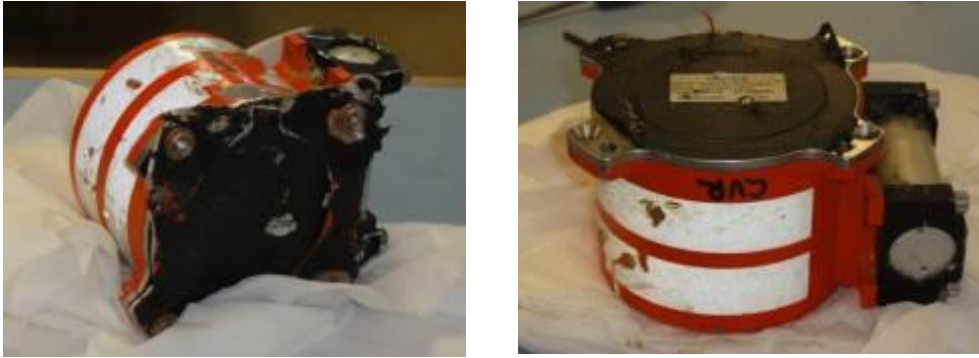
Fig. 23-24. The crash-protected memory units from DFDR and CVR. (Image SHK.)

The memory units' contact wiring had been torn away, but new wiring could be soldered and the units' binary data could be read.

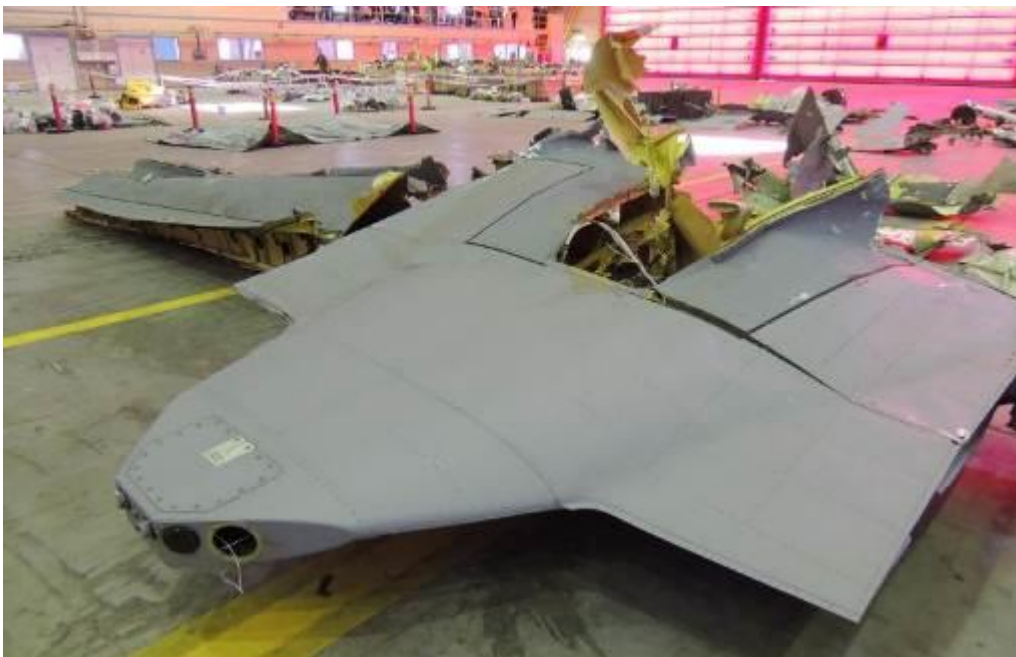
The great majority of the salvaged parts are very small parts of the wreckage. Parts of the tail section, the upper part of the tail fin and parts from the left side of the aircraft are some of the few larger parts of the wreckage seized, see fig. 30.

Fig. 30. Some of the larger parts of the wreckage in the hangar. Parts of the tail section in the foreground. (Photo: SHK.)

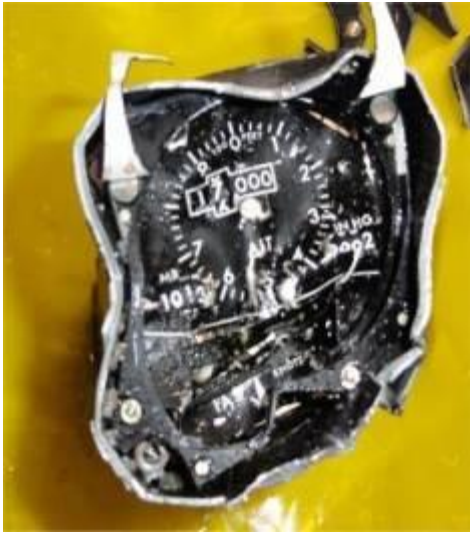
At the site of the accident, one standby instrument was found; a combined altimeter and airspeed indicator. The instrument was damaged, but the values for both altitude and airspeed could be read. The value for the altitude, with three fixed

zeros, was 17,000 feet STD. The value for the *Indicated Air Speed (IAS)* was around 220 knots – see figs. 35-36.

Fig. 35. Standby instrument for altitude and airspeed. (Photo: SHK)

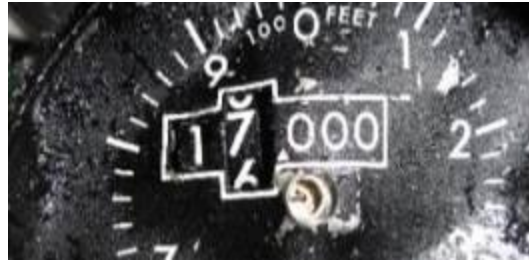
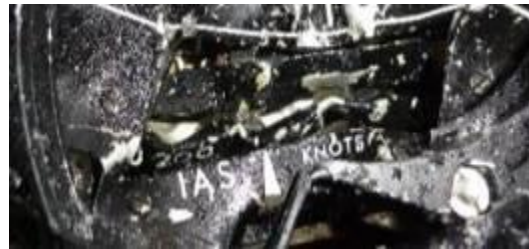
Fig. 36. Instrument values for altitude (in feet) and airspeed (IAS in knots). (Photo: SHK)

A more thorough examination of the instrument was prepared in order to ascertain whether the leftmost (ten thousand) digit of the indicated altitude may have been altered in connection with the collision. The point of collision is at an altitude that with the prevailing atmospheric pressure corresponds to 7,000 feet STD. This examination was however deemed unnecessary once the aircraft's CVR and DFDR were recovered.

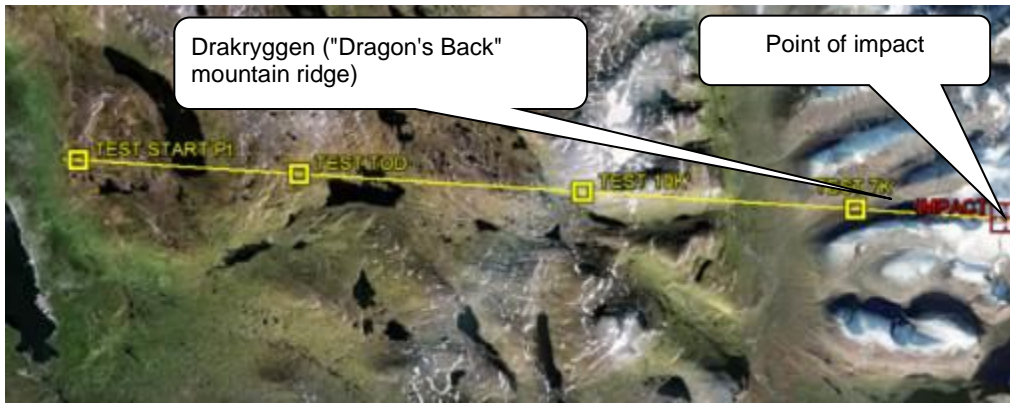
Fig. 37. Flight path for the reference flight.

This flight path was then used as a basis for the reference flights; see fig. 37 above. In order to follow this flight path during the reference flight, the following values were aimed for at the points noted in the figure.

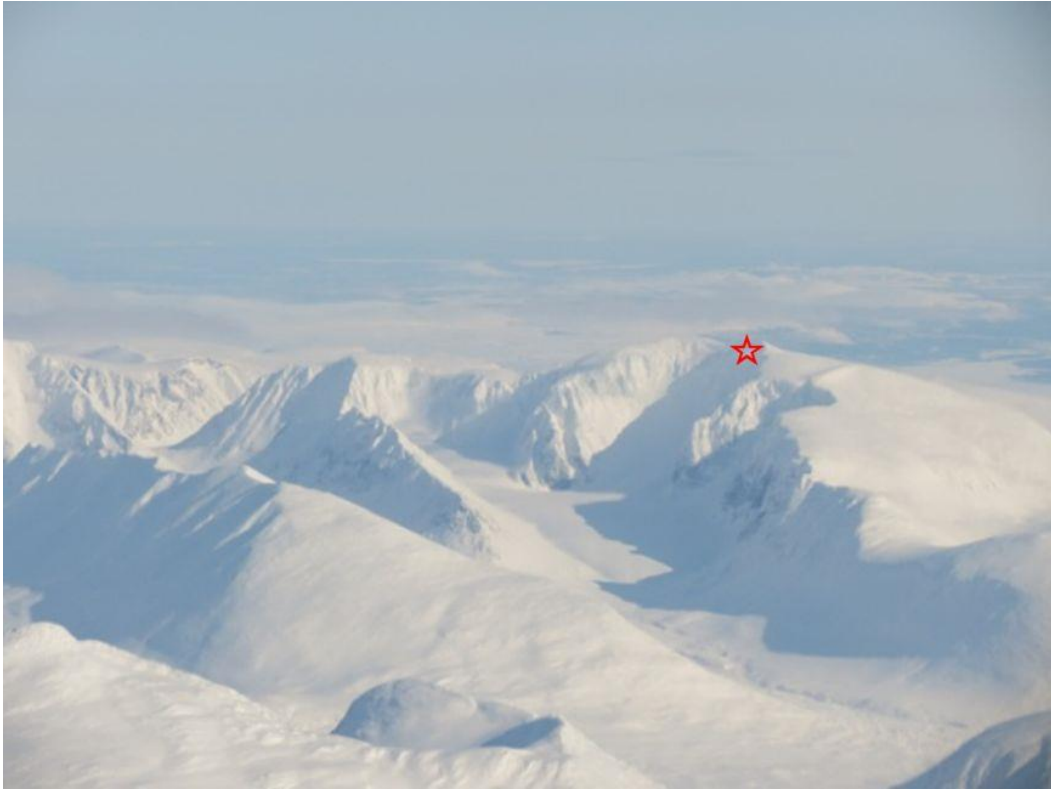
Fig. 38. View from the cockpit at the point TEST TOD during the reference flight (that is, in good visibility). Point of impact marked with a red star. (Photo: SHK)

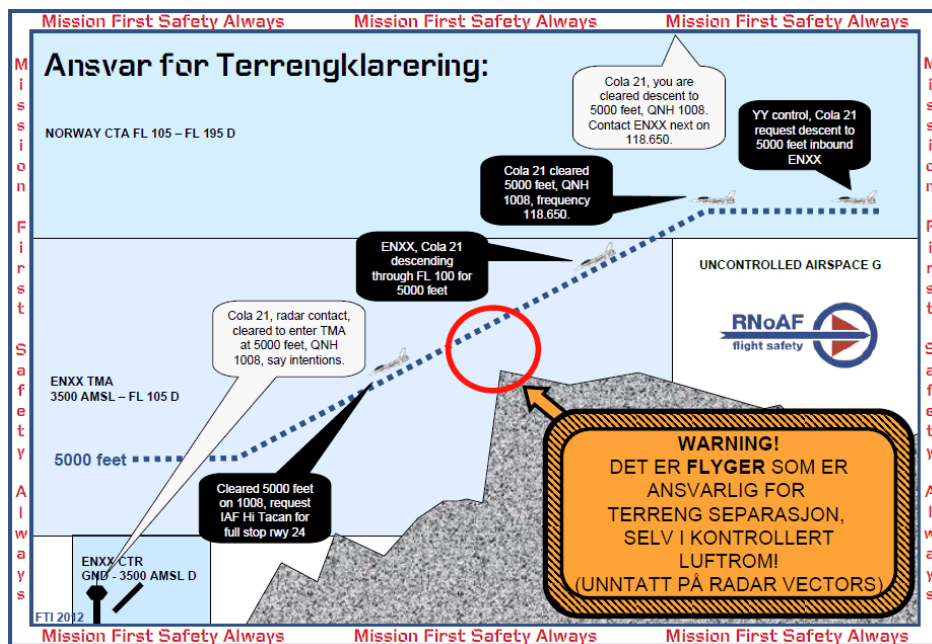
Fig. 42. FTI's Safety Poster sent to squadrons in May 2012. Title: Responsibility for terrain clearance. Bottom right: "Warning! The pilot is responsible for terrain separation in controlled airspace! (Except for radar vectors)".

- The crews of the Air Force's squadrons have been informed of the actual circumstances of the accident.
- Flytryggingssinspektoratet (FTI, the Norwegian Flight Safety Inspectorate), through its contacts in the flight squadrons, has emphasised pilots' responsibilities in relation to terrain separation and IFR flight in all types of airspace.
- All pilots of the 335 Squadron have had a thorough run through of the GCAS and TAWS systems to increase understanding of their function and limitations.
- The Air Force has obtained an updated terrain database for TAWS NORMAL MODE.
- Limitations in the use of GCAS/TAWS in TACTICAL mode have been introduced in the crew's checklists for the Norwegian C-130J-30.

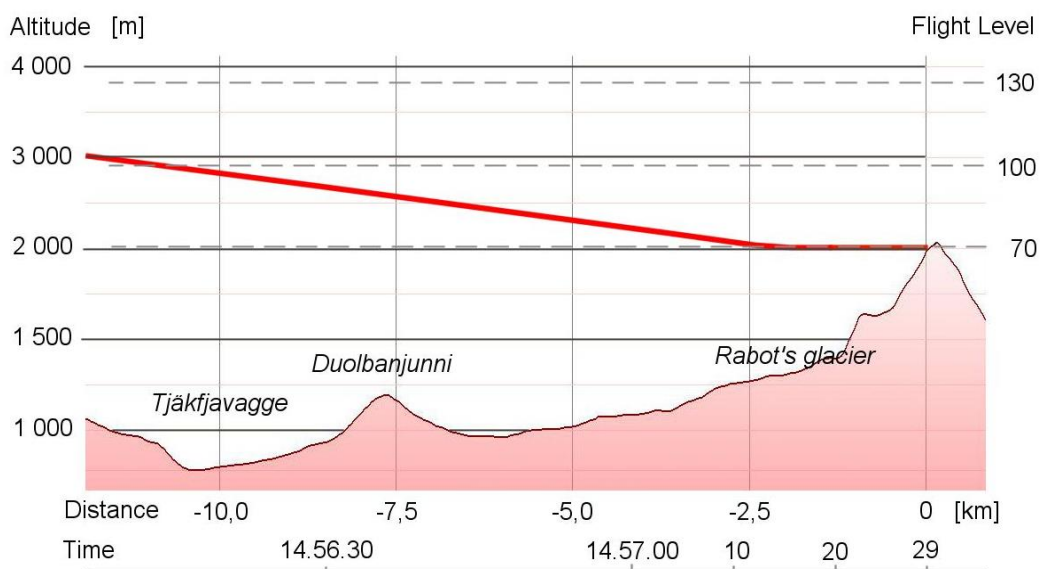
Studies of the terrain profile under the flight path, see Fig. 44, shows that the downward-looking function of GCAS had not been able to give any warning before the moment of collision as it was only in direct connection with the collision that the distance to the ground went below the set warning level of 200 ft. This is also confirmed by the reference flight, where no alert occurred even with the reference altitude set to 1,000 ft before the site of the accident and the ridge between the South and North Peaks was passed.

Studies of the terrain profile and the specifications of the GCAS/TAWS system suggest that the reference altitude would have had to be set to at least 1,500 feet in order to trigger a warning along the flight path in question that would facilitate evasive manoeuvres to avoid collision with the terrain.

Fig. 44. The terrain curve under the flight path, indicated with a red line. (Terrain profile retrieved from Google Earth.)

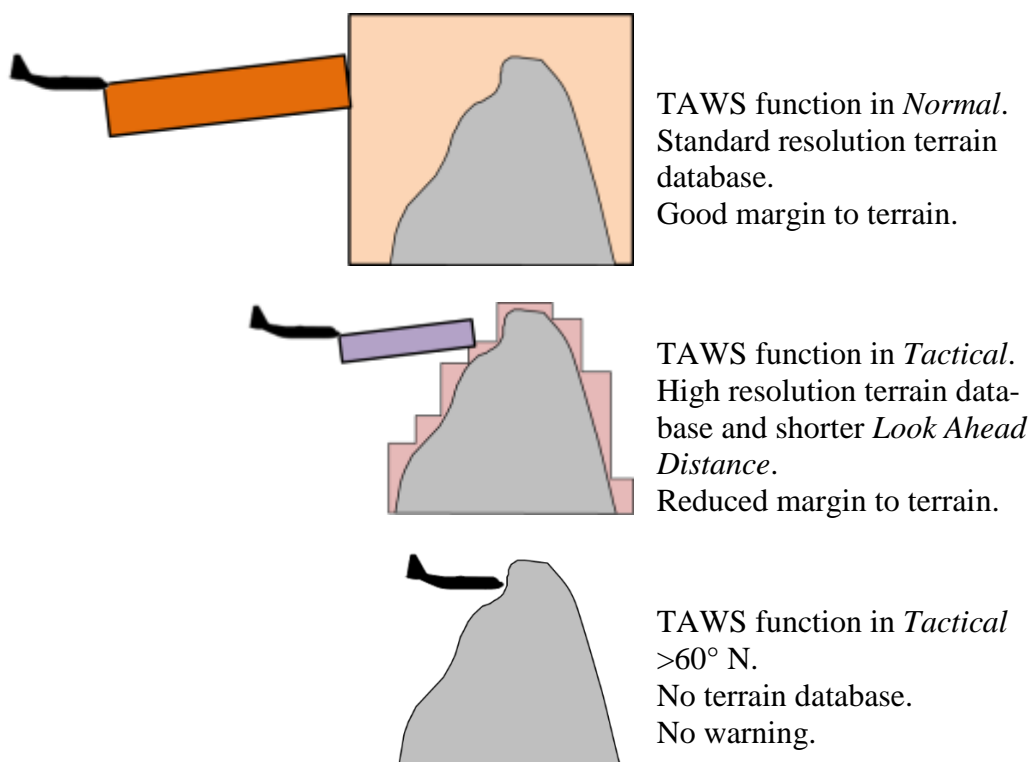
Fig. 45. Schematic of the aircraft's terrain warning function: Terrain database and distance for warning. (Caution: "TERRAIN AHEAD").

In relation to the schematic pictures in Figure 45, a comparison can be made between two different theoretical cases and the outcome of the flight in question.
