**Statens haverikommission**  
Swedish Accident Investigation Board

## ***Report RL 2010:12e***

**Aircraft incidents to SE-DZB in airspace  
near Malmö/Sturup airport, Skåne County,  
on 9 November 2008**

Case L-27/08

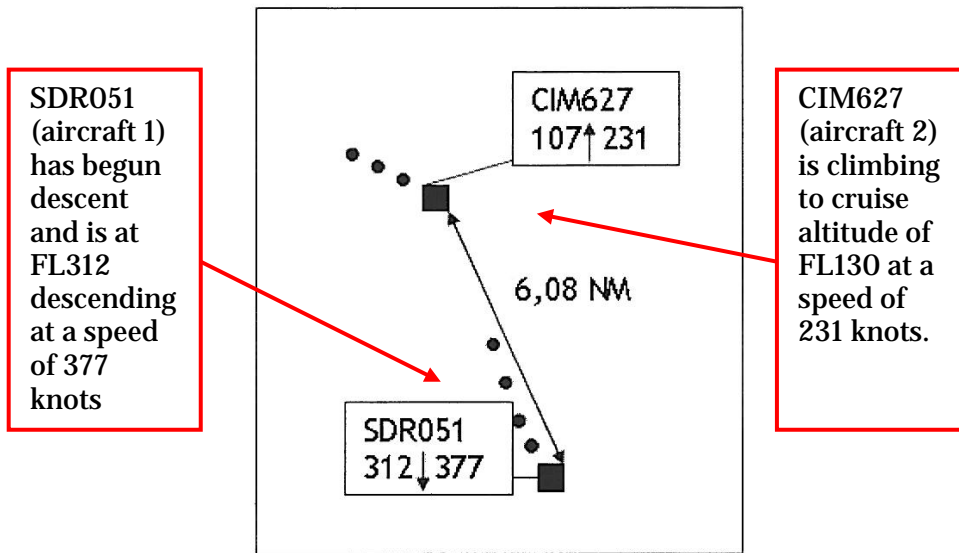
Fig. 1. Phase leading up to the sequence of events.

At this stage, aircraft 1 had commenced its descent. The air traffic controller experienced difficulty in communicating with the pilots. The aircraft requested radar vectors for a landing at Sturup. Clearance was given to FL150, but the air traffic controller was not sure whether this was sufficient and whether the aircraft would remain at that flight level.

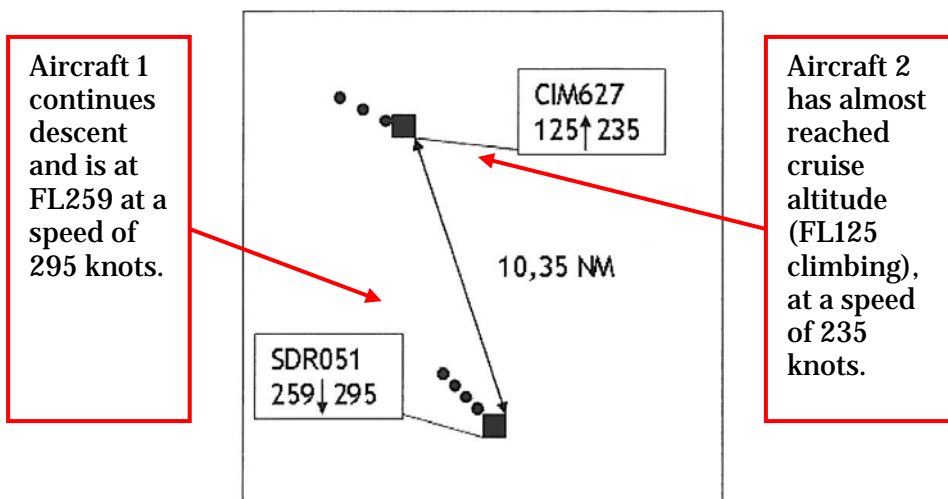
Fig. 2. Continued sequence of events.

Aircraft 1 was instructed to change frequency and contacted Malmö control for continued radar vectoring towards Sturup. At this stage 3.5 minutes had passed since the aircraft had declared an “emergency descent”.

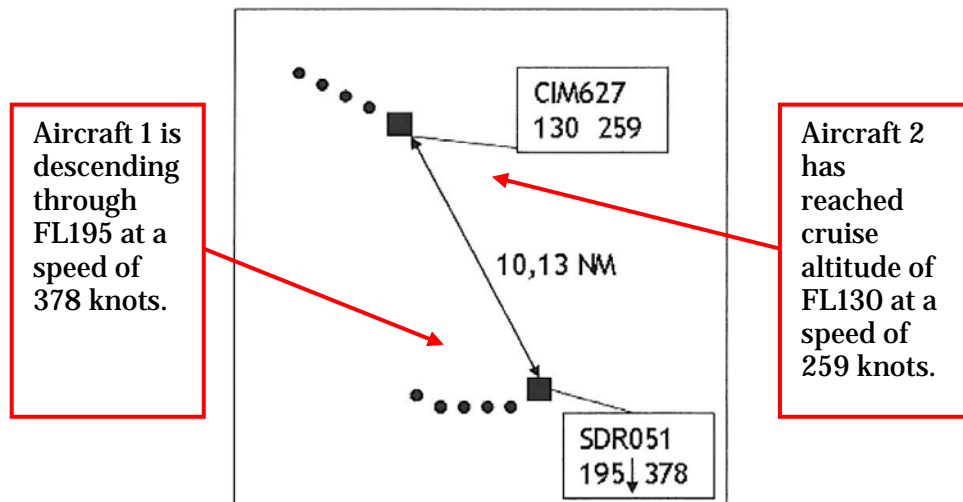
Fig. 3. Continued sequence of events.

Aircraft 1 was making a left turn towards the cleared heading of 340°. When the aircraft called up on the new frequency, it reported that it was making an emergency descent and intended to descend to FL100. The air traffic controller then instructed aircraft 1 to stop descending and stay at FL140 because of conflicting traffic. Aircraft 1 replied to this by asking the air traffic controller to confirm FL140. The air traffic controller confirmed the new altitude clearance but at the same time asked aircraft 2 to descend immediately to FL70.
