**Statens haverikommission**  
Swedish Accident Investigation Board

***Report RL 2010:15e***

**Accident to aircraft SE-LYK at Vinsta,  
Stockholm County, Sweden,  
on 8 August 2008**

Case L-20/08

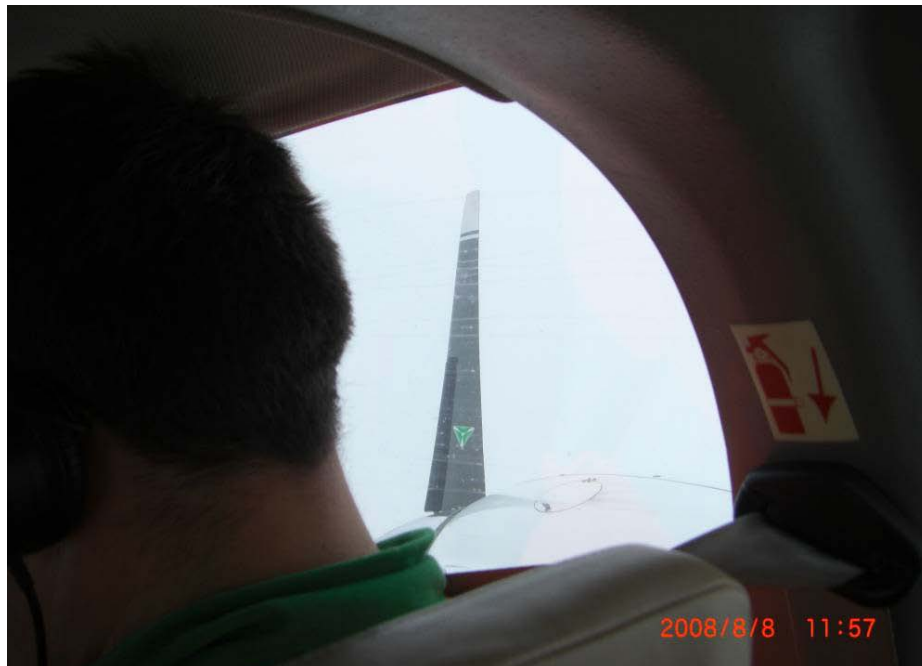
Figure 4. Photograph taken during the accident flight.

The photograph below, that was taken from inside the aircraft, shows that rain was present during the flight.
