Statens haverikommission
Swedish Accident Investigation Board

Report RL 2010:14e

**Aeroplane incident to OE-GVA on approach to
Stockholm/Bromma airport in Stockholm
County, Sweden on the 26th of November 2008**

Case L-28/08

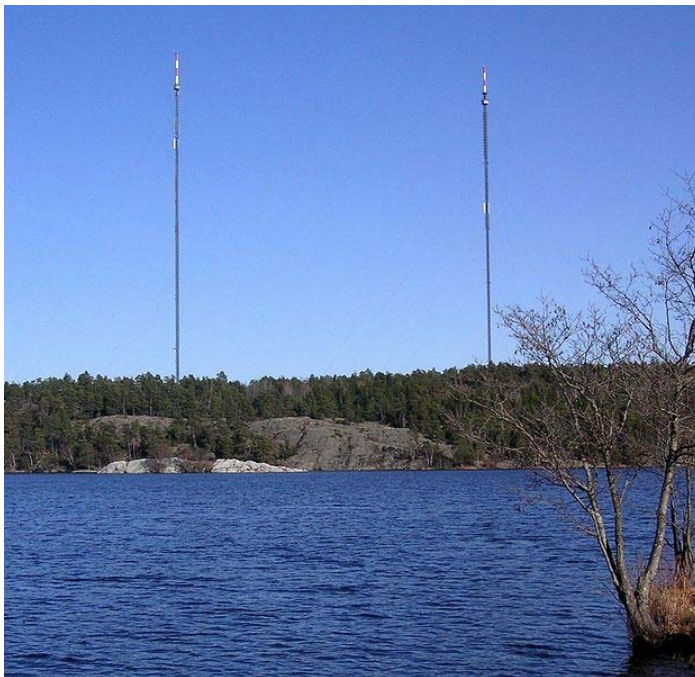
The radio/TV-broadcasting antennas, Fig. 1, are located in Nacka at position 59 17 46N, 18 10 34.9E. The height of the antennas are about 1 171 feet (about 357 m) above sea level and the lowest altitude of the aeroplane was about 650 feet (about 200 m). The minimum horizontal distance to the antennas was about 1.4 km.

Fig. 1. Radio/TV-broadcasting antennas in Nacka.

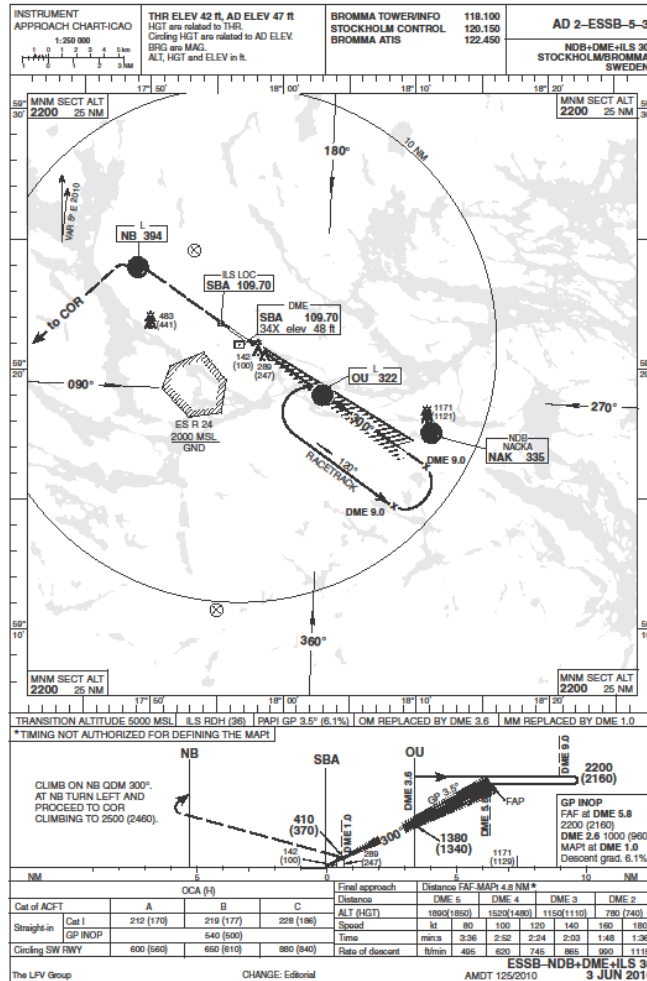
Fig. 4. Approach chart to runway 30 at Stockholm/Bromma airport. LFV IAIP.

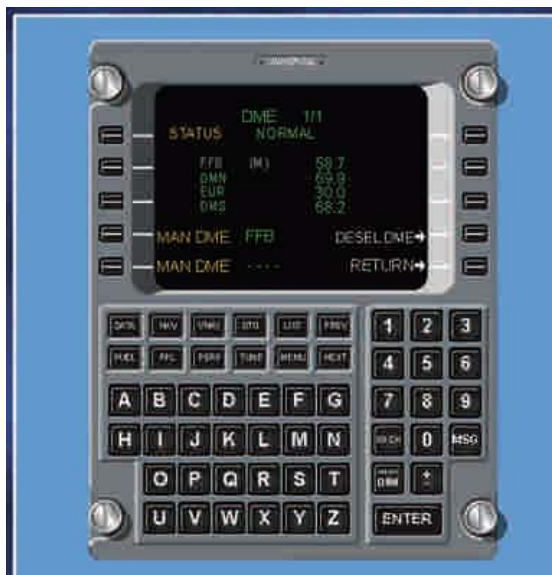
The aeroplane was equipped with two FMSs. The FMS are operated by two identical keyboards with integrated displays, Fig. 10, which are placed on the pedestal between the pilots, Fig. 12.

Fig. 10. FMS pilot interface.

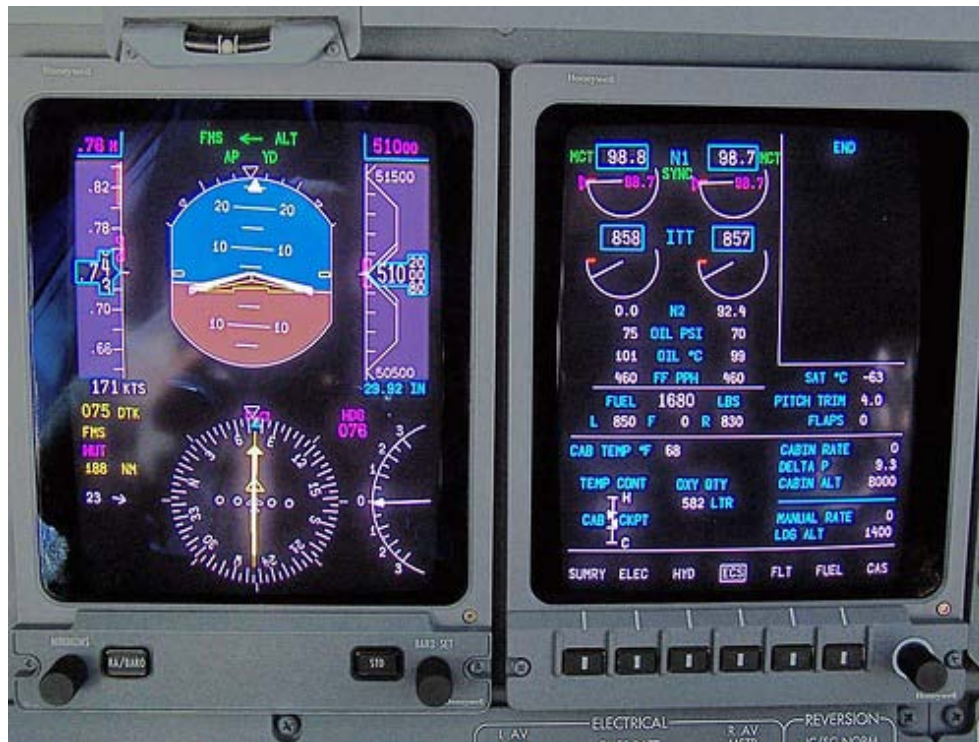
There are two large EFIS-colour screens on the instrument panel at each pilot position, the PFD³¹ and the MFD³², Fig. 11, and two smaller EICAS-screens in the mid part of the panel, Fig. 12. The PFD displays information about aeroplane attitude, heading, altitude, speed and vertical speed. Furthermore, navigational information, altimeter reference pressure, activated modes of autopilot and FMS, warnings and instructions of the automatic collision avoidance system, TCAS³³. The aeroplane was also equipped with GPWS, a system that basically warns the pilots if the aeroplane approaches the ground without being configured for landing. The warnings are displayed in the PFD together with a voice warning.

Fig. 11. The PFID is displayed to the left and the MFD to the right.

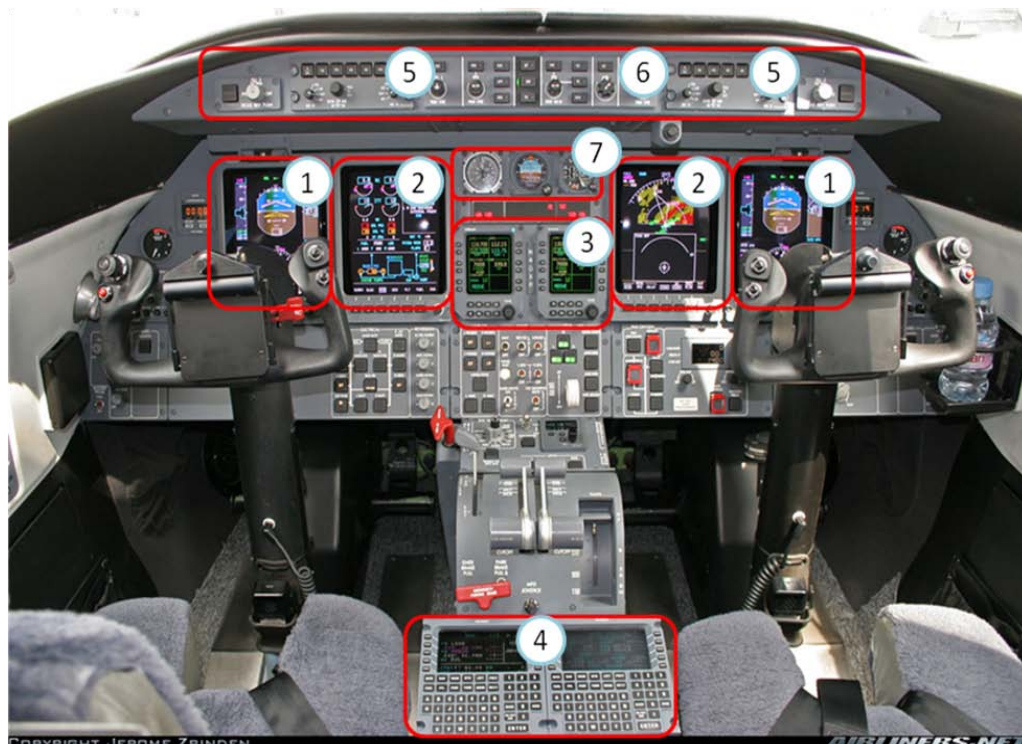
Fig. 12. The pilot positions in Learjet 40XR. The numbers indicate: 1 – PFID, 2 – MFD, 3 – EICAS, 4 – FMS, 5 – FD, 6 – autopilot, 7 – electromechanical emergency instruments.

The two EICAS-screens, Fig. 12, monitor the engine, electric, hydraulic and pressure cabin systems and replace the conventional electromechanical instruments. Some essential aeroplane systems can also be shown schematically on the EICAS-screens. Warnings of malfunctioning systems can also be shown in prioritized order. The EICAS information can be transferred to the MFD.
