Final report RL 2012: 10e

**Serious incident on 3 June 2010
to aircraft SE-DFY
at Tarbes Pyrénées Airport, France.**

Case no: L-63/10
2012-03-22

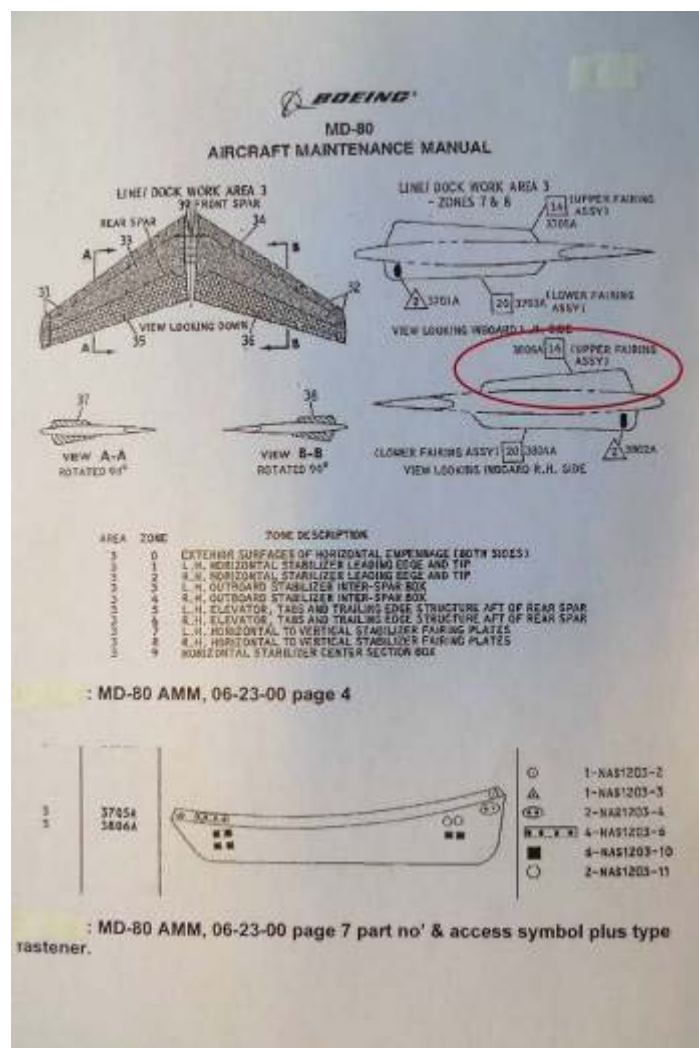
Fig. 3 Horizontal stabilizer – extract from AMM with identification of panel number 3806A

Panel number 3806A on the right upper side of the stabilizer, which was found next to the runway, was fitted with four screws NAS 1203 out of a total of sixteen intended (see fig. 1.). When the panel separated from the aircraft, one screw was pulled out of its anchor nut (fixed in one of four holes in mounting number two) and hit the elevator. In fastening number three there was two screws tightened, and here the nut part was pressed out of the fastening and stayed in the panel when it separated from the aircraft (see figure 2). The two rear screws on the panel were tightened and remained in place throughout the flight (see fig. 2.) The rear of the panel was broken off in front of these two screws. A clear fracture surface with plasticization was visible.

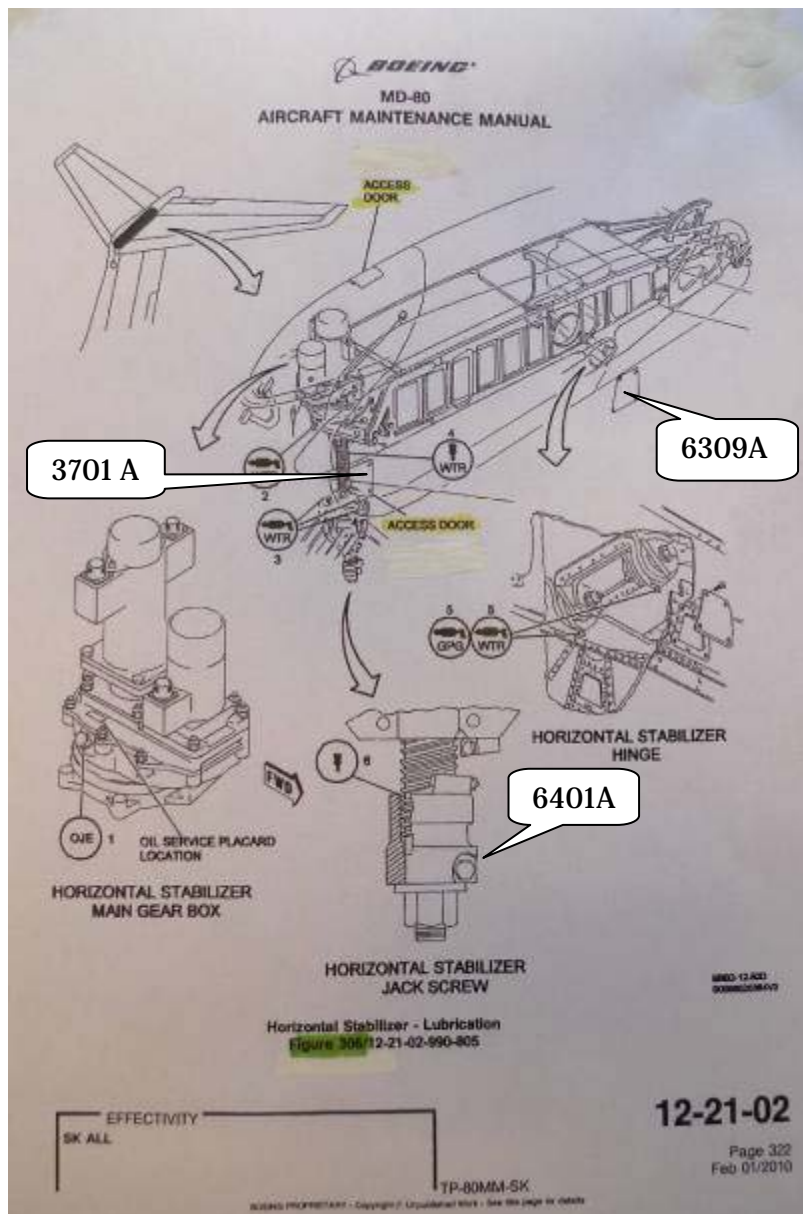
Fig. 4 Lubrication of the jack screw and removal of panel numbers 3701A and 6401A, see also fig. 6 for positioning of the panels

Access for lubricating of the jack screw and stop is gained by the removal of two panels. Fig. 4 shows the location and identification of the two panels on the aircraft vertical stabilizer; the top panel is number 3701A and the lower panel is number 6401A.

The panels with numbers 3705A and 3806A had been removed and later partially re-fitted to improve access to the spaces above the stabilizer jacks. In the technical log that was available for the time the aircraft was parked, there is no note of any maintenance work carried out on that part of the aircraft.

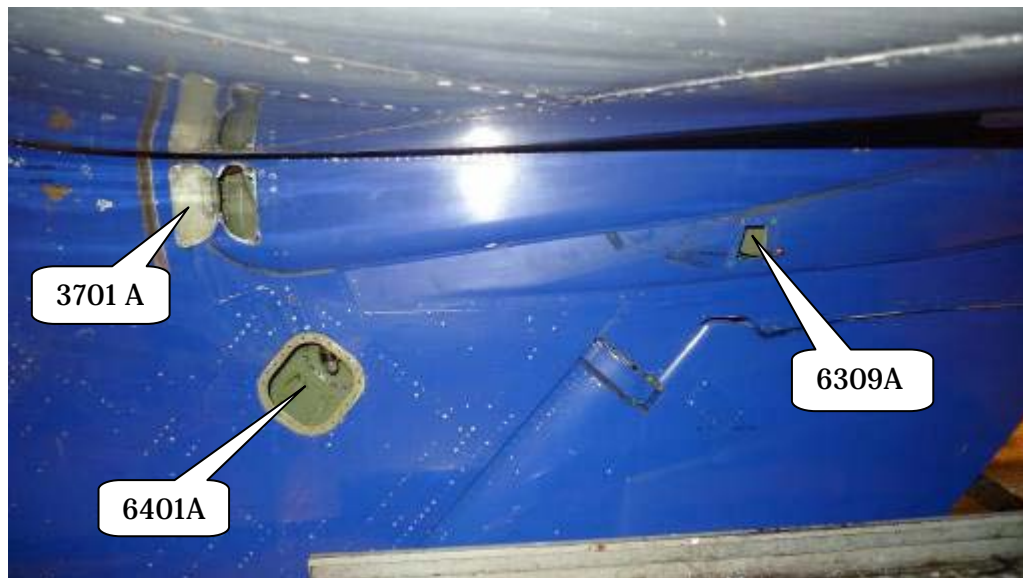
Fig. 6 Opened panels on the left side for lubrication of stabilizer jack screw and stabilizer hinges in accordance with Boeing MD-80 AMM

SHK has monitored on site the lubrication of the stabilizer in accordance with the Boeing MD-80 AMM 12-21-02, page 305 onwards, pos 7 Horizontal Stabilizer Lubrication. In all parts the work followed the AMM and access to lubrication points was via panel 6401A on the left side of the fin and panel 3701A on the left side of the panel 3703A (see also figs. 6 and 8). To access the stabilizer hinge, panel 6309A was opened (see fig. 9). In order to ensure the best accessibility and to visually check that the grease reaches the intended positions, the corresponding panels on the right side of the fin were removed. At SAS the work was carried out by two engineers, one injecting the grease and the other visually checking the grease penetration at each lubrication point.

There is no need to remove panels 3705A and 3806A (which separated during takeoff) above the stabilizer when using the work platform which SAS Technical Services had access to at Arlanda. The engineers who carried out the work said that these two panels are generally removed when the oil in the gearbox of the stabilizer jack screw needs to be changed.

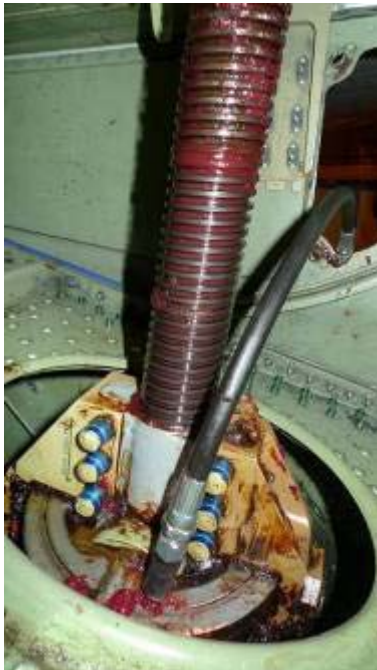
Fig. 7 Lubrication of stabilizer jack screw gimbal ring via panel 3701A

In fig. 7 the three points are lubricated and access to the grease nipples is good. When the panels are opened on either side of the work area, the procedure can be checked well.

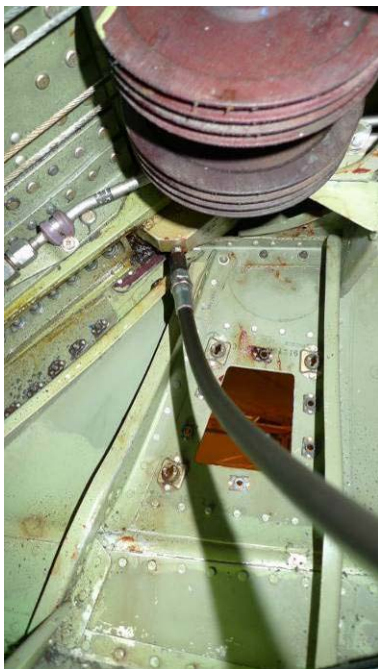
Fig. 9 Lubrication of stabilizer hinges via panel 6309A

When using tools recommended by the type certificate holder access was good for lubricating the points monitored by SHK. There was no immediate need to remove additional panels in order to implement those parts of the corrosion-preventive maintenance work which SAS had ordered, according to the work documentation that was available and which TARMAC had used as a signing list.

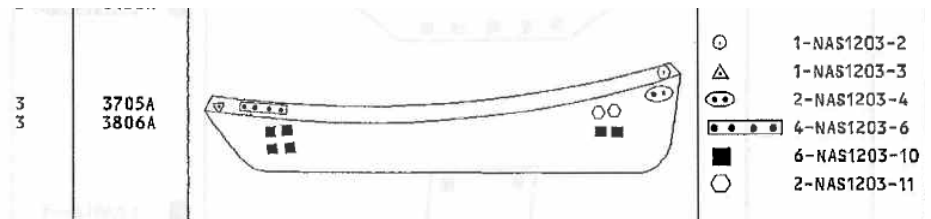
Figure 2: MD-80 AMM, 06-23-00 page 7 part no' & access symbol plus type fastener.

The screws in the horizontal surface NAS1203-6 were, in fact, just 2 in number and not 4 as shown in figure 2 taken from the AMM. Each fairing is individually drilled to match the holes / brackets on the aircraft and it is conceivable there are some differences.

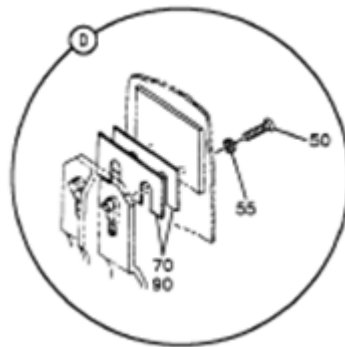
View D

IPC P/N NAS1203-4 L=0.526

Actual P/N ? L=0.630

NAS333CPA and NAS1203 bolts are similar in diameter, head size and strength. However, because the thread lengths are not identical, they are not directly interchangeable parts and not generally interchangeable without analysis of installation.

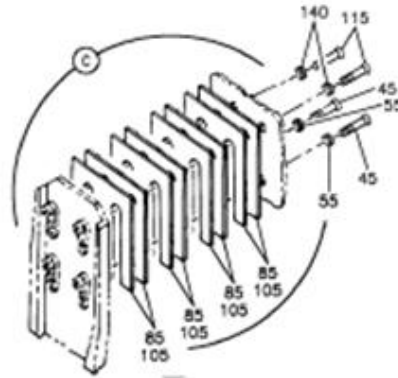
View C

Item 45, 2 each lower;
 IPC P/N NAS1203-11 L=0.964
 Actual fwd Missing
 Actual aft P/N NAS 333-12 L=1.299

Item 115, 2 each top;
 IPC P/N NAS1203-10 L=0.901
 Actual fwd P/N NAS333-13 L=1.417
 Actual aft P/N NAS333-12 L=1.299

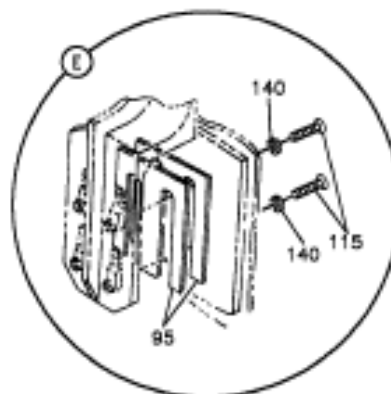
View E

Item 115, 4 each.
 IPC P/N NAS1203-10 L=0.901

Actual top fwd P/N NAS333-6 L=0.781
 Actual top aft P/N NAS333-? L=0.866
 Actual lower fwd P/N NAS333-6 L=0.81
 Actual lower aft Missing

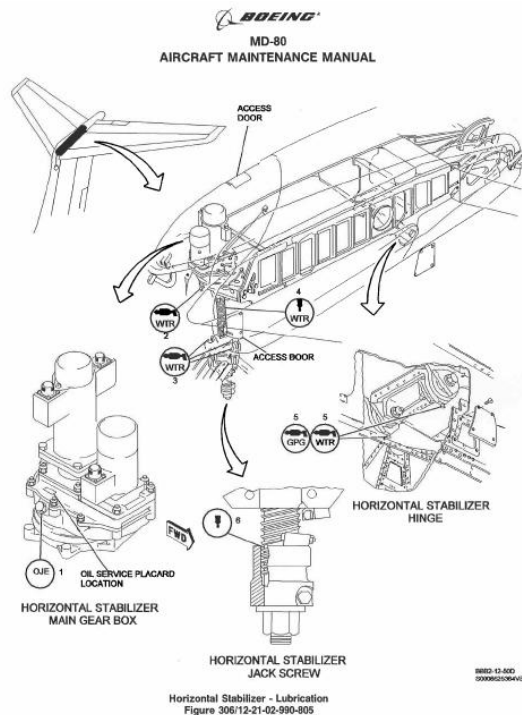
As part of the preservation procedure detailed in the MD-80 aircraft maintenance manual (AMM) the horizontal stabilizer should be lubricated and this includes lubrication of the jack screw stop. AMM 12-21-02 section 7 (see attachment 2) and described in the following figure.

The lubrication of the jack screw is done via two access doors as shown in the figure. Removal of the top cowling and /or removal or loosening of the fairings may conceivably make the lubrication task easier but that is not described. The preservation procedure is scheduled to be repeated every 90 days.

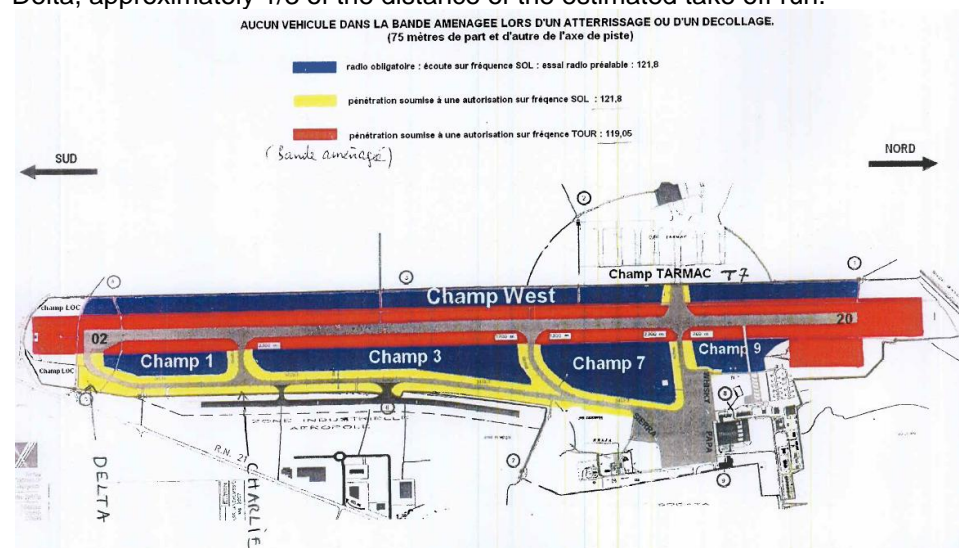
The RH upper fairing was found on runway 02, between taxi way Charlie & Delta, approximately 1/3 of the distance of the estimated take off run.
