Final report RL 2013:03e

**Serious incident involving the airplane
LN-RPS on 4 April 2012 in the airspace
east of Gävle, Gävleborg County, Sweden**

Ref no L-30/12
2013-01-25

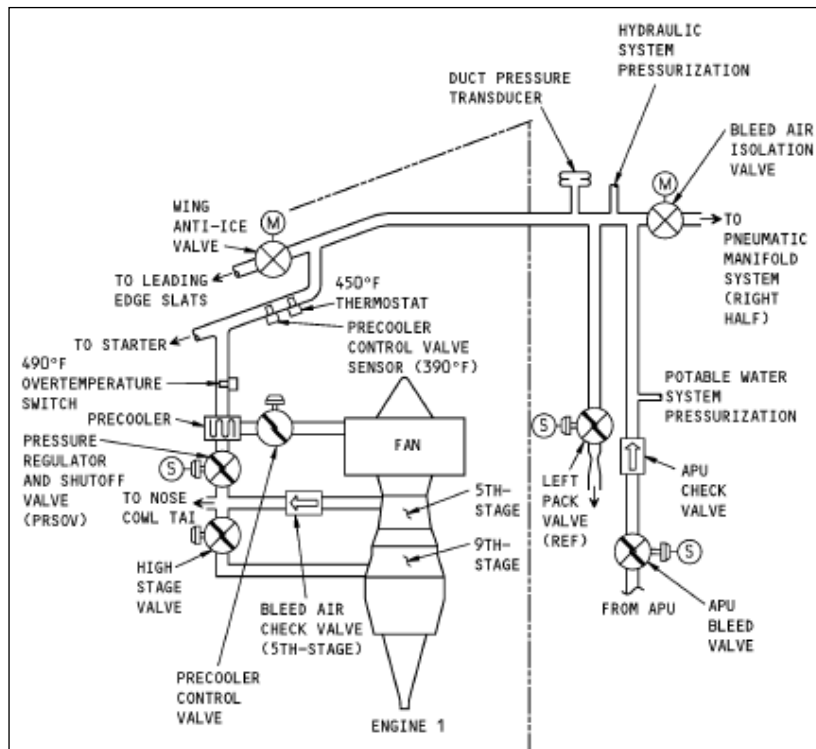
Fig. 1. Schematic of the Bleed Air System (left engine).

The technicians that commenced the fault isolation on the aircraft's systems established upon physical checks of the left engine components that the HSV¹⁶ was in a half-open position. It should have been closed. They also noted that the shaft for the control valve, PCCV, showed signs of extensive wear. Both of these units were replaced. For identification of units, see Figure 1.

Following a replaced components leak check during engine run, it was established that both left- and right-side systems were functioning without remark.
