Final report RL 2014:09e

Accident in Porjus, Norrbotten county on November 8, 2012 involving the helicopter SE-HOM of the model Bell 206B, operated by Fiskflyg AB.

File number L-125/12

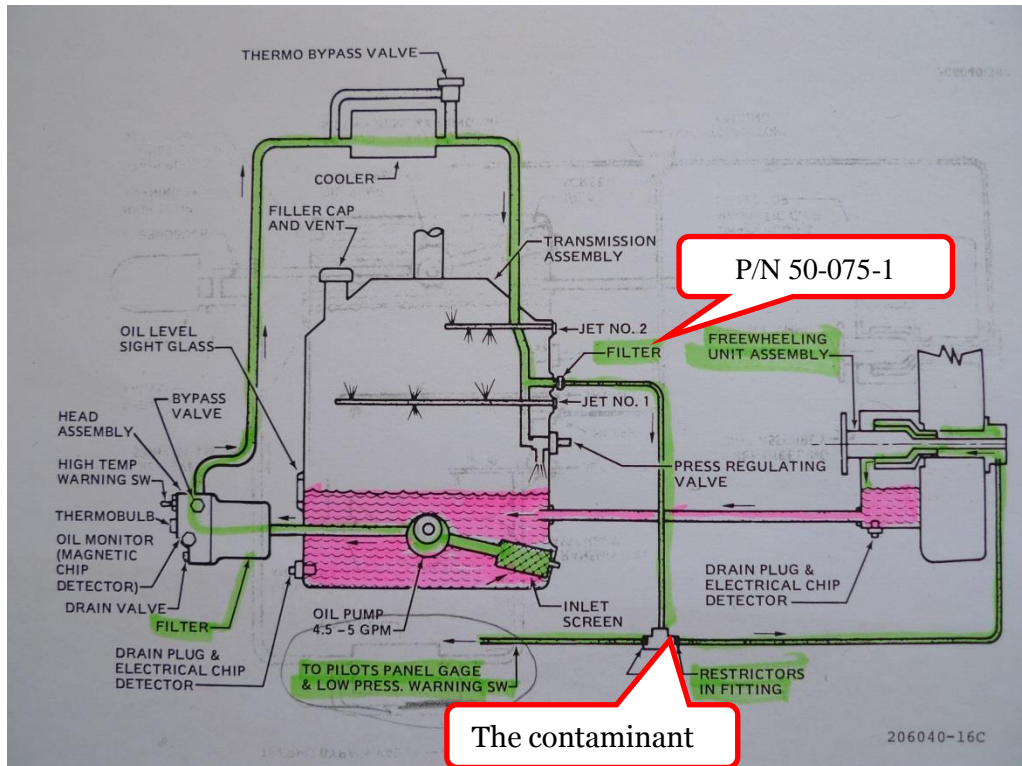
Fig. 8 Lubrication system main transmission and freewheel. The green colouring signifies pressurised oil and the pink colouring return oil. Normal oil pressure is between 2.1 and 3.5 bar. (Bell Maintenance & Overhaul Instructions).

The bottom of Figure 8, slightly to the right, shows “Restrictors in fitting”, where the flow out to the freewheel lubrication is limited by means of a restrictor whose orifice is 0.99-1.12 mm in diameter. At this restrictor, see also Figure 9, a contaminant was found.

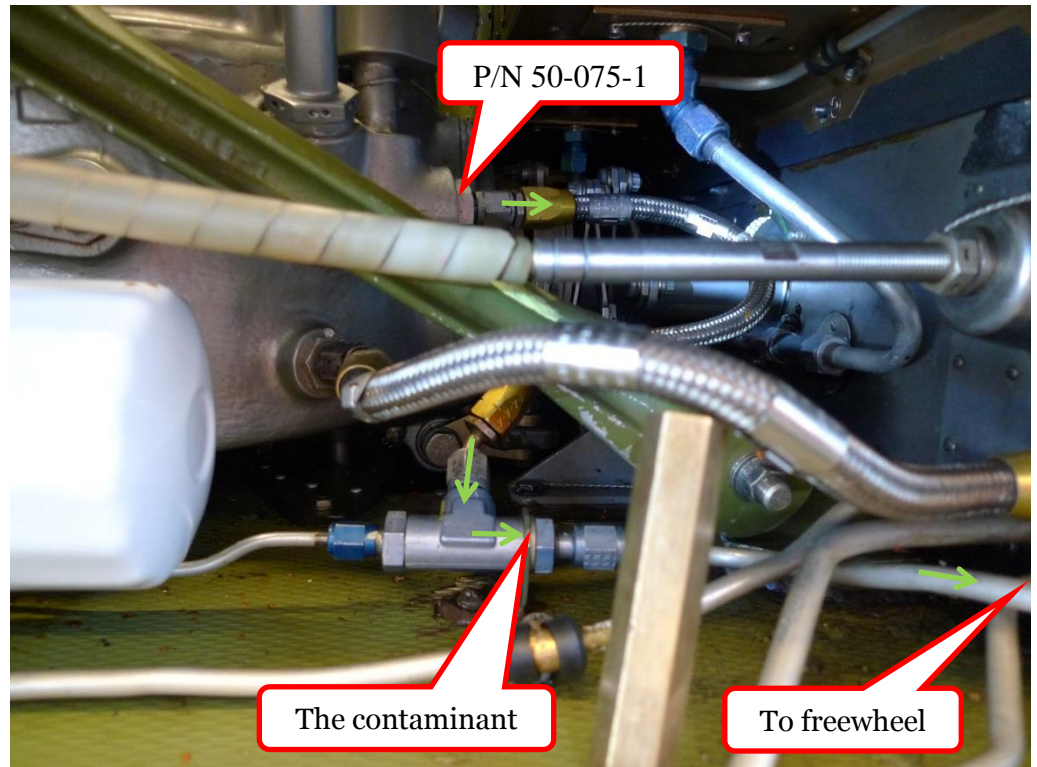
Fig. 9 Parts of the lubrication system to the freewheel.

By means of SEM⁶ and FTIR⁷ analysis, it has been possible to determine the origin of the contaminant. Comparisons with another sealant and paint debris from the main transmission show that the plug consists of sealant of type Pro Seal 890 Class B (AMS-S-8802, Class B, MIL-S-8802).

An analysis of the contaminant has shown that it consists of sealant material that has been used between the cover and the transmission housing.

Filter P/N 50-075-1 is mounted on the main transmission on the outgoing lubrication loop to the freewheel, see Figure 8. After the filter, but before the restrictor, the oil is led in a line that is about half a metre long, see Figure 9. According to the maintenance system, the filter and other parts are to be inspected every 1 500 operating hours.
