Statens haverikommission
Swedish Accident Investigation Board

Final Report RL 2011:10e

**Serious incident to Aircraft LN-KKD
at Arlanda airport, Stockholm County,
Sweden on December 20, 2009**

Case L-22/09

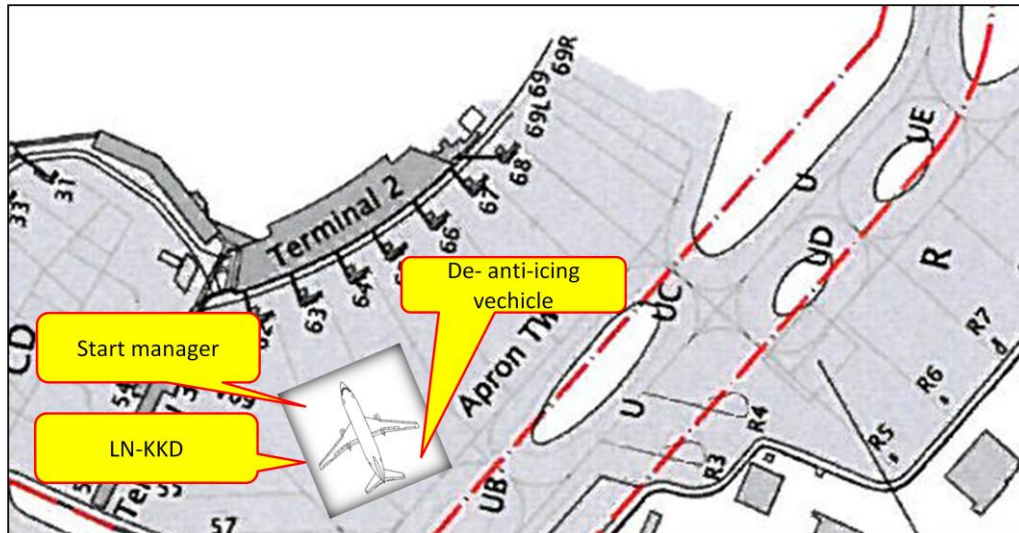
On Apron D at Terminal 2, outside gate 63, at 59 38 42N 017 55 33E, 31 m above sea level, see Fig. 2.

Figure 2. Magnified part of the Arlanda airport map of LFV AIP Sweden showing the positions of the airplane, de-icing vehicle and ground staff at the incident.

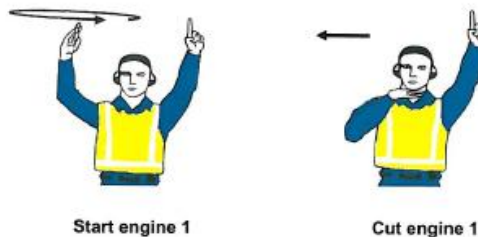
Nordic Aero AB provided specific education and training for staff who served on the ground outside the airplane at departure and arrival. The training material described hand signals that should be used in different situations. For example, signals for connection and disconnection of ground power were shown, Fig. 6, and for engine start, Fig. 7.

Fig. 7. Hand signals for starting and stopping of engines in the Nordic Aero AB's training materials.

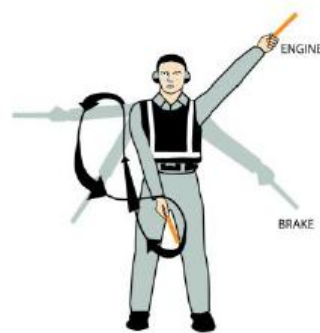
SHK notes that in the regulations of the Swedish Transport Agency and general advice on the rules of the air, TSFS 2010:145, Appendix 5, paragraph 21. Fire, hand signals for fire are established, Figure 9. The regulation came into force on 1 November 2010.

Fig. 9. Hand signals for fire. (TSFS 2020:145, Appendix 4, paragraph 21).
