# Ambulance Helicopter Accident in Åland on February 12, 2022

L2022-01

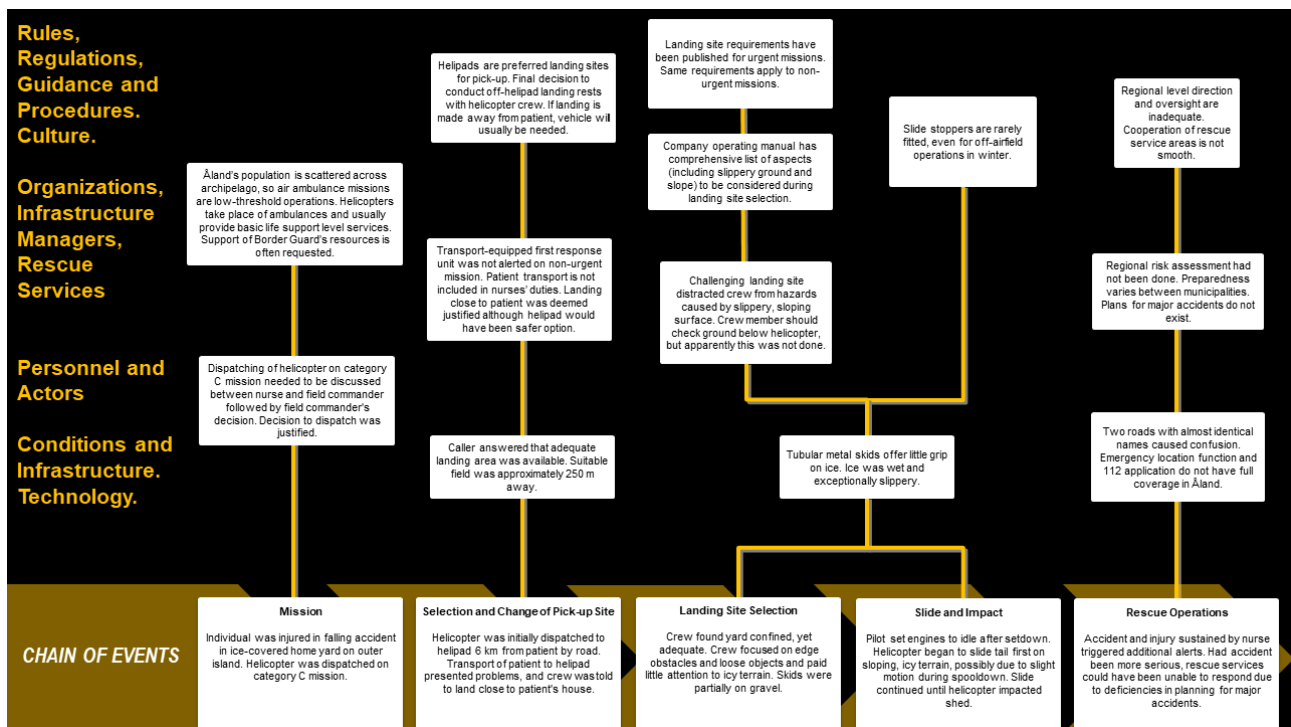
A SIAF-developed format of the AcciMap approach<sup>22</sup> was used to support the analysis of the occurrence. The following text is arranged in accordance with an AcciMap diagram created during the investigation and shown below. The occurrence is depicted as a chain of events along the bottom of the diagram. Contributing factors at various levels can be examined by moving up and down the diagram.

Kuva 14. AcciMap diagram, investigation L2022-01. (Photo: SIAF)
