Final report RL 2016:10e

**Accident at LövnäsvalLEN, Dalarna county,
on 06/02/2016 involving the helicopter
SE-JLZ of the model EC 120B, operated
by Jämtlandsflyg**

File no. L-17/16

30/11/2016

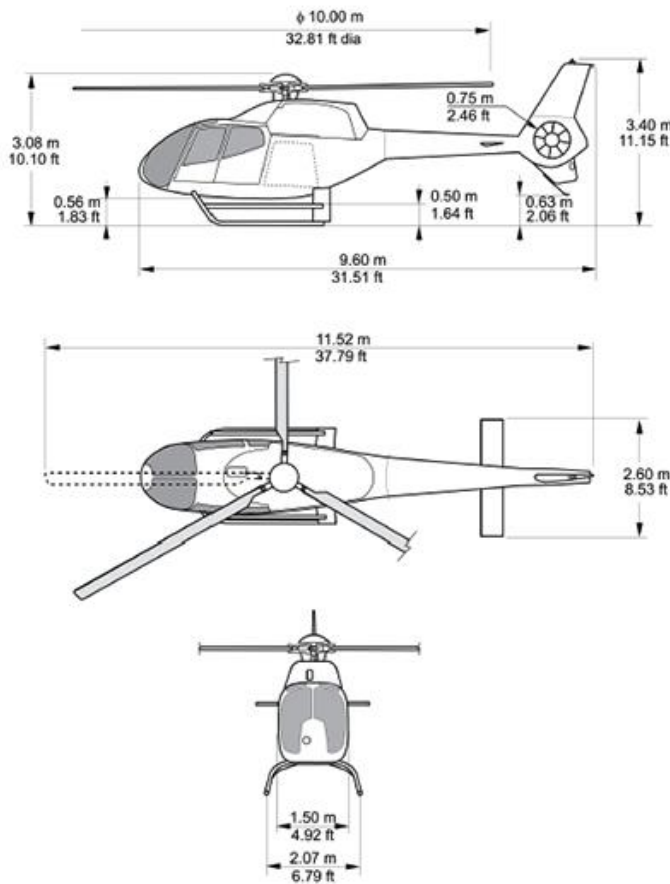
The helicopter has a rotor diameter of 10 metres (see Figure 4). This means that the minimum distance from rotor centre to an obstacle may be $5+3 = 8$ metres.

Figure 4. EC 120 Dimensions. Source: Airbus Helicopters, Inc.

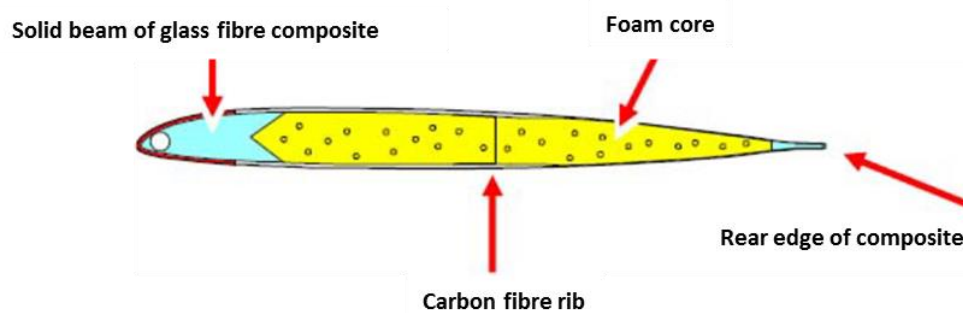
The rotor blades are designed with a robust metal-clad beam of glass fibre composite in the front part that is resilient to the effect of high-energy collisions. The beam is an important part of the rotor blades since it transfers all rotational force from the blade tip to the blade root. The beam is also protected by a blade front edge of metal that transfers the impact energy to surrounding areas of the beam. The rear part of the rotor blades are more susceptible to the effect as it is built up of a lighter composite material with a core of filler material in the form of a foam (see Figure 5).

Figure 5. Design of a rotor blade. Source: Airbus Helicopters, Inc.
