Final Report RL 2017:04e

**Accident at Ängsö, Västmanland County,
on 22 January 2016 involving the
aeroplane SE-LVR of the model Diamond
DA42, operated by Airways
Flygutbildning Svenska AB.**

Reference no. L-06/16

21 March 2017

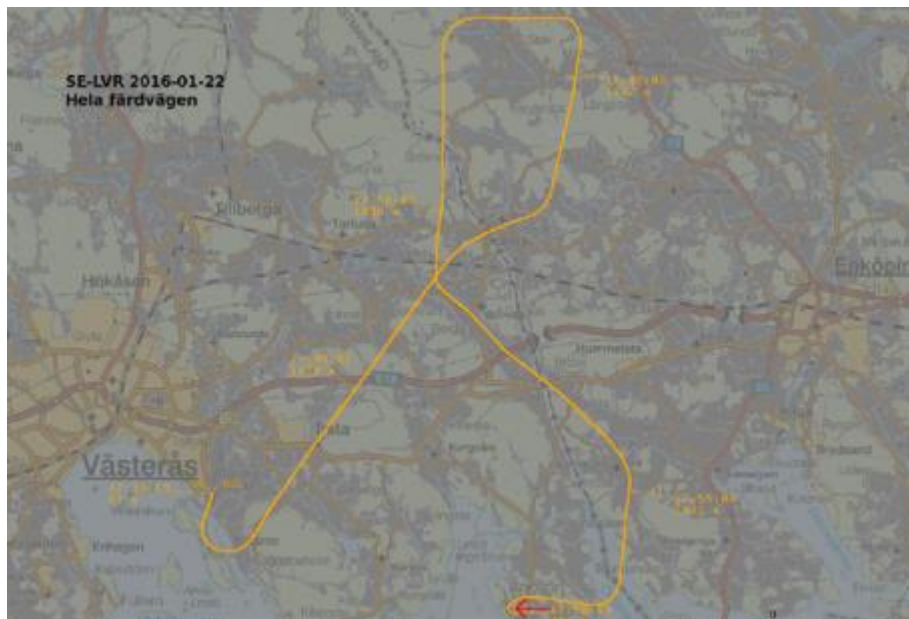
Figure 2. Map of the area with a radar track showing the aeroplane's flightpath. Source: Swedish Armed Forces.

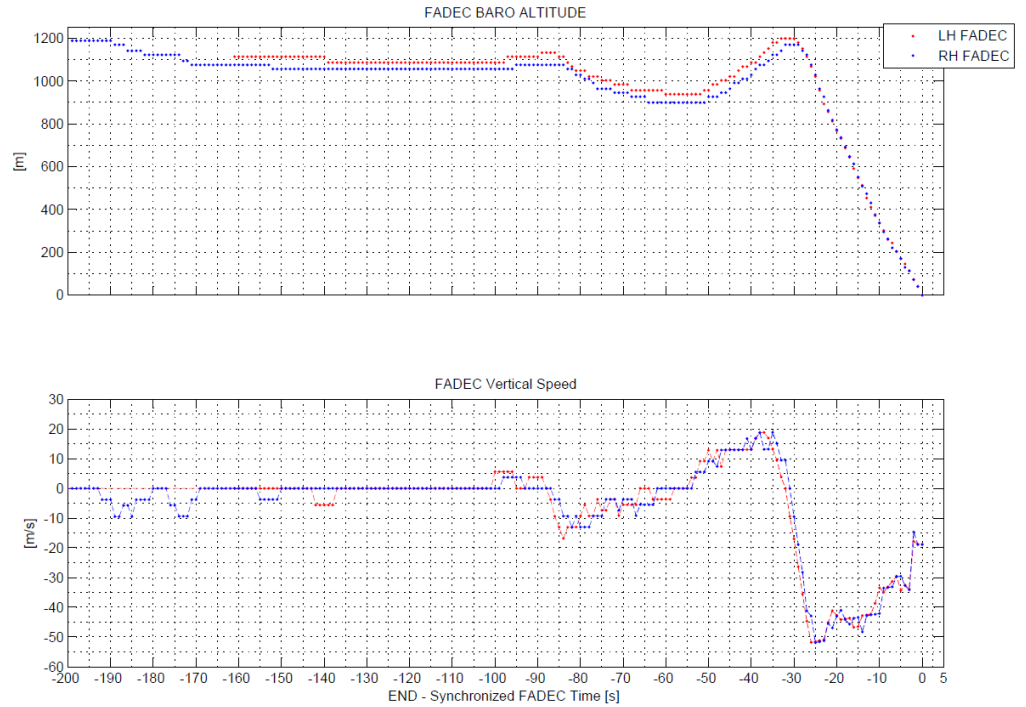
Figure 5. Graphic showing data from the FADECs pertaining to altitude and rate of descent.

As earlier stated, see the graphic in Figure 5, the rate of descent was approx. 52 m/s (approx. 10,236 ft/min) during the initial phase of the spin. The diagram also shows that there was a gradual reduction in the rate of descent, which can be estimated at 19 m/s (approx. 3 700 ft/min) at the time of the impact with the first trees. For details of these calculations, please refer to Appendix 1 to the report.

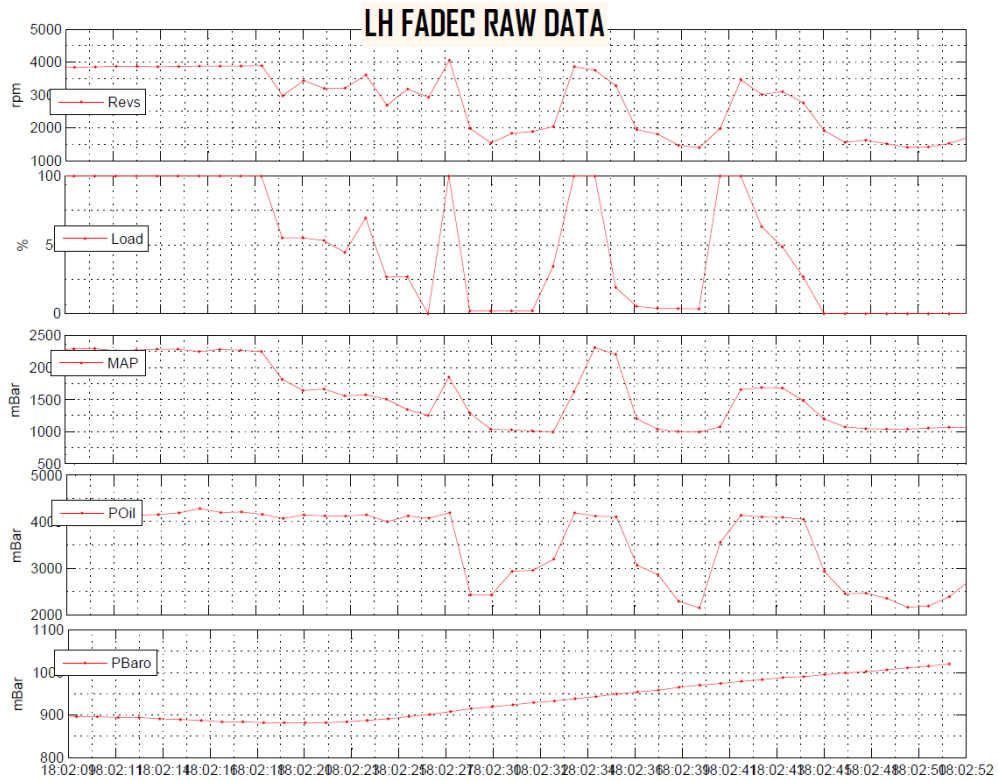
Figure 6. Graphic showing engine data covering the last 60 seconds from the FADEC on the left engine.

According to data from the FADECs, the engine power varied during the just over 30-second-long sequence of events. The parameters that have been analysed can be seen in the graphic in Figures 6 and 7.

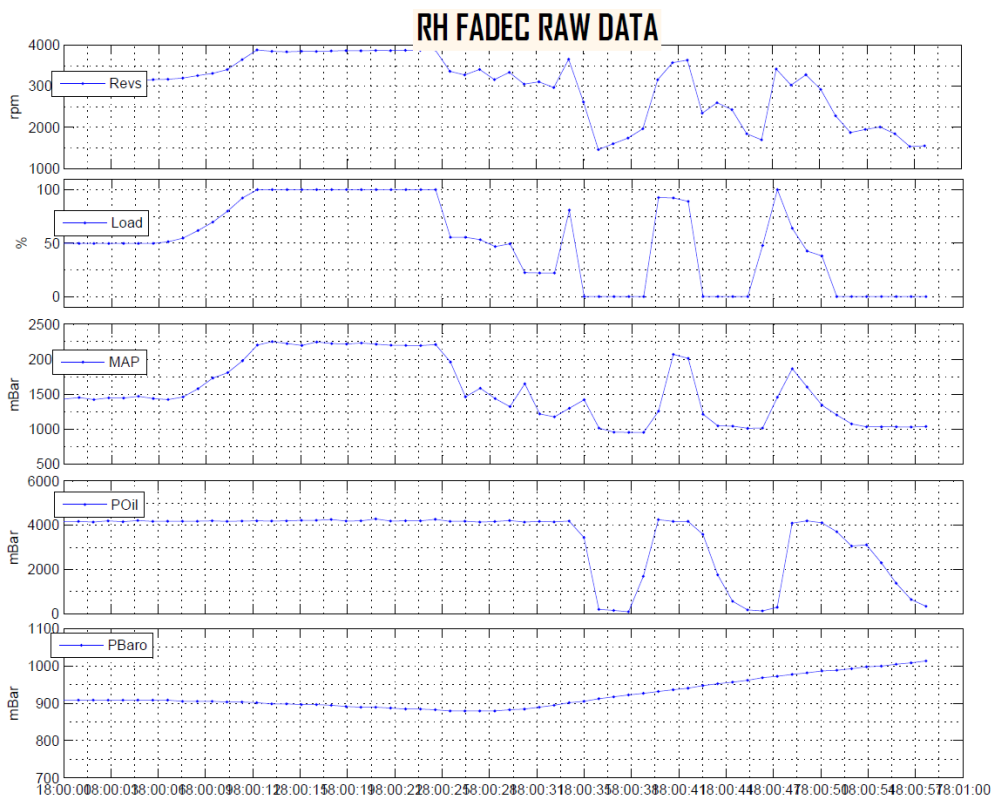
Figure 7. Graphic showing engine data covering the last 60 seconds from the FADEC on the right engine.

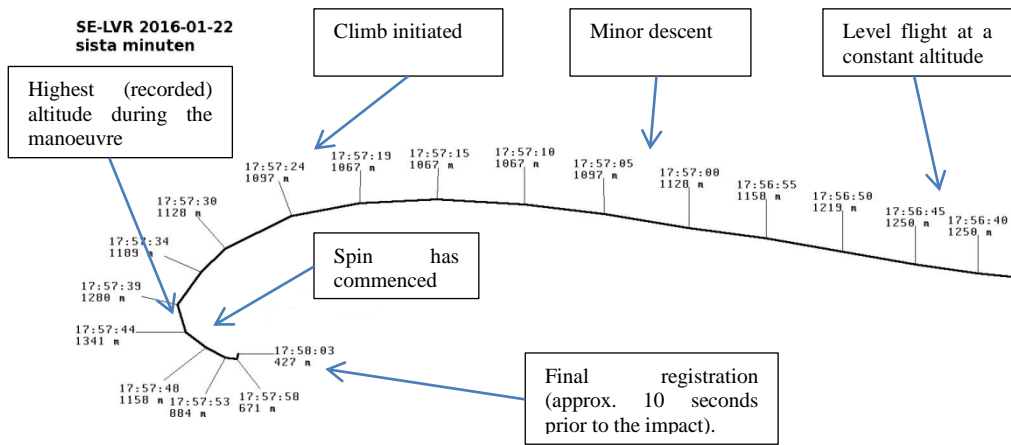
This information is based on radar images with a 5 second sampling time between each pulse. It is therefore not possible to establish the exact time – or altitude – at which the demonstrated manoeuvre “topped” and the aeroplane entered the uncontrolled spin.

Figure 8. Graphic based on radar data from the Swedish Armed Forces.

The graphic in Figure 8 can be interpreted as indicating that the aeroplane has largely remained at a constant altitude and has then initiated a minor descent. A climb has then started in order to accomplish the previously described manoeuvre involving the stall demonstration manoeuvre.

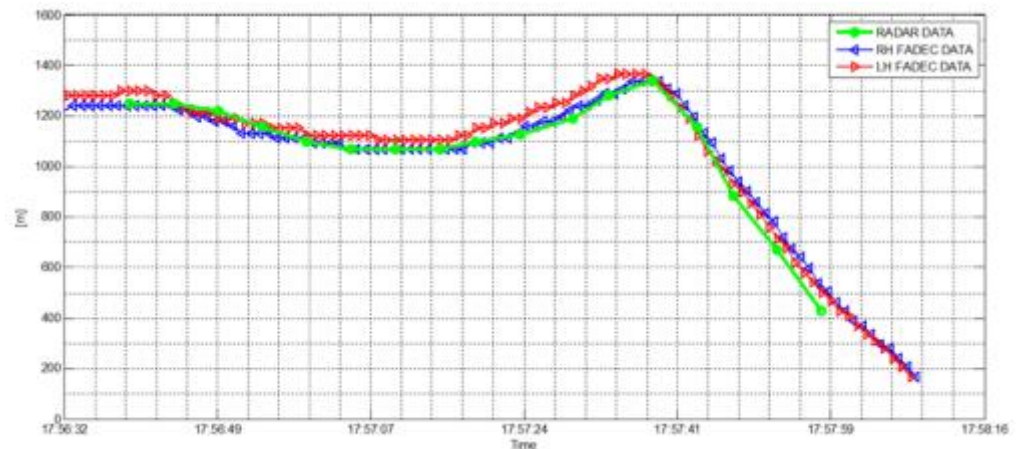
established that demonstrates with a high degree of probability the aeroplane's vertical movements during the sequence of events, see Figure 15.

Figure 15. Combined data from radar and right and left FADEC respectively.
