Final Report RS 2014:01e

Serious accident at sea on 15 October 2012 involving the vessel Liva Greta at Nockeby Bridge in the County of Stockholm, Sweden.

Diary No: S-165/12
2014-03-12

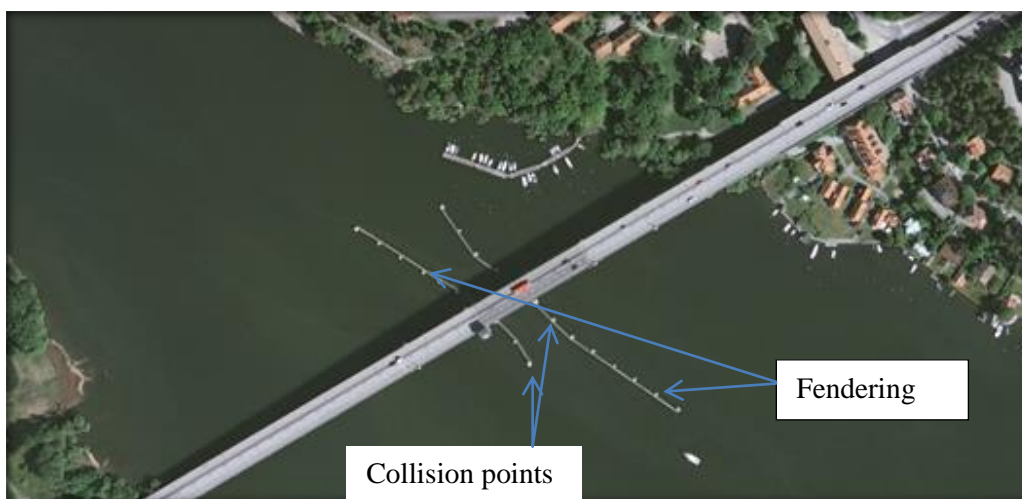
At Nockeby Bridge, extensive maintenance work was in progress on the fendering at the bridge (see Fig. 2). Any changes in navigation channels are to be reported to the Swedish Maritime Administration (Sjöfartsverket), which

Fig 2. General view, the scene of the collision taken at a point in time when the fendering was in position. Photo: © Lantmäteriet Diary No: R61749_130002

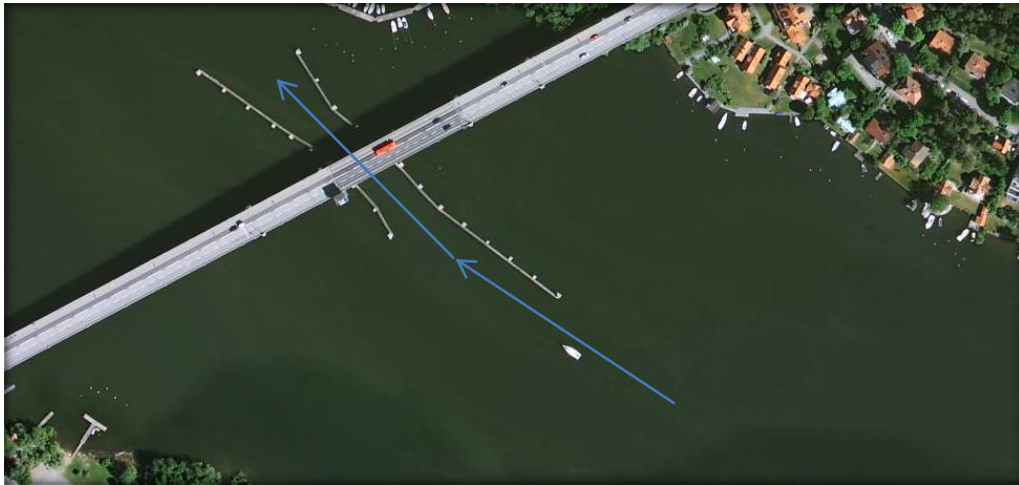
On those occasions when, for example, an adjustment in course needs to be made before entering a narrow section of channel, such as under a bridge, where the fairway and the bridge crossing require different courses, it is an advantage if the vessel has finished turning and is on a steady course in as good time as possible before the beginning of the narrow section. This technique can be referred to as “opening the bridge hole” (see Fig. 7).

Fig.7. Nockeby Bridge viewed from above. The arrows on the photo illustrate the required change in course for the purpose of “opening the bridge hole” and thereby acquiring the largest width of channel or fairway for the vessel as it crosses under the bridge. Photo: © Lantmäteriet Diary No. R61749_130002.

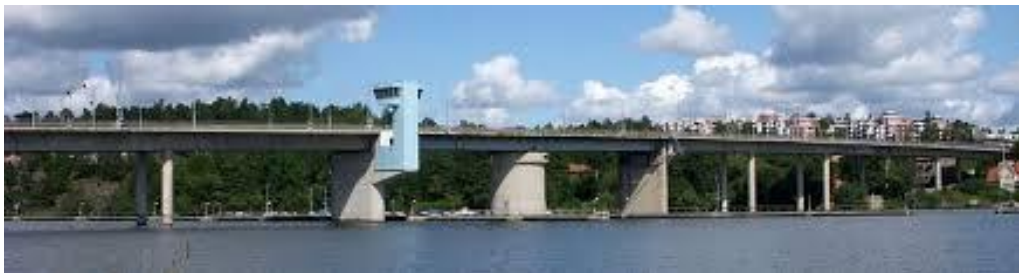
The Nockeby Bridge was built in 1973 and connects Drottningholm with Bromma in the County of Stockholm (see Fig. 8). The bridge is 694 m long and is openable by means of a swing span.

Fig.8. Nockeby Bridge viewed from the side. Photo: Holger Ellgaard
