Report RL 2003:08e

***Incident involving aircraft G-FLTA at
Arvidsjaur airport, BD County, Sweden,
on the 22nd of February 2002***

Dnr L-006/02

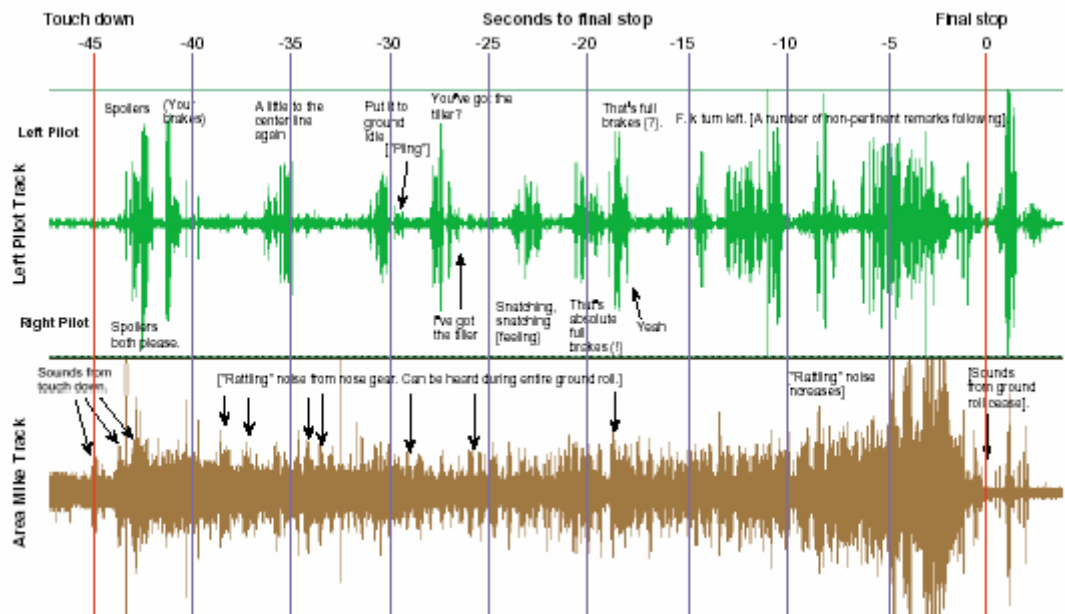
After the incident the aircraft cockpit voice recorder was sent to the AAIB in England for transcription. Sounds and conversations in the cockpit during the entire approach have been recorded with good quality from 12:47 hours. A transcript of the recorded sound has been compiled (Appendix 1.). From the touchdown and rollout on the runway, an illustration has been produced based on a time-amplitude diagram of the CVR sound with the pilots' communications inserted - see below.

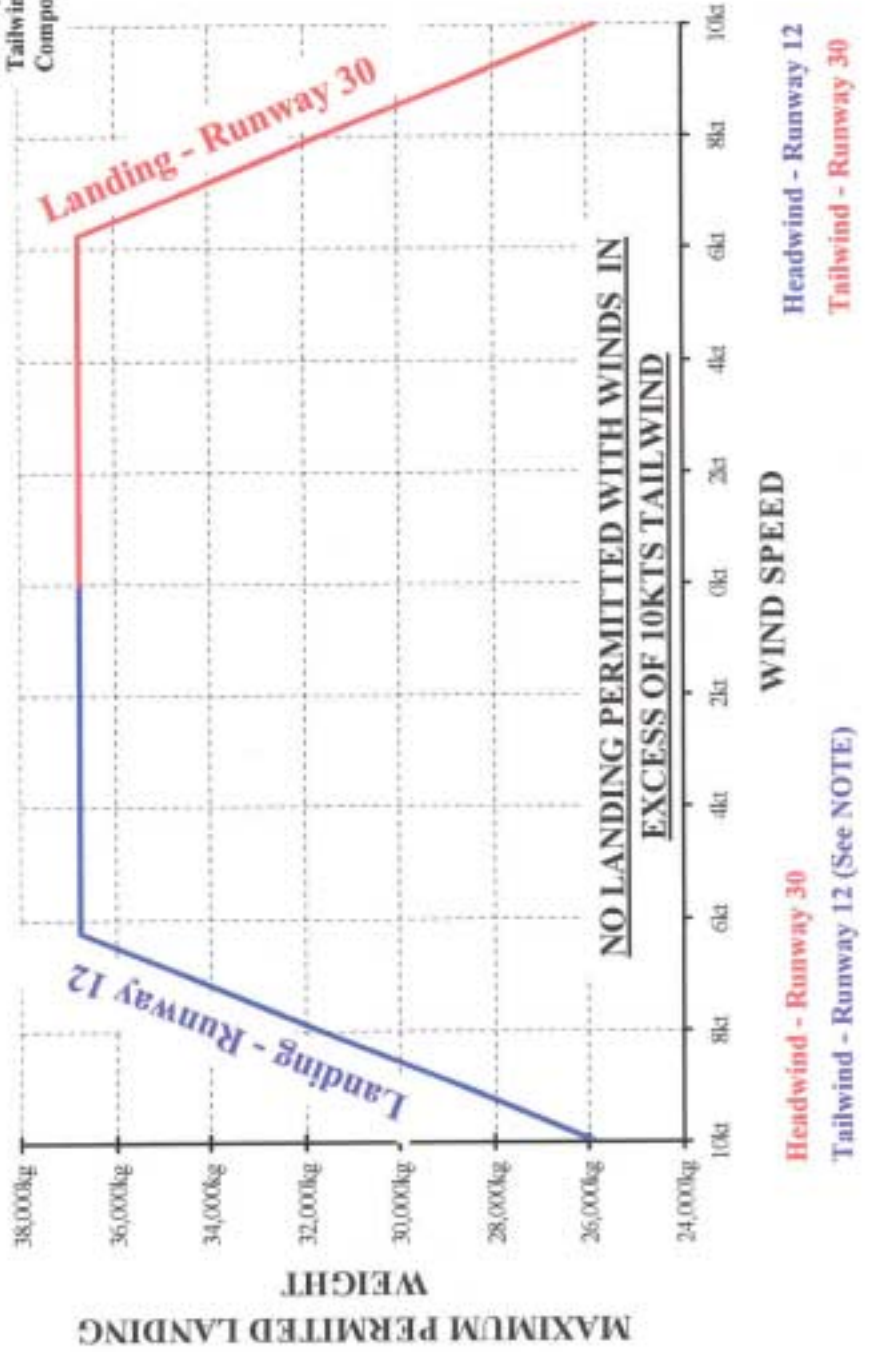
CONTAMINATED - COMPACTED SNOW

allowed, weather the runway condition in "Regulated Landing Weight on Contaminated Runways to JAR-OPS Requirements" should be defined as "CONTAMINATED – DRY or WET SNOW" or as "CONTAMINATED – COMPACTED SNOW".

Bae146-200 Regulated Landing Weights on Contaminated Runways to JAR-OPS Requirements

NOTE
BAE SYSTEMS
does not advise
landing on Downhill
runways with ANY
Tailwind
Component

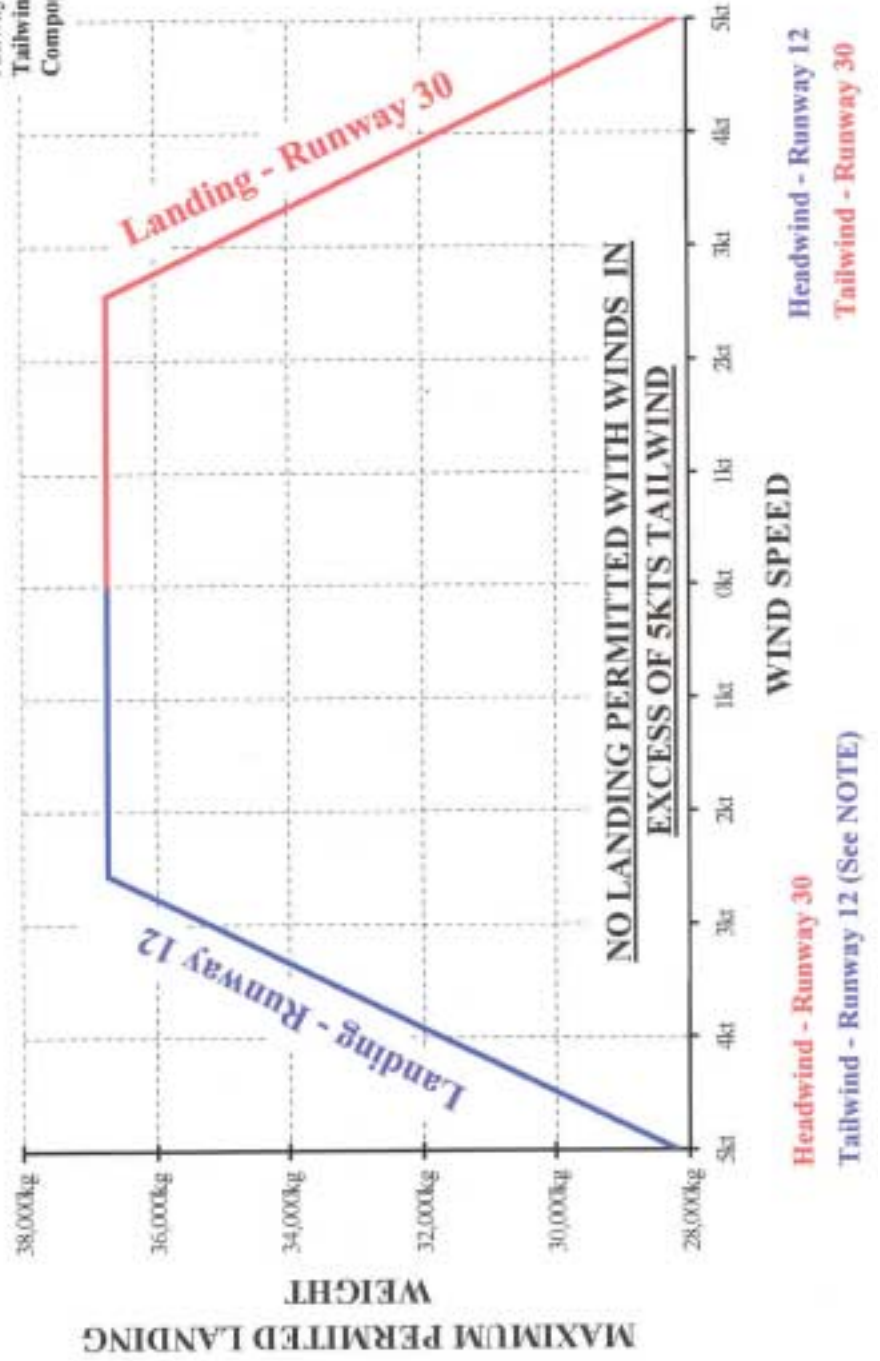
CONTAMINATED - DRY or WET SNOW

BAe146-200 Regulated Landing Weights on Contaminated Runways to JAR-OPS Requirements

NOTE
BAE SYSTEMS
does not advise
landing on Downhill
runways with ANY
Tailwind
Component
