## **MARINE SAFETY INVESTIGATION REPORT**

**Joint safety investigation into the collision between  
the Maltese bulk carrier**

***GOLDEN TRADER***

**21 nautical miles west of Thyboroen, Denmark  
on 10 September 2011**

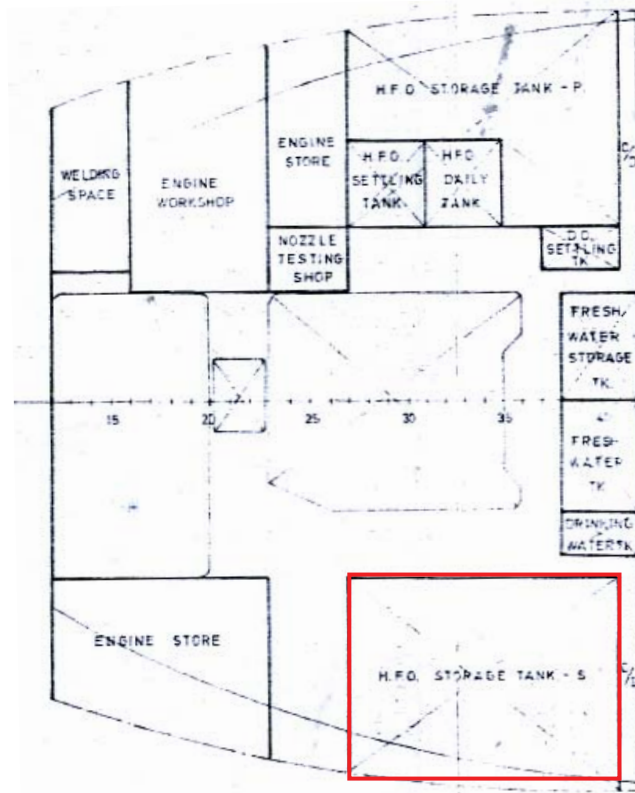
Figure 1: MV *Golden Trader* 2nd platform 9900 mm from the Base Line

*Golden Trader* has one continuous deck, a forecastle deck, raked stem, and a transom stern. The vessel is also fitted with double bottoms and the engine-room forward bulkhead is fitted at frame 42. The distance between the forward and aft engine-room bulkheads is 24 m. *Golden Trader* has two main heavy fuel oil storage tanks fitted in the engine-room, which serve as the vessel’s bunker tanks. The port side heavy fuel oil storage tank is smaller than the one on starboard side (Figure 1) owing that the former has a recess for the heavy fuel oil setting and day tanks. The capacity plan indicates that the starboard heavy fuel oil storage tank has a capacity of about 886 m<sup>3</sup> (depending on the specific gravity of the heavy fuel oil).

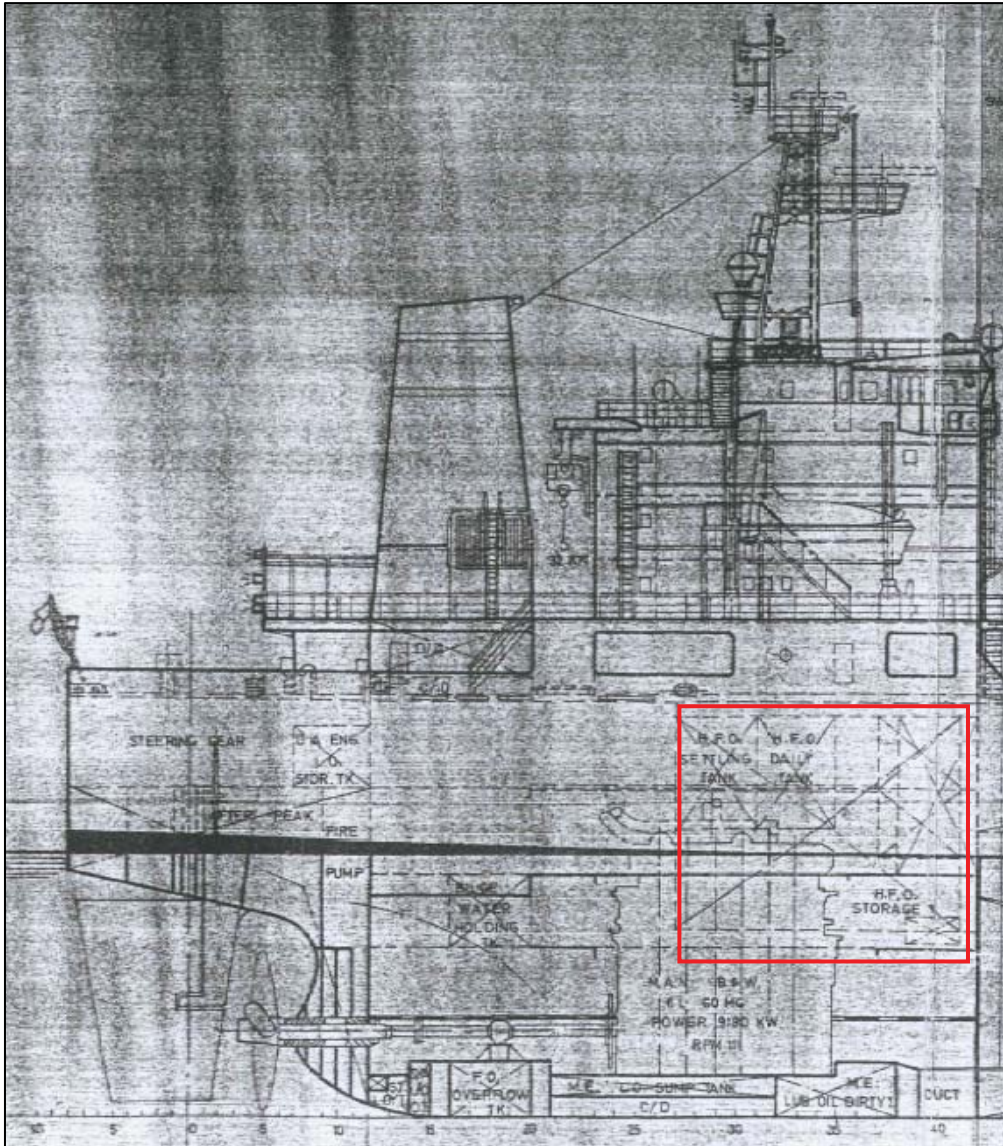
**Figure 5: Location of the no. 1 starboard heavy fuel oil storage tank in relation with the location of the engine-room**

As a result of the collision, *Golden Trader* sustained damage to its side shell plating over an area approximately 3800 mm by 1600 mm between frames 30 and 34 at the lower end of the sheer strake, which is i.w.o. no. 1 heavy fuel oil storage tank (Figures 2 to 5).

The breach in the hull i.w.o. no. 1 heavy fuel oil storage tank resulted in loss of heavy fuel oil over board. The precise amount of heavy fuel oil lost over board remains undetermined. Initially, the master estimated that a small amount of heavy fuel oil was lost. In fact, an entry in the deck log made at 1455 indicated “no leakage outside.” Subsequently, the master reported that approximately 4 m<sup>3</sup> of heavy fuel oil were lost<sup>9</sup>.

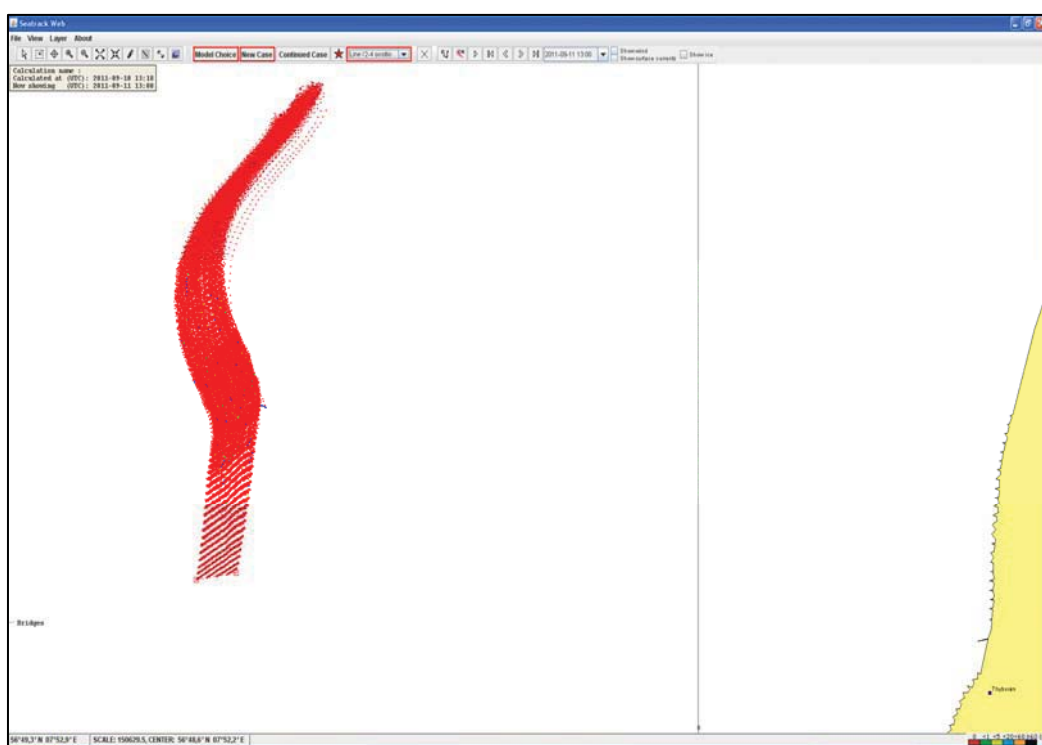
After sounding the damaged starboard side heavy fuel oil storage tank, later that same evening, it was established that about 418 mt of heavy fuel oil remained in the storage tank. It was not possible to obtain a clear indication of the quantity of oil that had been in the storage tank before the collision due to the fact that the last information in the Oil Record Book was dated 04 September 2011. Based on the tank's total capacity of 789 mt, SOK found that the maximum spill could have been up to about 370 mt, if the storage tank had been completely full before the collision. Nevertheless, SOK estimated that the release of fuel oil was in the order of 150 mt.

SOK made an early assessment calculation with a computer program (SeaTrackWeb) to obtain a forecast of the oil's path one day ahead in order to find out the spread of the presumed oil spill (Figure 9).

Figure 9: Oil drift prognosis for 10 to 11 September 2011 off the Danish west coast

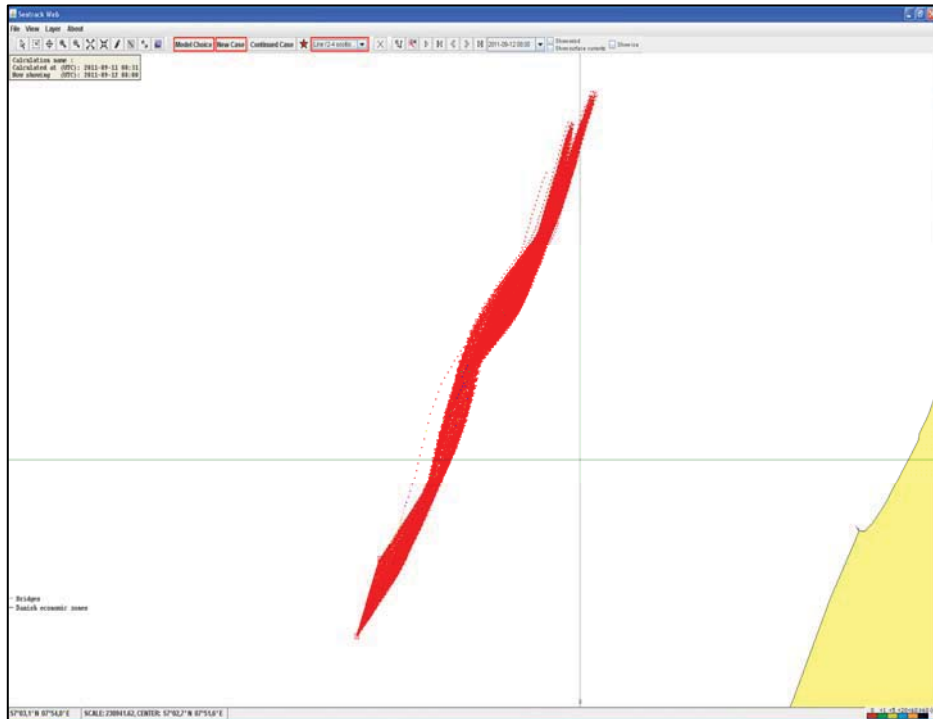
Based on the two observations during the day, SOK made two oil drift calculations, the first with an assumed starting position in the morning and the other in the afternoon based on where *GUTH* found the oil (Figures 10 and 11). Oil drift calculations that had been done gave a drift speed of 0.8 knots, while observations on the oil on 11 and 12 September indicated a drifting speed of 1.2 knots.

**Figure 10: Oil drift prognosis, September 11 to 12 off the Danish west coast**  
*Source: SOK*

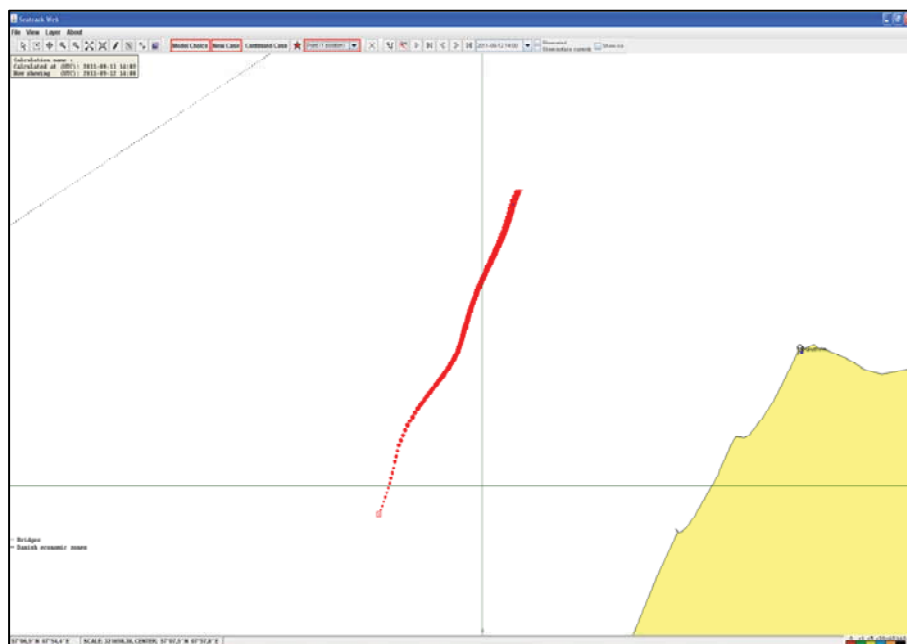
**Figure 11: Oil drift prognosis, September 11 to 12 off the Danish west coast**  
*Source: SOK*

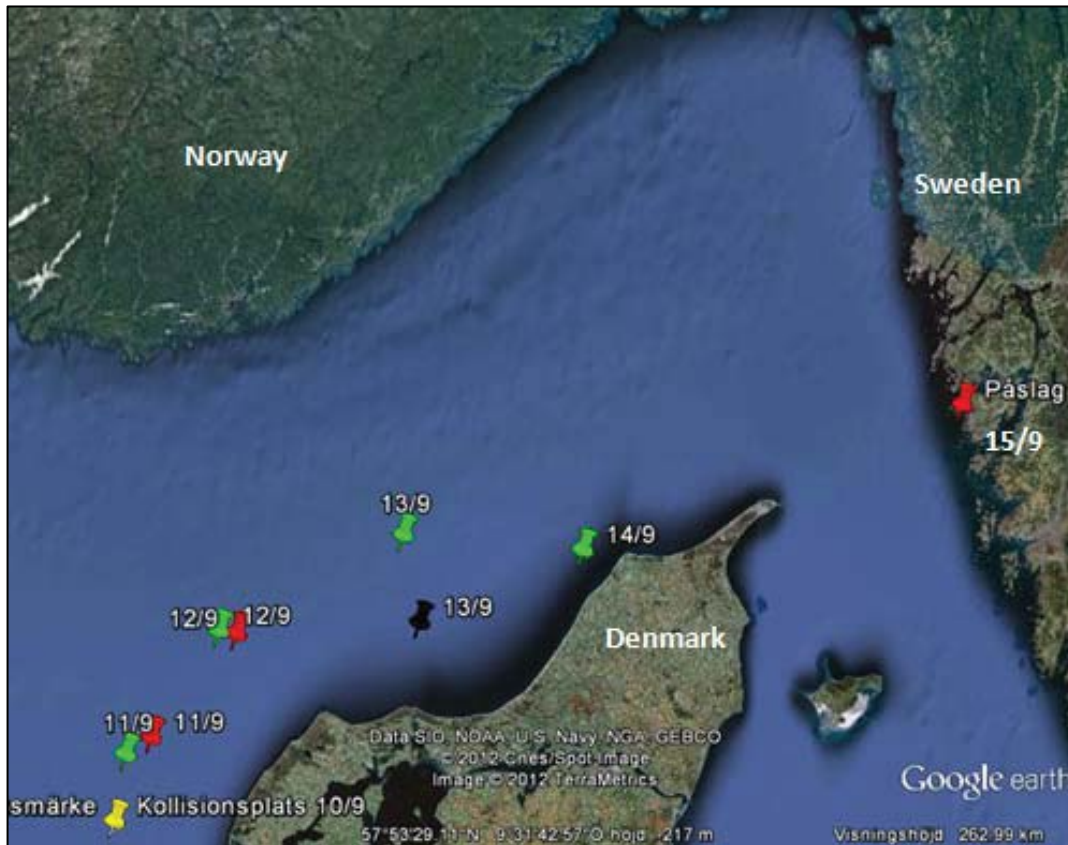
The weather in the area during the day of 11 September 2011 was windy with speeds of  $10 \text{ ms}^{-1}$  and a significant wave height of 1 m. The observation of oil was about five nautical miles North-west of the forecasted position (Figure 12).

Figure 12: Forecasts of oil drift. The observation on 12 September 2011 was made at 0835 and forecast at 1400

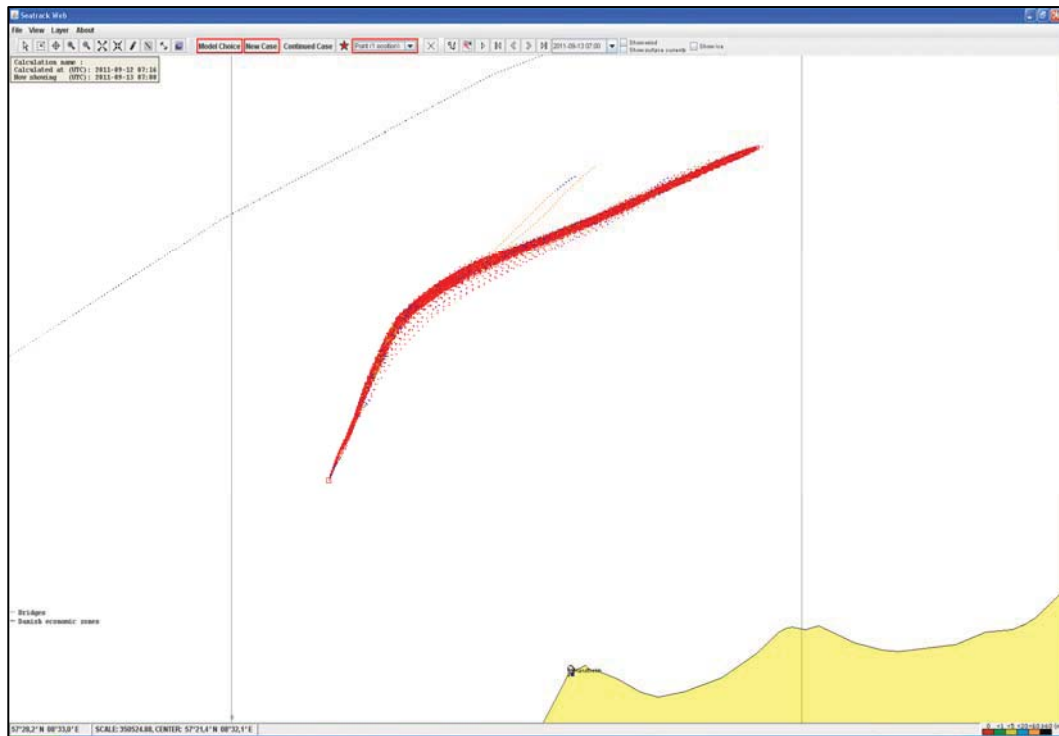
The weather was about the same as the day before, although the wave heights had increased slightly to over one metre. After the oil had been detected at around 0800 on Monday morning, SOK calculated a new forecast for the following 24 hours. The forecasted track showed that the oil's path changed course by about 45° to the East, which meant that the course in general followed the coastline at a speed of about 1.3 knots (Figure 13).

**Figure 13: Oil drift forecast 12 to 13 September off the Danish coast**  
**Source: SOK**

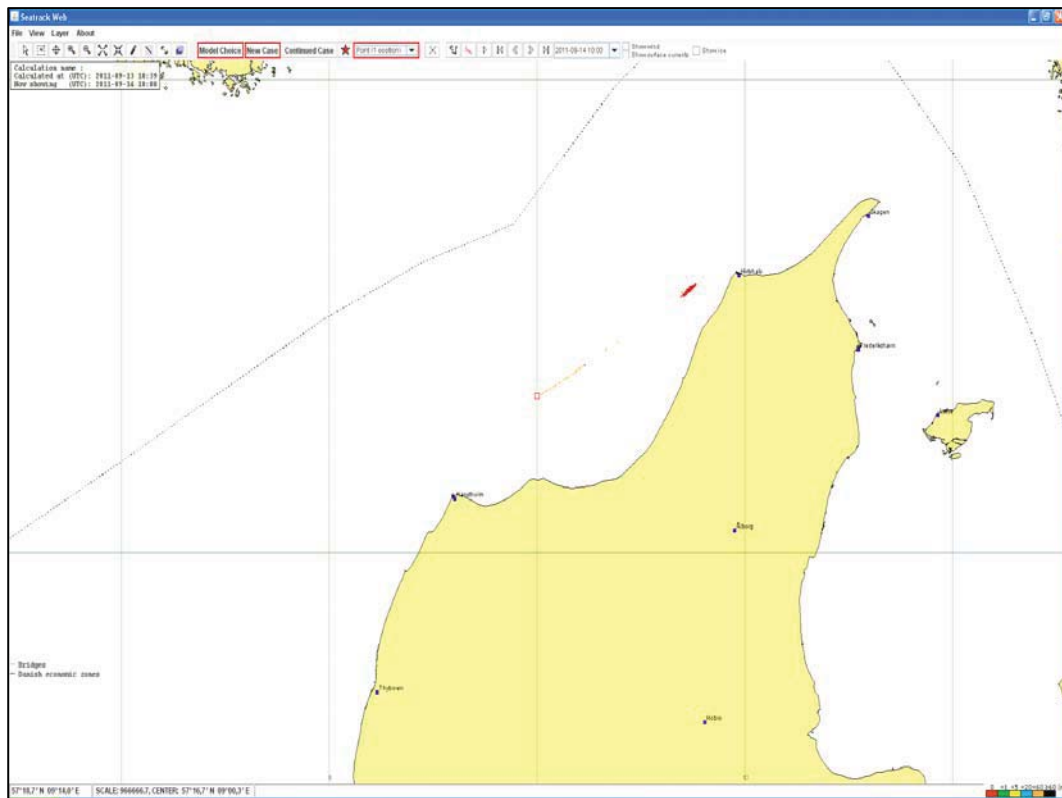
SOK warned the police in the western and northern Jylland that there was a risk of an oil spill on the beaches. Reports of oil on the beaches were received neither on 13 September nor at a later date. SOK made an oil drift calculation based on the area where traces of oil were observed in the morning (Figure 14). The forecast track continued to follow the shoreline in a North-easterly direction with a drift velocity of about 1.1 knots.

**Figure 14: Oil drift forecast 13 to 14 September off the Danish north coast**  
**Source: SOK**

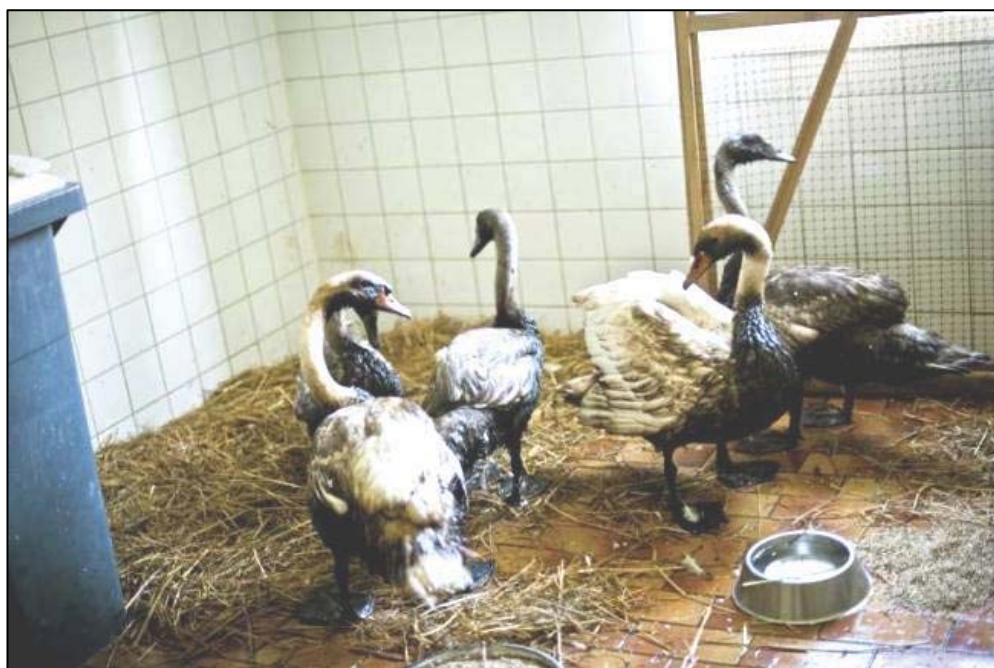
Several authorities were involved in the decontamination operation with a large number of employees and other resources. Furthermore, two non profit organisations were helping with the clean up of birds covered in oil<sup>11</sup> (Figure 16).

Figure 16: Birds brought in for cleaning by volunteers
