Accident involving the rollercoaster Jetline at Gröna Lund

The Swedish Accident Investigation Authority has investigated an accident at Gröna Lund in Stockholm on 25 June 2023.

14 June 2024

File number: O-6/23

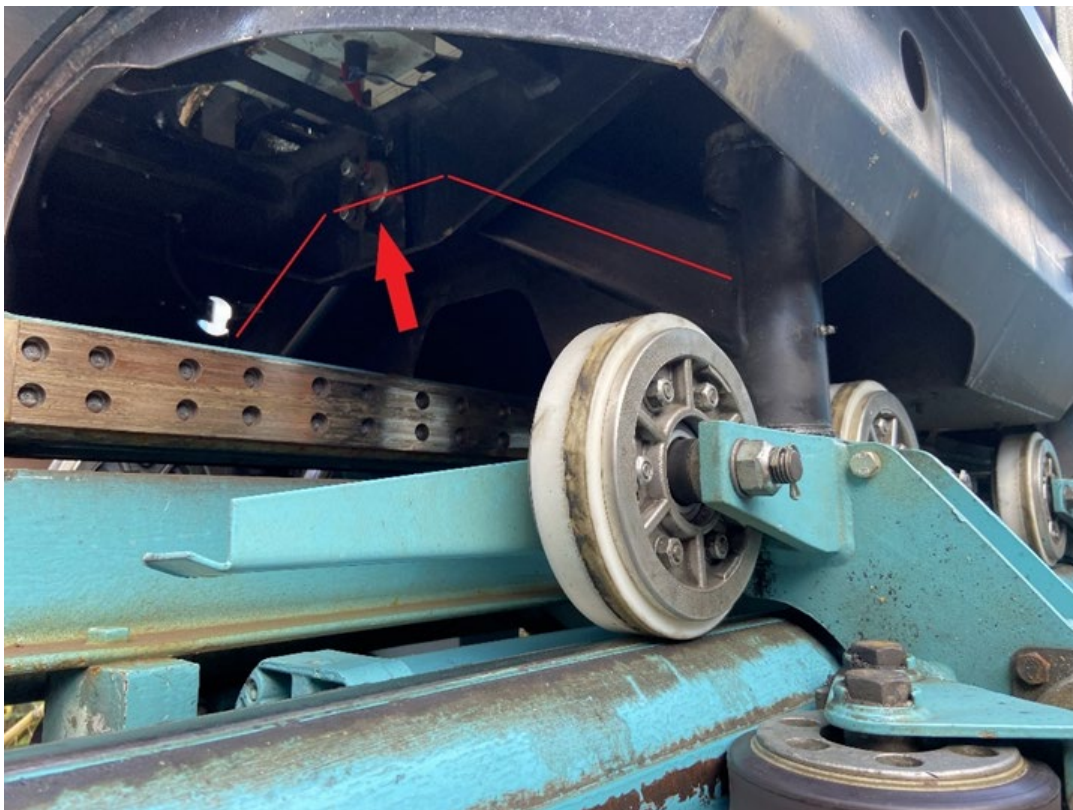
Figure 3. The underside of the front car of one of the trains with the front mobile control arm marked with a red line. The red arrow points to the end of the axle on which the control arm is mounted. (The picture does not depict the train involved in the accident.)

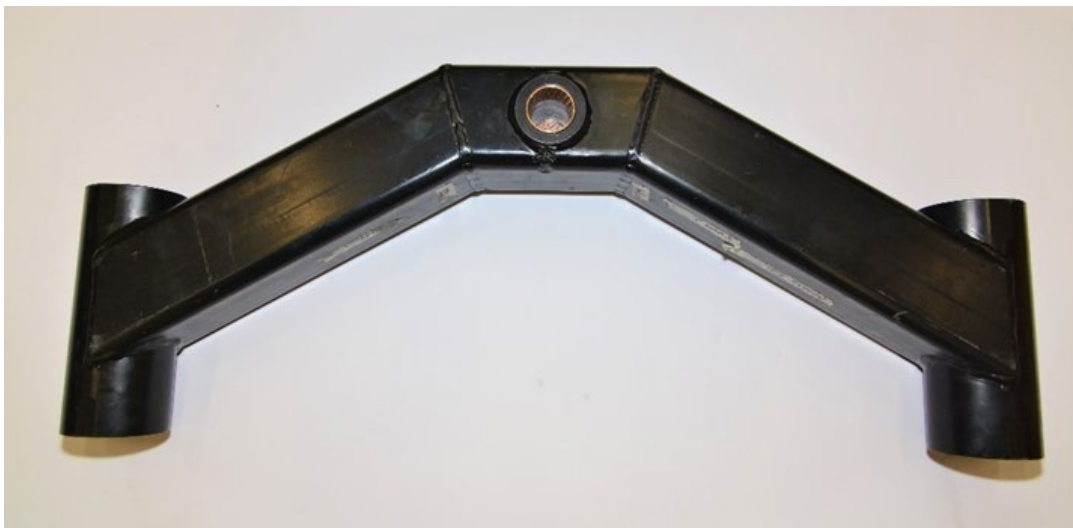
Figure 8. A front control arm on a Jetline train with the hole in the middle for the axle attachment to the car.

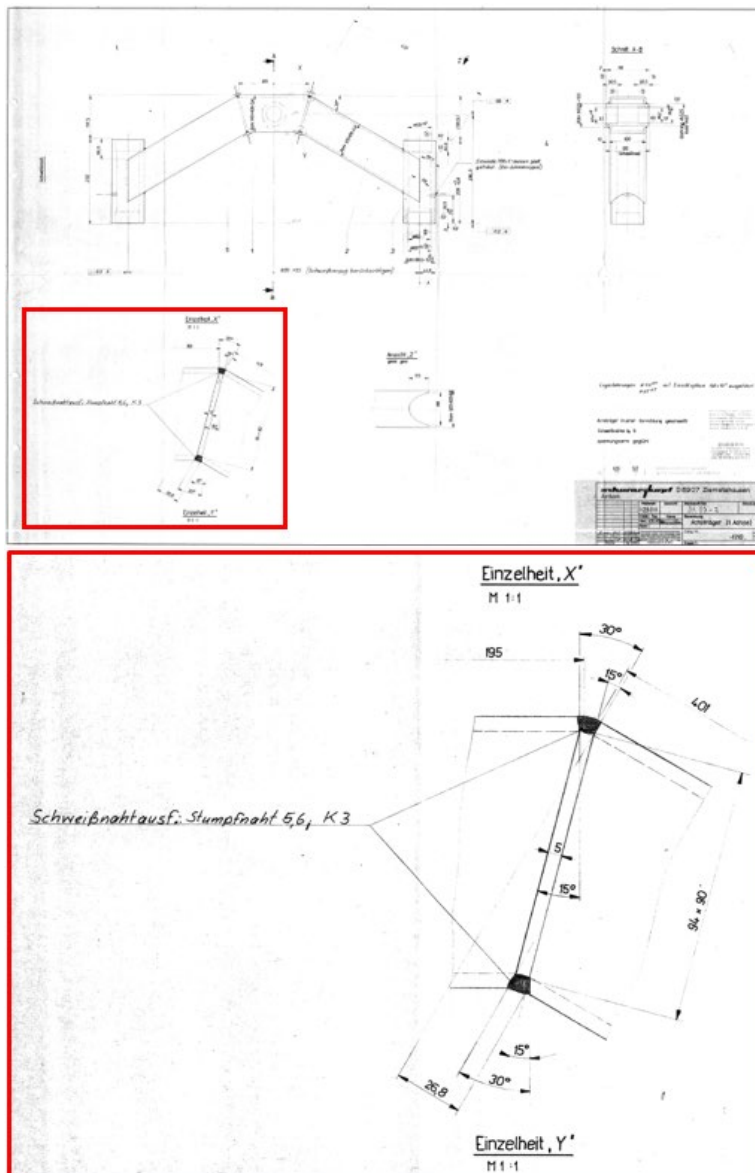
The drawing showed how the welds in the joints between the square tubes in the control arms were to be formed. What was specified were measurements and angles for the ends of the tubes and that the welds were to be executed as butt welds. Butt welding involves the material being welded together end to end with a certain distance between the ends and a certain angle between the edges of the ends. At the joints closest to the middle of the control arms, the welds were to be executed in a root gap of 5 mm between the square tubes and with the edges of the tubes at an angle of 15 degrees (see Figure 24). The butt weld was also

to have an even surface and a smooth transition towards the material that is welded together.

Figure 24. The entire drawing of the control arm from the order in 2019 is shown above. The image below shows an enlargement of the area in the square marking on the drawing. The measurements and infill (the black infill) for the weld in the joints in the square tubes closest to the middle of the control arm. The German word Einzelheit on the drawing means detail. Drawing from Gröna Lund (Appendix 1).
