# RON JEREMY– the sinking of the vessel off the coast of Piteå

The Swedish Accident Investigation Authority has investigated a marine accident that occurred off Piteå, in Norrbotten County, on 1 June 2025

29 May 2026

File number: S-127/25

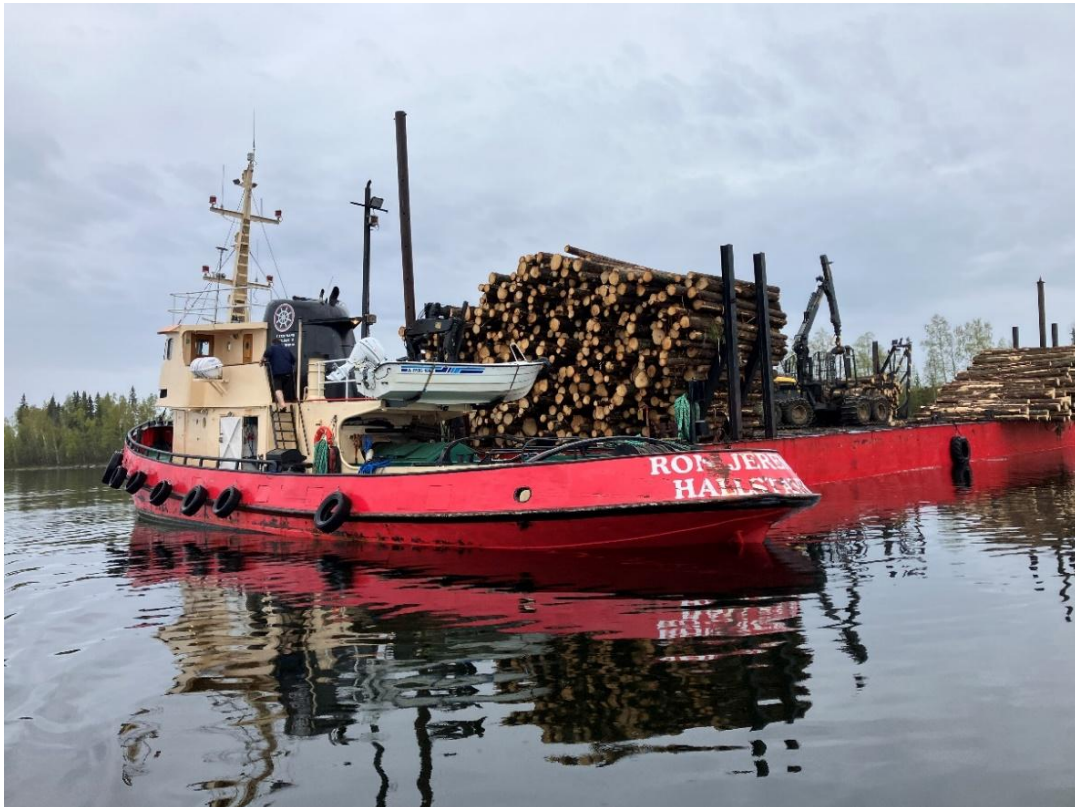
Figure 1. The image shows the vessel moored alongside the barge. The photo was taken on 31 May 2025. Photo: The Swedish Coast Guard.

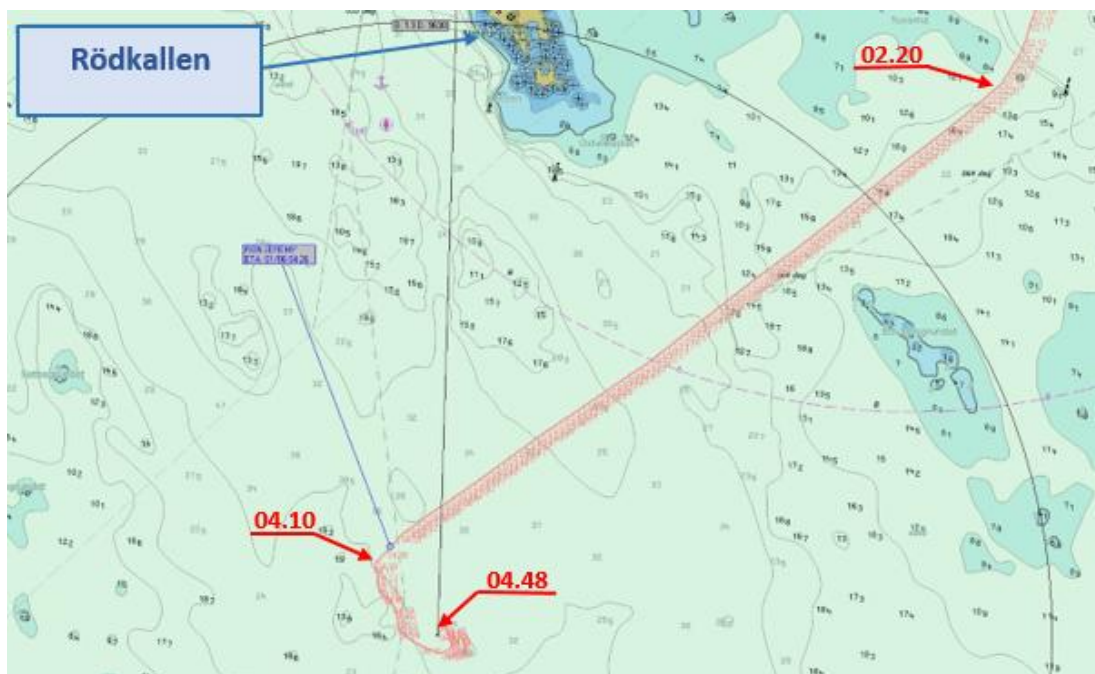
Figure 4. The AIS track after the vessel set a south-westerly course at 02:20, until the master altered course to south-east at 04:10, and the vessel's final position just under 10 kilometres south of the island of Rödskallen at 04:48. ©Swedish Maritime Administration no. 26-00511. Annotations added by SHK.

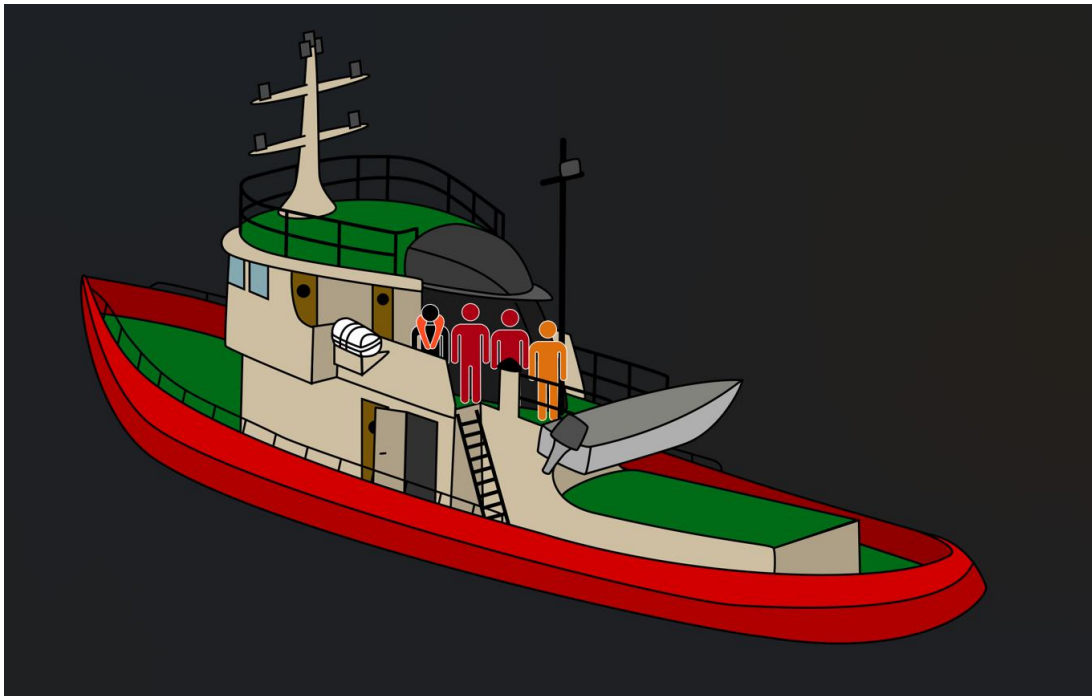
Figure 7. The image shows the approximate positions of the crew. Deckhand 2, wearing a red lifejacket, is furthest forward, followed by the chief officer and deckhand 1 in red immersion suits, and the master furthest aft in an orange immersion suit. The port-side life raft was in its cradle. Note the port engine room door, which was reportedly open.

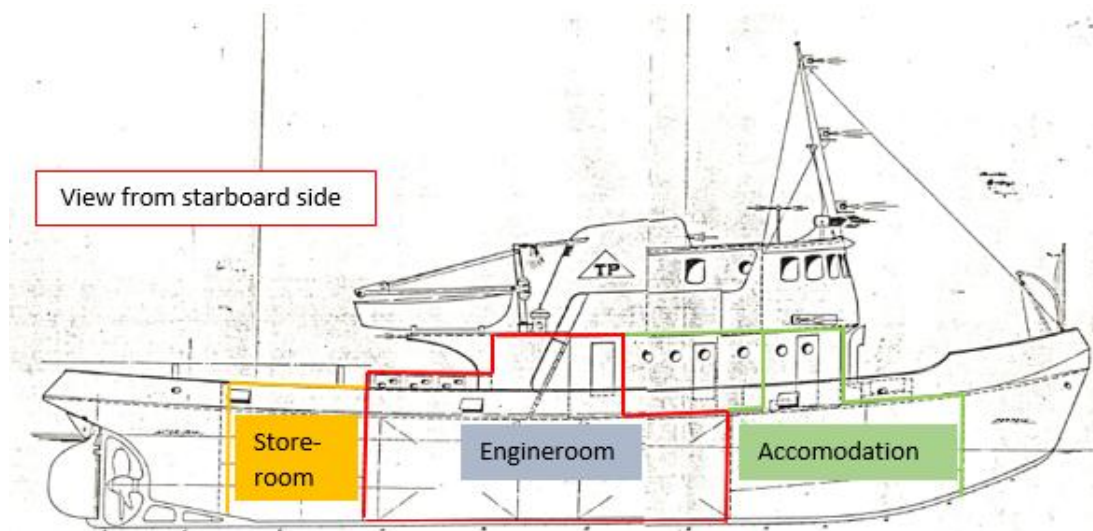
The vessel was divided into three watertight compartments: a storeroom at the aft end, the engine room amidships, and accommodation at the forward end, see Figure 10.

Figure 10. The image is from an old stability document from the Swedish Transport Agency and shows an overview of the vessel's layout and its three watertight compartments: storeroom, engine room, and accommodation. Aft of the storeroom and forward of the accommodation were two ballast tanks. Image: Swedish Transport Agency. Annotations added by SHK.

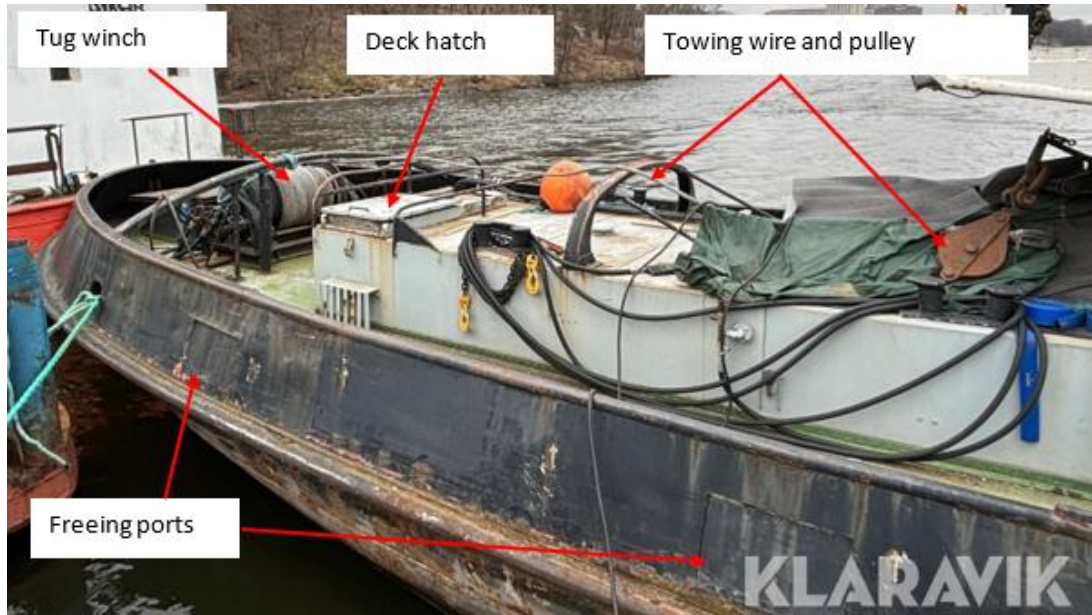
Access to the compartments was via openings on the main deck. The storeroom at the aft end was reached through a hatch located on a raised section of the aft deck, approximately one metre high. The hatch was designed as a sliding hatch and opened sideways to port. Since the hatch was positioned on the raised section and the towing wire ran over it, it was only possible to enter the storeroom when the vessel was not towing or was stationary, see Figure 11.

Figure 11. The vessel's aft deck, showing, among other things, the deck hatch to storeroom and the towing wire. Image: Klaravik. Annotations added by SHK.

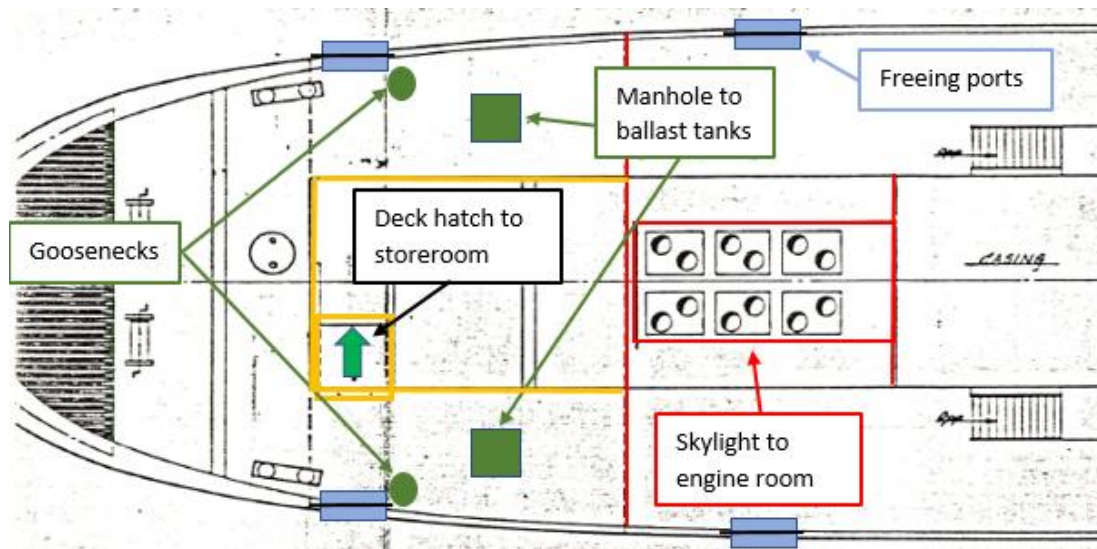
To prevent water from breaking seas from accumulating on deck, there were openings in the vessel's rail, known as freeing ports. From photographs, four freeing ports have been identified on the aft deck, evenly distributed on each side of the vessel, see Figure 12.

Figure 12 shows the vessel's aft deck and the locations of the freeing ports, goosenecks, and manholes to the starboard and port ballast tanks, as well as the access hatch to the storeroom and the skylight to the engine room.
